Port Darlington Shore Protection Concepts

October 5 2018 | 12875.101

Central Lake Ontario Conservation Authority
100 Whiting Avenue
Oshawa, Ontario L1H 3T3

W.F. Baird & Associates Coastal Engineers Ltd.

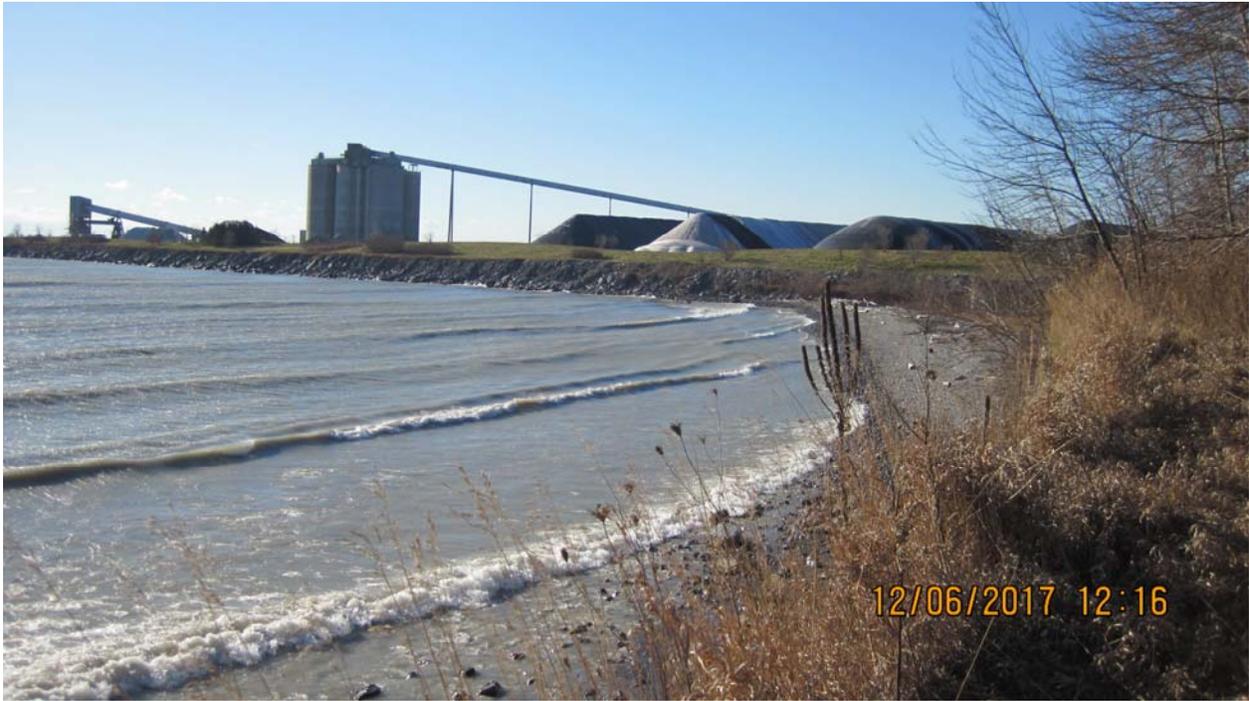
Figure 2.1: West end of study shoreline with fillet beach deposit on east side of St. Marys Cement

The west end of the study shoreline features eroding cohesive bluffs. A fillet beach has deposited at the west end of the reach, adjacent to the St. Marys Cement pier as shown in Figures 2.1 and 2.2. The beach is sand, cobble and boulder composition. A drainage channel has been excavated from the Westside Creek Marsh. On the day of the site visit (December 6, 2017), the beach deposit obstructed the channel mouth.

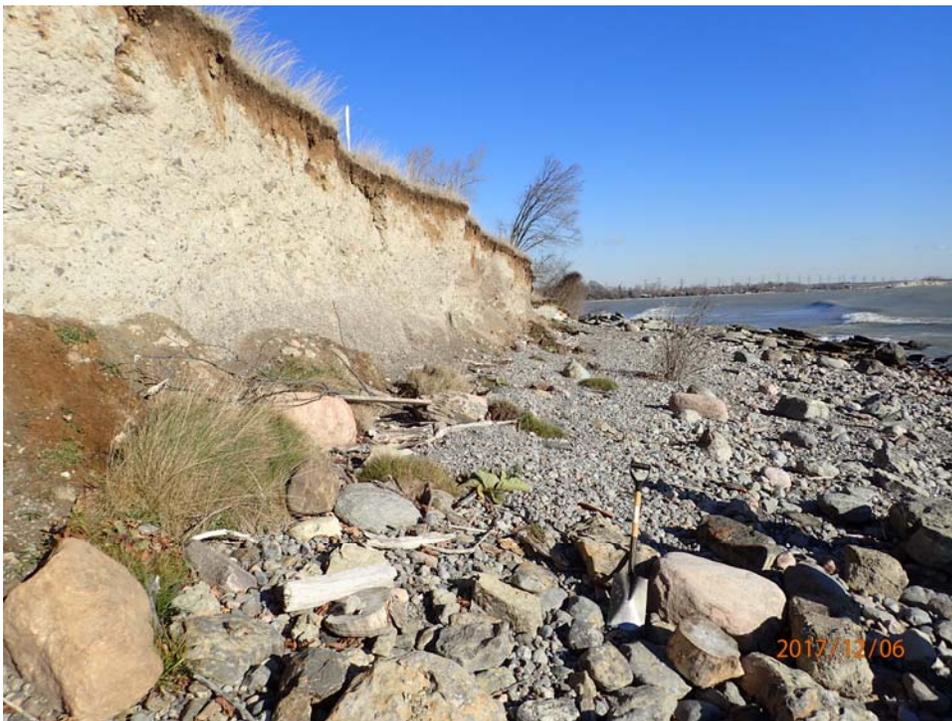
Figure 2.2: Eroding bluff and cobble and boulder beach at west end of study shoreline

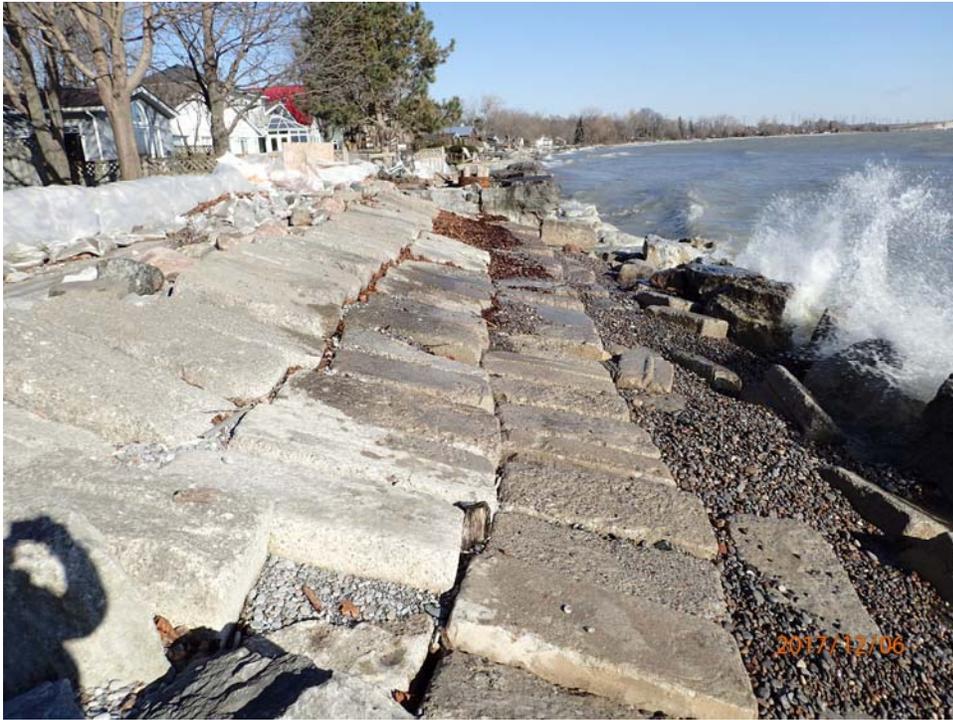
Figure 2.3: Concrete block revetment at Cedar Crest Beach Road

East of the cohesive bluff, along the shoreline backed by Cedar Crest Beach Road, the shoreline historically was a barrier beach, separating the Westside Creek Marsh from Lake Ontario. Presently, it is developed with permanent residences. The area has experienced erosion and flooding, and the shoreline is armoured with various types of protection including concrete wall, armourstone, gabions and ad hoc protection; examples are shown in Figures 2.3 to 2.6.

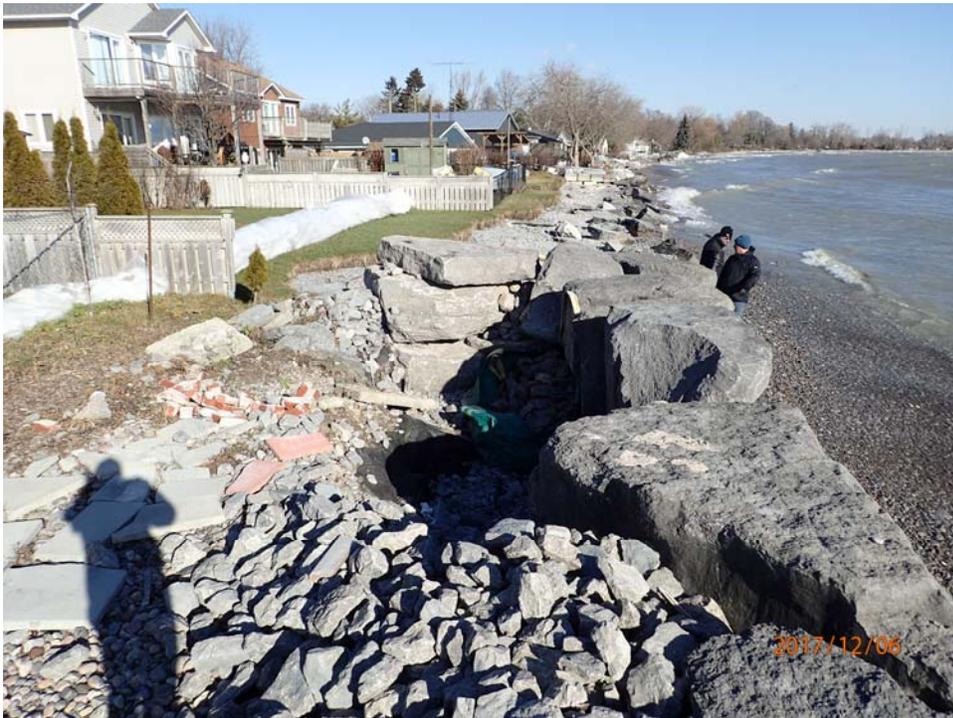
Figure 2.4: Armourstone protection at Cedar Crest Beach Road

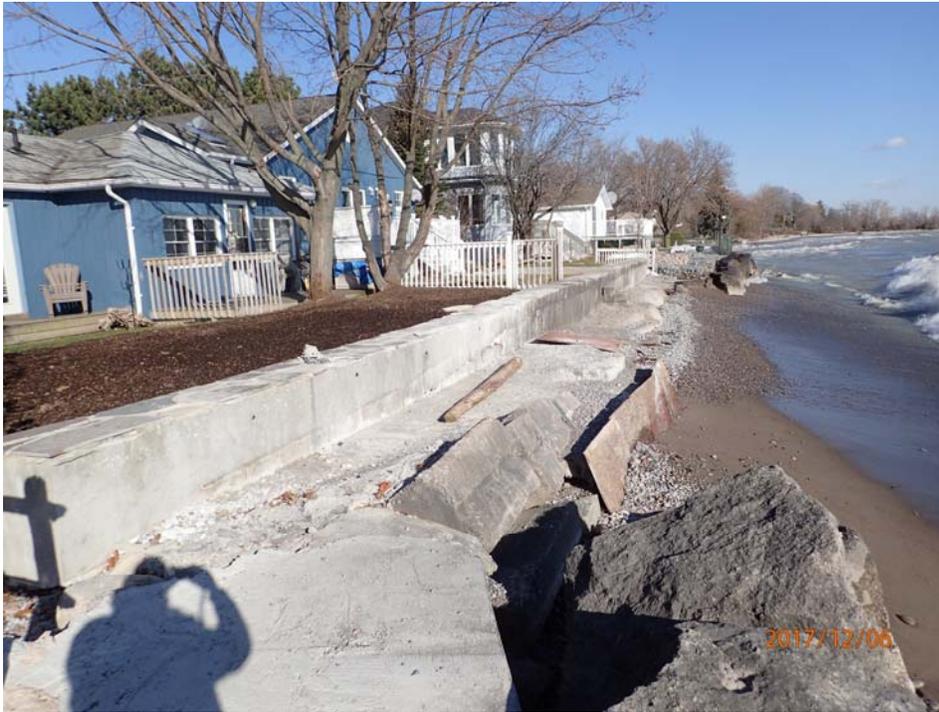
Figure 2.5: Concrete seawall at Cedar Crest Beach Road

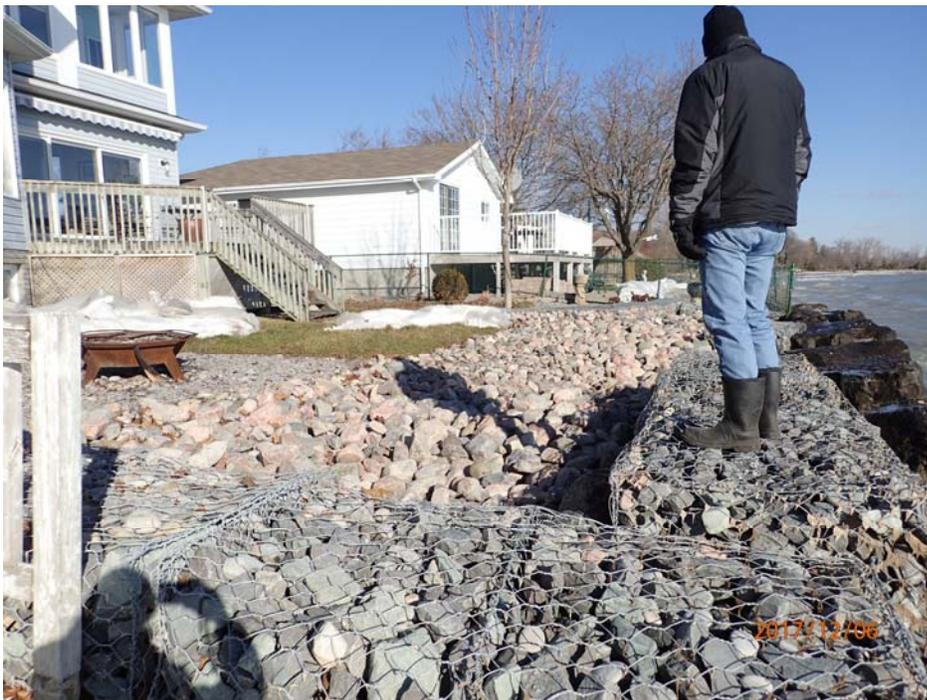
Figure 2.6: Gabion shore protection at Cedar Crest Beach Road

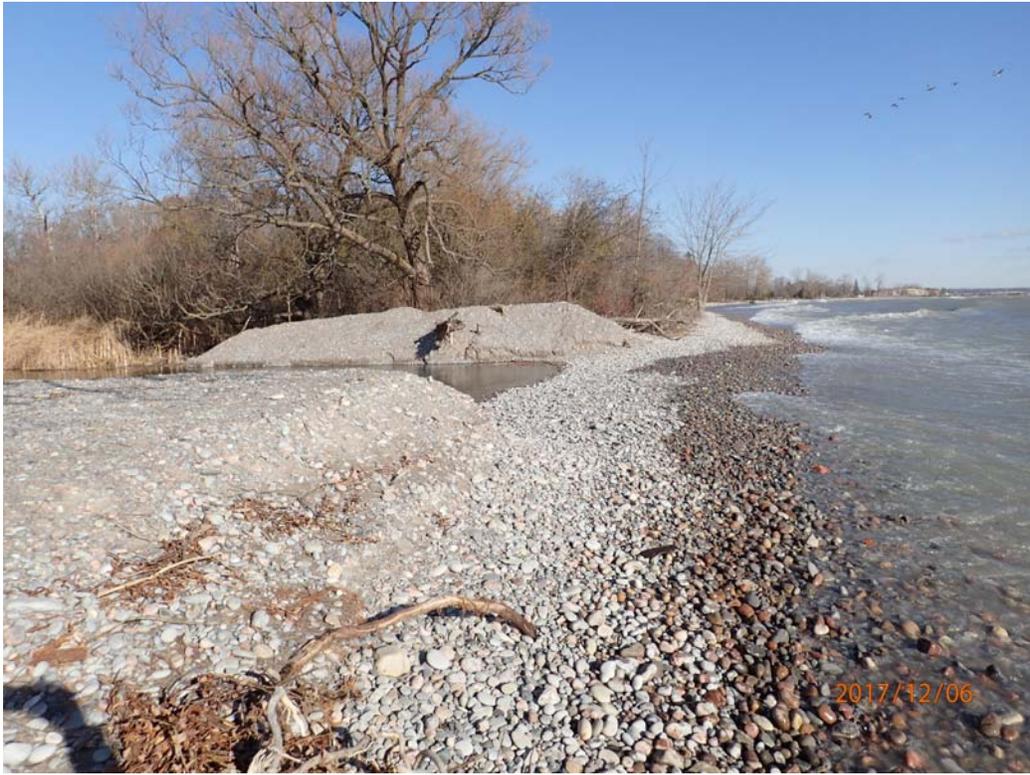
Figure 2.7: Mouth of Westside Creek with dredge spoil visible on east bank

Westside Creek marks the eastern limit of Cedar Crest Beach Road. A sand and cobble bar obstructed flow at the creek mouth on the day of the site visit (Figure 2.7). The mouth had been dredged to permit flow and dredge spoil was visible on the east bank.

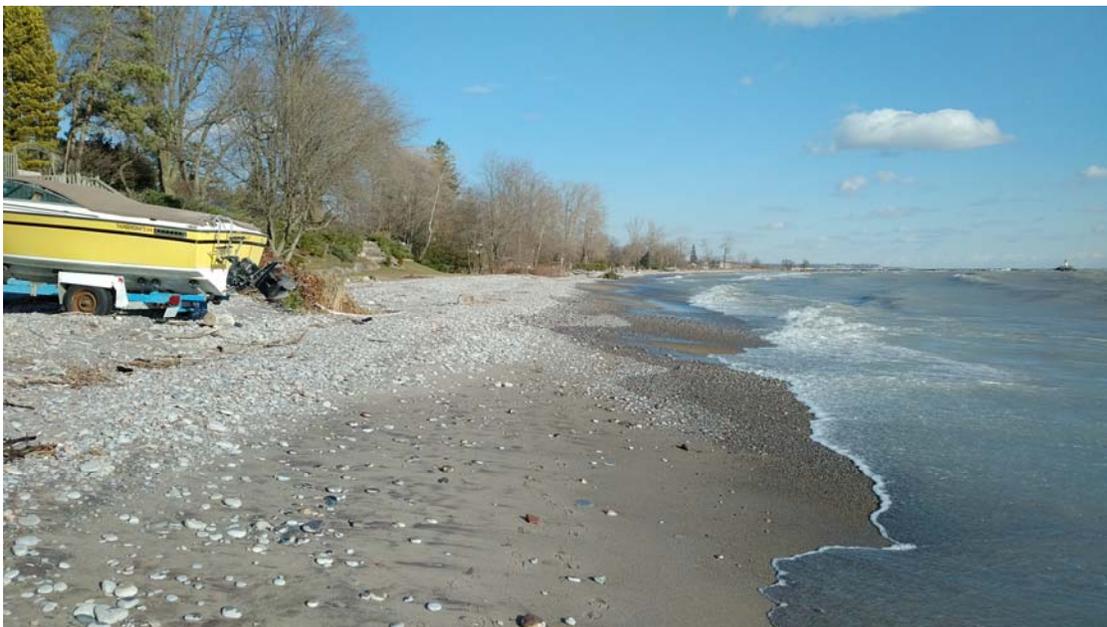
Figure 2.8: View east from Westside Creek along beach backed by Cove Road

The shoreline east of Westside Creek, backed by Cove Road is a sand and cobble beach. The properties are deeper than those along Cedar Crest Beach Road, and houses are generally setback further from Lake Ontario as shown in Figures 2.8 and 2.9. Shore protection structures have generally not been constructed and the beach has a natural appearance.

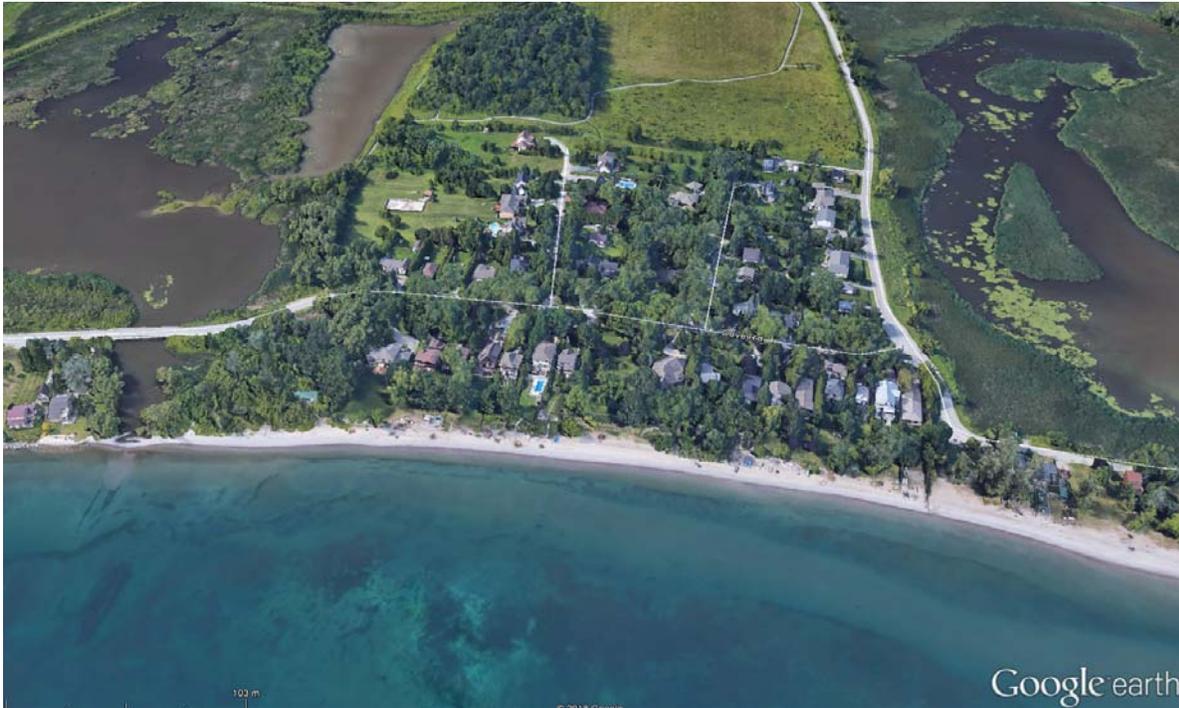
Figure 2.9: Shoreline backed by Cove Road in centre of image, showing larger setbacks for houses compared to adjacent shorelines along Cedar Crest Beach Road and West Beach Road

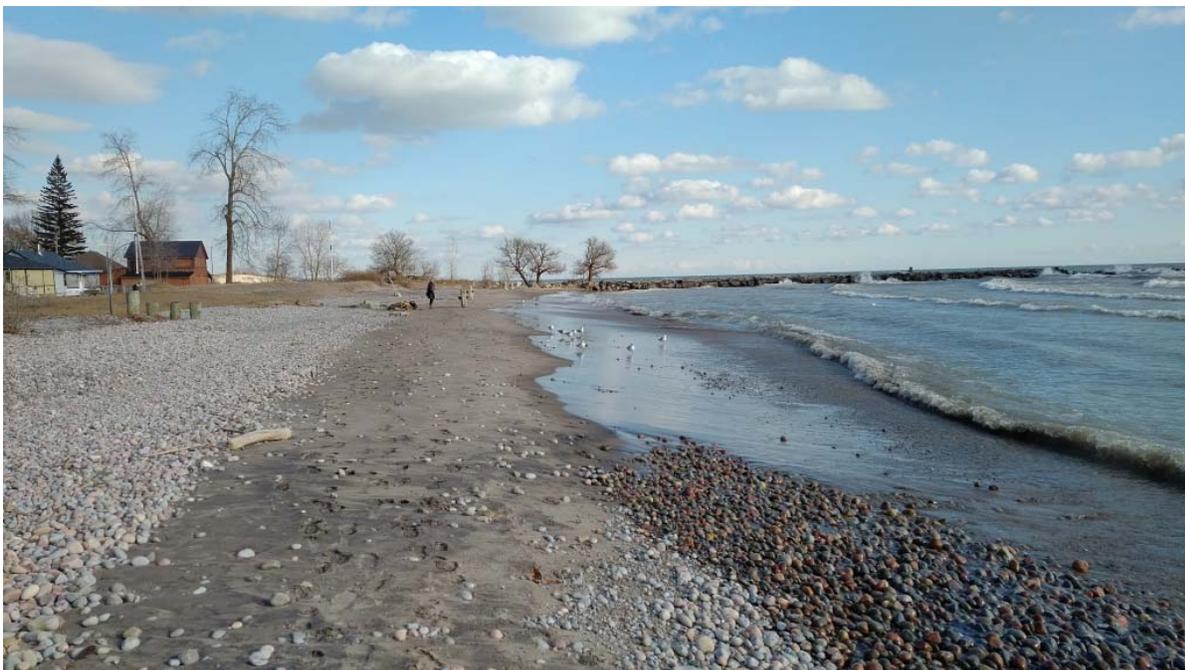
Figure 2.10: View east along shoreline fronting West Beach Road with Darlington Harbour pier in background

West Beach Road is located east of Cove Road. This stretch of shoreline is a sandy barrier beach that separates the Bowmanville Marsh from Lake Ontario. The beach has accreted as sediment is transported in an easterly direction and deposits on the west side of the breakwater at the mouth of Bowmanville Creek (Figure 2.10). The breakwaters that mark the entrance to Bowmanville Harbour are in a state of disrepair, and the sand is now bypassing the west breakwater by moving over, through and around the offshore end of the structure, and depositing in the channel. This is discussed further in Section 2.4. The houses are generally set back from Lake Ontario and the beach is unprotected along this shoreline.

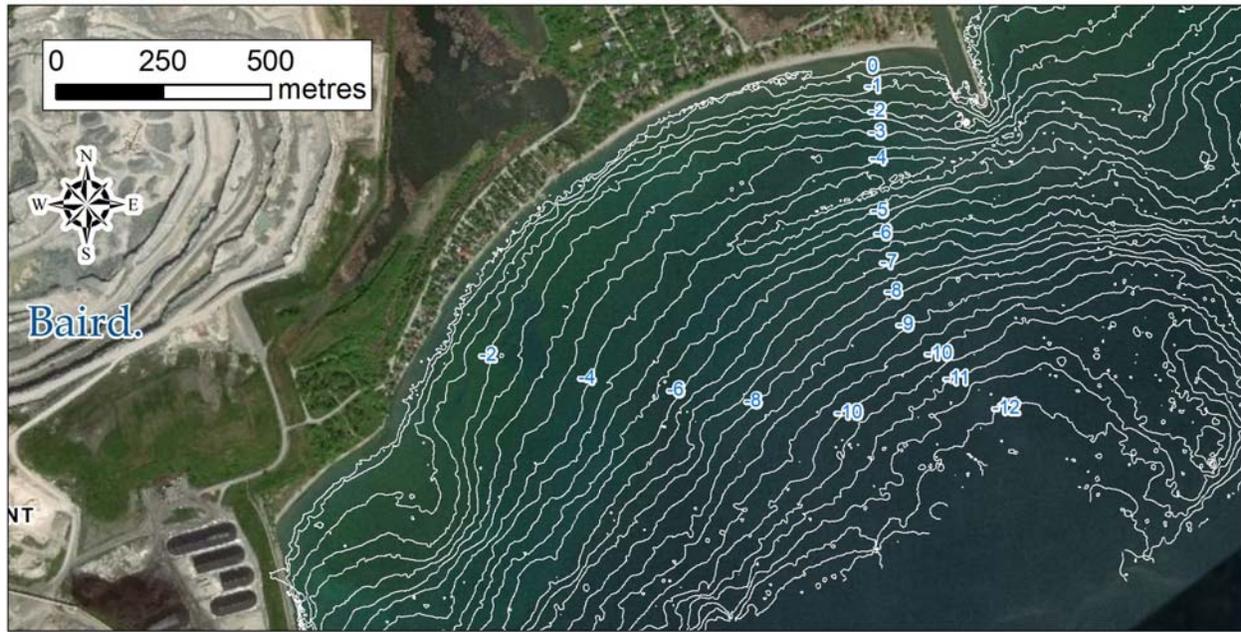
The 2001 Scanning Hydrographic Operational Airborne LiDAR Survey (SHOALS) data were used to define the bathymetry in the study area. Figure 2.11 shows a shallower shelf feature at the west end of the study site, indicating harder substrate compared to the lakebed to the east. The contours indicate an area of sediment deposition on the west side of the breakwater west of Bowmanville Creek where the fillet beach has deposited.

Figure 2.11: Bathymetry data from 2001 SHOALS

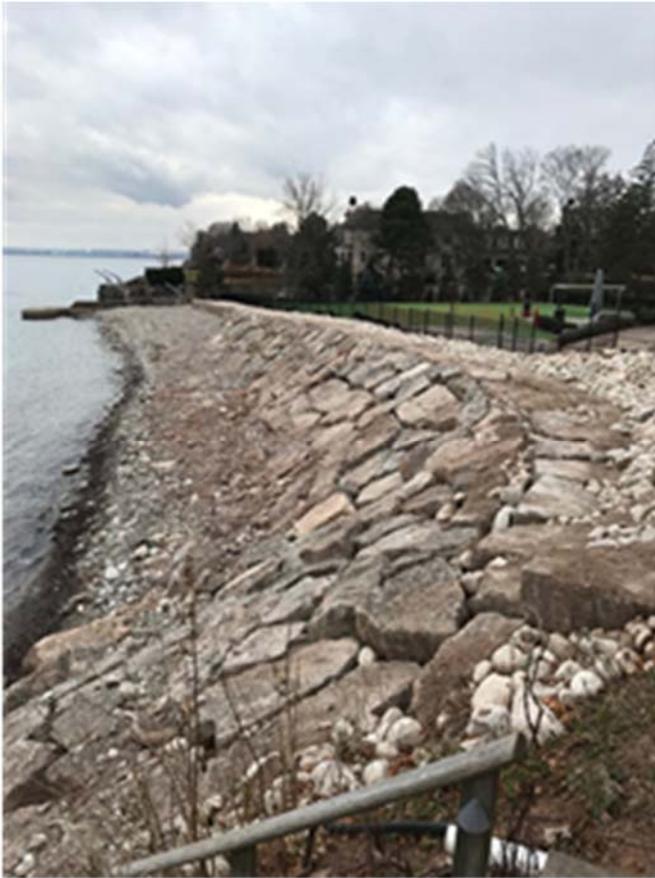
Concept 4 is an armourstone revetment; an example of an armourstone revetment is shown in Figure 3.4. The entire shoreline is currently protected by various seawalls, revetments, gabions and ad-hoc measures. Many are in a state of disrepair or are not designed to provide the required level of protection. This option would involve replacing existing structures with an armourstone revetment along the properties on Cedar Crest Beach Road. It does not include jetties to impede sand bar formation at the mouth of Westside Creek and the flood drainage channel.

This concept will mitigate further shoreline erosion, but it will do little to address flooding during high water levels. The backshore elevations are below the flood level, and the crest elevation would have to exceed the backshore elevation to address the flood hazard (e.g. runup and overtopping) from Lake Ontario. In doing so, it would trap flood water from inland (Westside Creek and Bowmanville Creek), exacerbating inland flooding hazard.

Figure 3.4: Concept 4 - Example of armourstone revetment

Concept 4 (along with Concept 2), provides the second highest level of protection against erosion. The crest elevation of the structure would have to be designed to limit overtopping and this would be challenging considering the elevation of the land behind. A large splash pad would mitigate damage during overtopping, however this also creates a barrier to lake access. There are challenges with increasing the structure height due to the flood risk from inshore and the risk of trapping flood water from the marshes. This alternative has the lowest capital cost, however maintenance costs would be relatively high, as it does not include jetties to address the sand bars blocking flow from the creek and channel, and maintenance dredging would therefore be required to maintain flow. This concept received the lowest ranking for Socio Economic as it does not result in the creation of any public space or beach amenity. No new habitat is created with this concept.
