Lake Ontario Shoreline Management Plan

Central Lake Ontario Conservation Authority

November 5, 2020

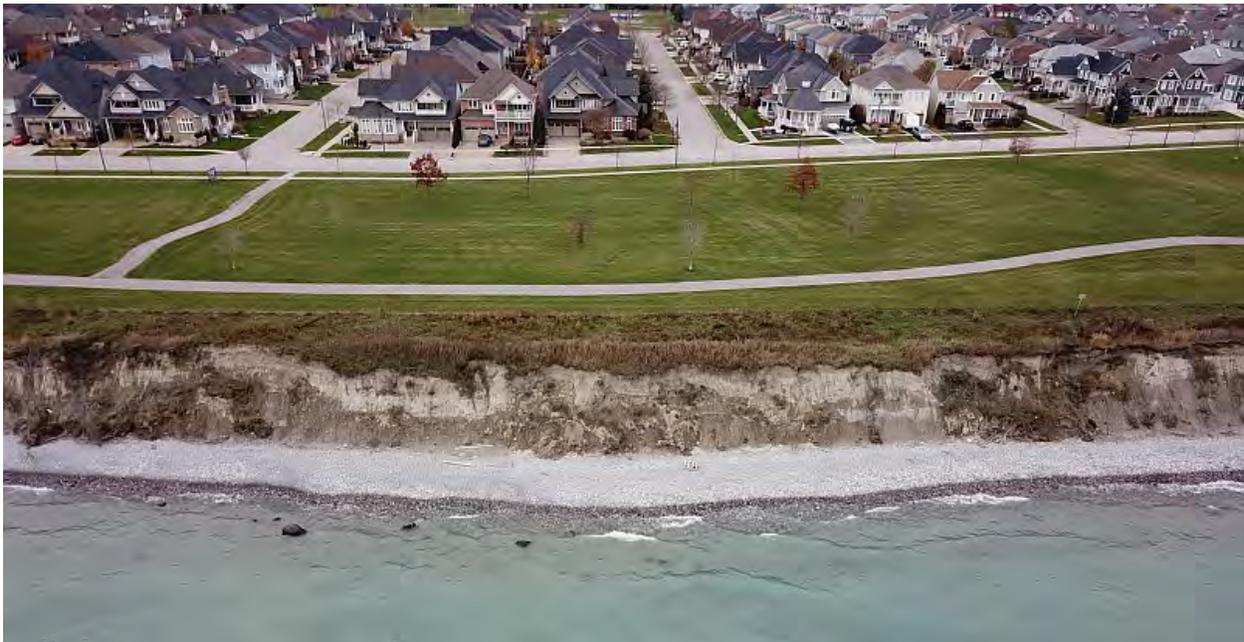
Figure 1.1 Erosion Buffer and Natural Area, Newcastle, Ontario

The report also included recommendations for land use planning to protect the aesthetic and recreational benefits of the shoreline. The 1990 SMP identified appropriate flooding and erosion hazard setbacks to protect future development within 66 individual shoreline reaches. The SMP is partly responsible for some of the most successful large-scale development setbacks on Lake Ontario. Refer to Figure 1.1 for an example of a large natural setback that buffers the development in Newcastle, Ontario.

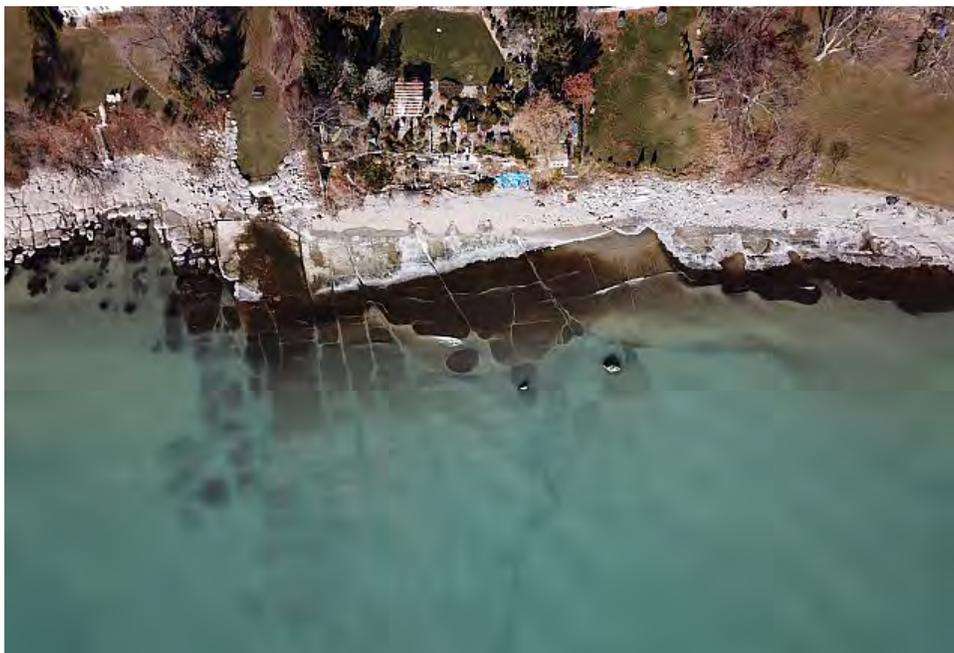
Figure 4.1 Exposed Limestone Bedrock East of Cobourg Harbour

The surficial bedrock in the study area consists of limestones and shales from the Middle Ordovician period, when the Great Lakes region was part of a warm tropical sea (OGS, 1991; SSW, 1990). In the western portion of the study area, the bedrock is covered by more recent glacial deposits. However, east of Cobourg, the limestone bedrock is often found at the waters edge and in the nearshore. Refer to Figure 4.1 for an aerial view of the exposed bedrock east of Cobourg Harbour.

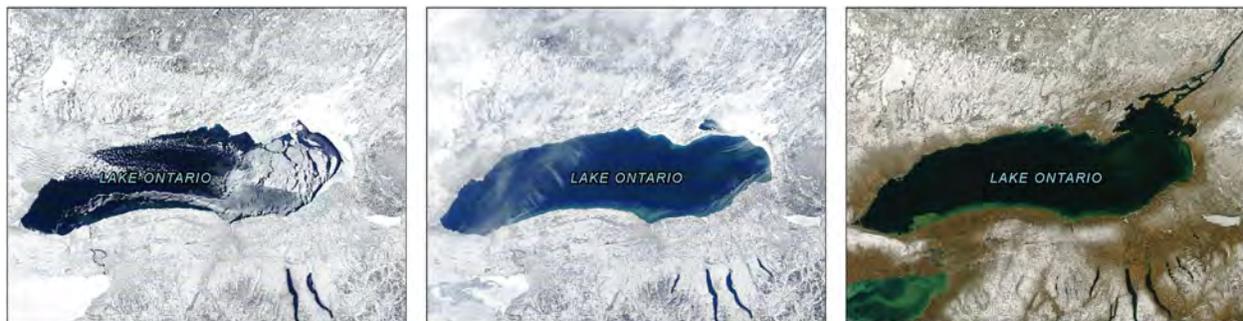
Figure 4.16 Schematic Diagram of Reduced Lake Ontario Ice Coverage

Ice cover in the Great Lakes has been decreasing since 1973 (Wang et al, 2012) with similar trends documented across the northern hemisphere (Sharma et al, 2019). The projected winter warming will continue to increase land and lake temperature, resulting in further reductions in ice cover in the future. Figure 4.16 provides a conceptual diagram of these potential changes with extensive ice cover in the eastern basin (left-hand panel), coverage limited to the Kingston Basin in the middle image, and no ice coverage in the open lake for the winter image in the right-hand panel. As the winter temperatures continue to warm in Southern Ontario, the duration of lake ice coverage will continue to decrease and could approach zero by late century (e.g., 2080).

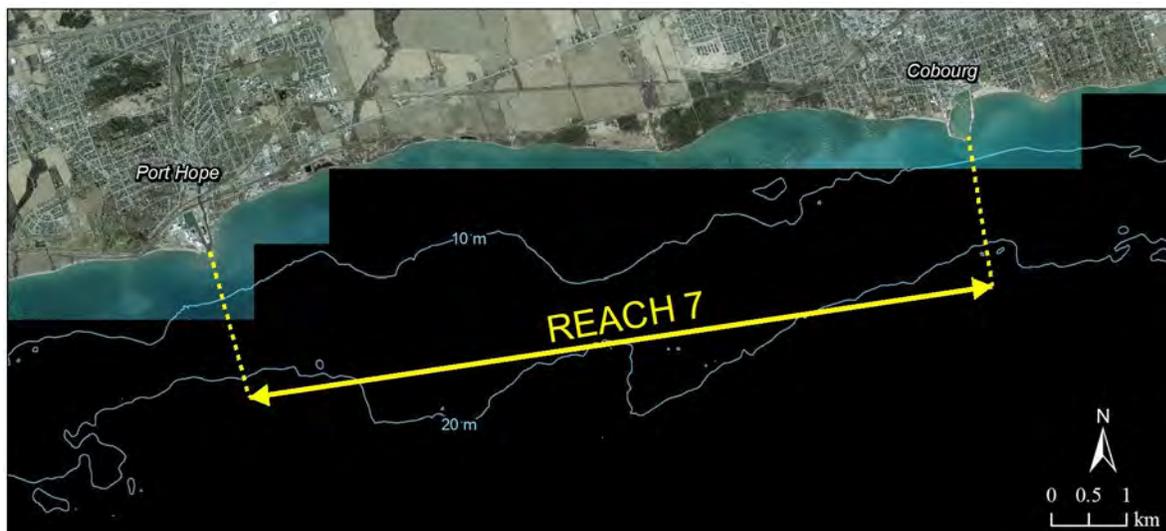
Figure 4.18 Reach 7 Boundaries from Port Hope to Cobourg

Today, much of the historical littoral cell from East Point to Presqu'ile has been sub-divided into small sub-cells by harbour jetties and port facilities on headlands, which are partial barriers to longshore sediment transport. For example, the coast from Port Hope to Cobourg is a sub-cell of the larger littoral cell from East Point to Presqu'ile. In this region there is only limited exchange of sediment with the adjacent sub-cells due to the harbour and rivermouth jetties at Port Hope and Cobourg (refer to Figure 4.18).

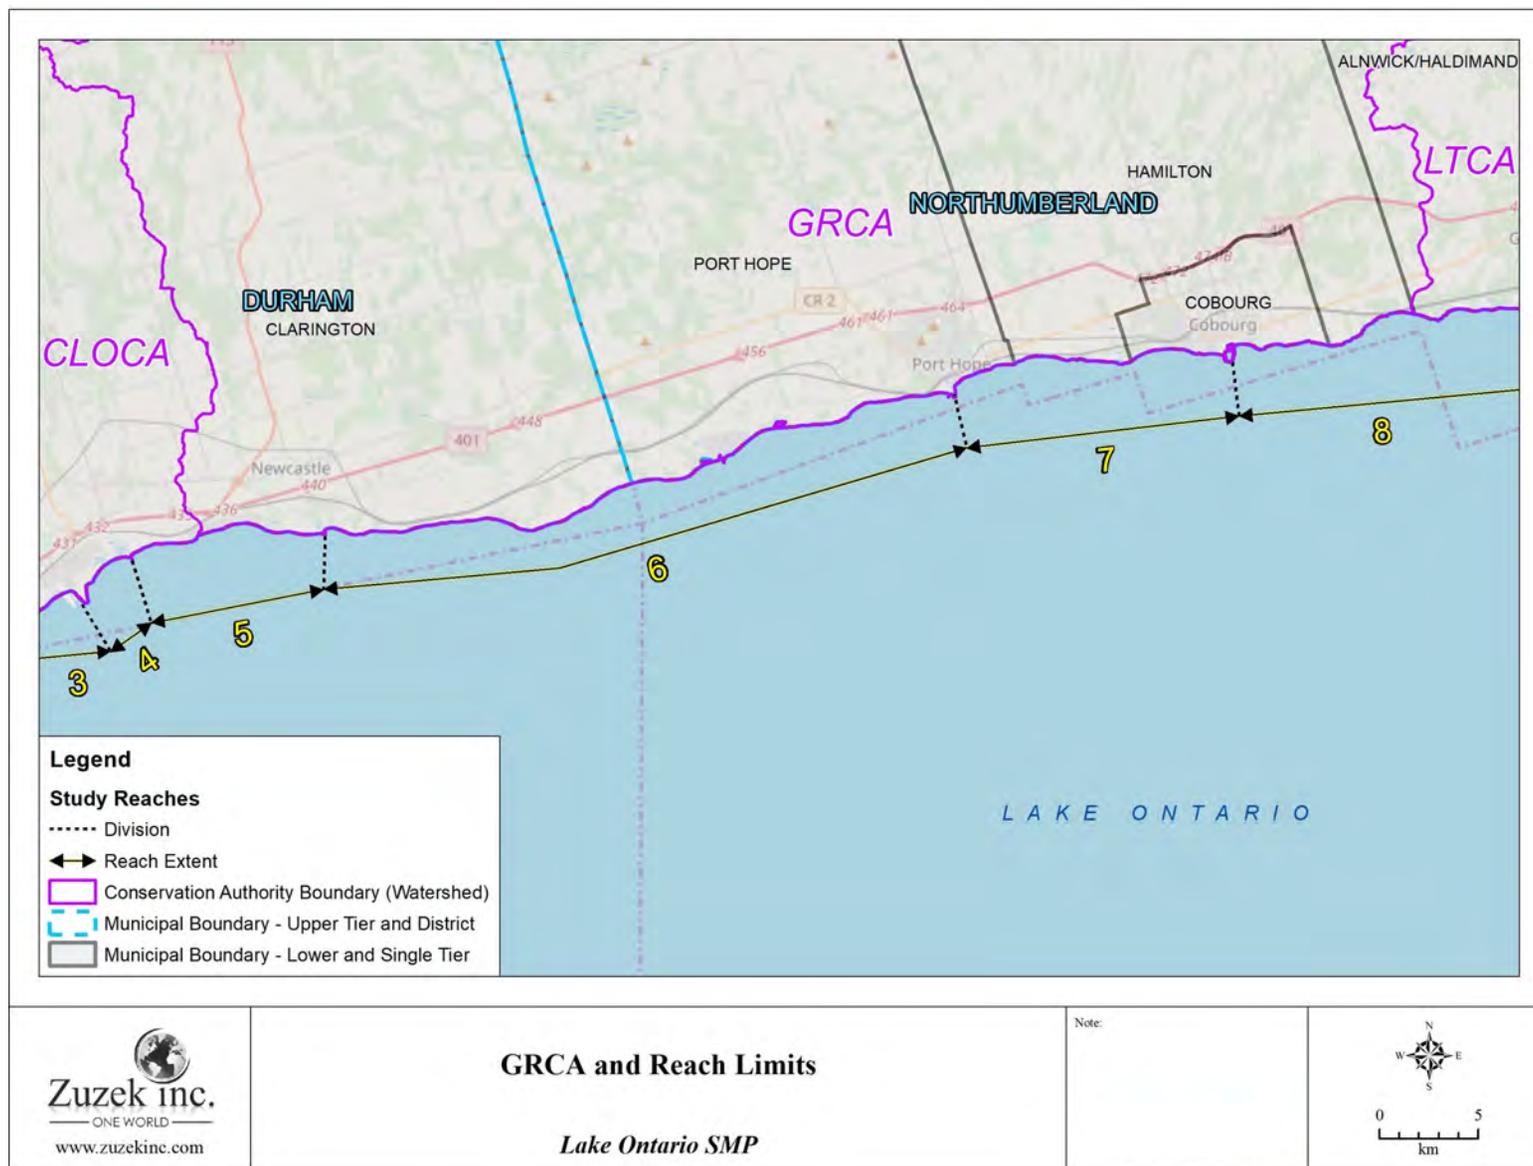
Figure 4.20 GRCA Shoreline Reaches

The sub-cell boundaries from the Reinders (1988) report, the field observations from this study, and results from the longshore sediment modelling were used to map a total of 12 reaches for this SMP update. Port Hope to Cobourg was identified as Reach 7. The 12 reaches covering the study area from west to east are presented in Figure 4.19 to Figure 4.21. Principal findings of this SMP and shoreline management recommendations have been grouped based on these reaches, and are presented in Appendix A.

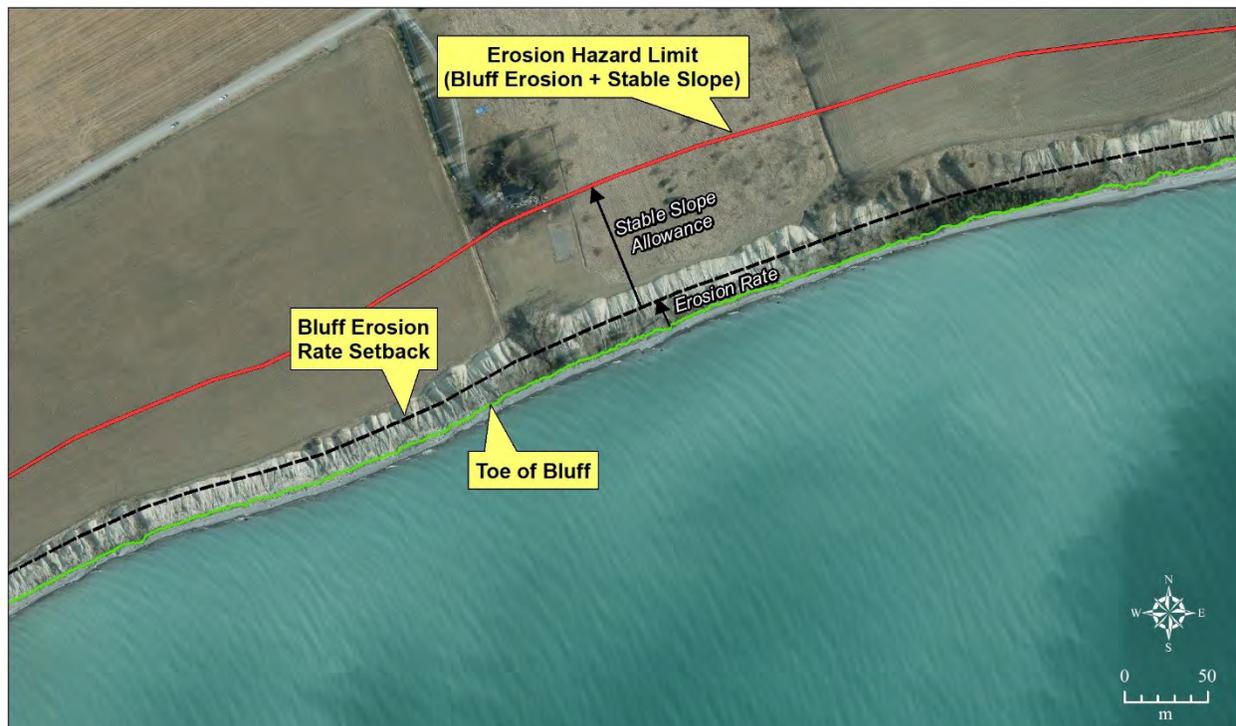
Figure 5.2 Erosion and Stable Slope Allowance/Setback for a High Bluff

- A horizontal allowance for the stable slope was calculated by estimating the height of the bluff/bank at the inland limit of the erosion allowance and applying a 3:1 (H:V) setback (i.e., height of bluff/bank times three, measured horizontally). For example, a bluff height of 10 m will have a stable slope allowance of 30 m (3 x 10 m). A stable slope of 3:1 (H:V) is the standard approach where detailed geotechnical information is not available, as is presented in the Technical Guide (MNR, 2001a).

Refer to Figure 5.2 for an example of the methodology.

Due to the influence of the bluff height on the stable slope allowance, the shoreline was subdivided into sections based on 2 m increments (e.g., 10 to 12 m, 12 to 14 m, etc.). When the elevation increased or decreased by more than 2m, a new stable slope allowance was calculated

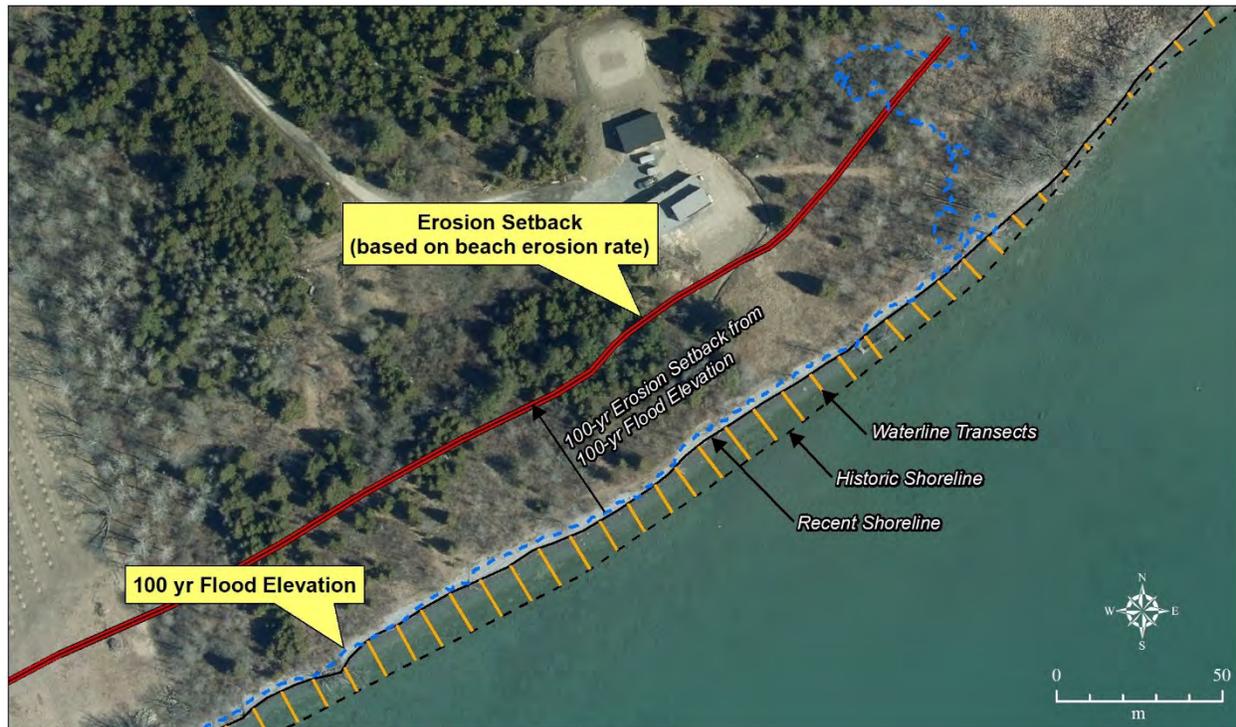
Figure 5.3 Erosion Hazard Setback Methodology for Beach Shorelines

This process was repeated for all eroding beach areas within the project study limits. A sample of the methodology is presented in Figure 5.3.

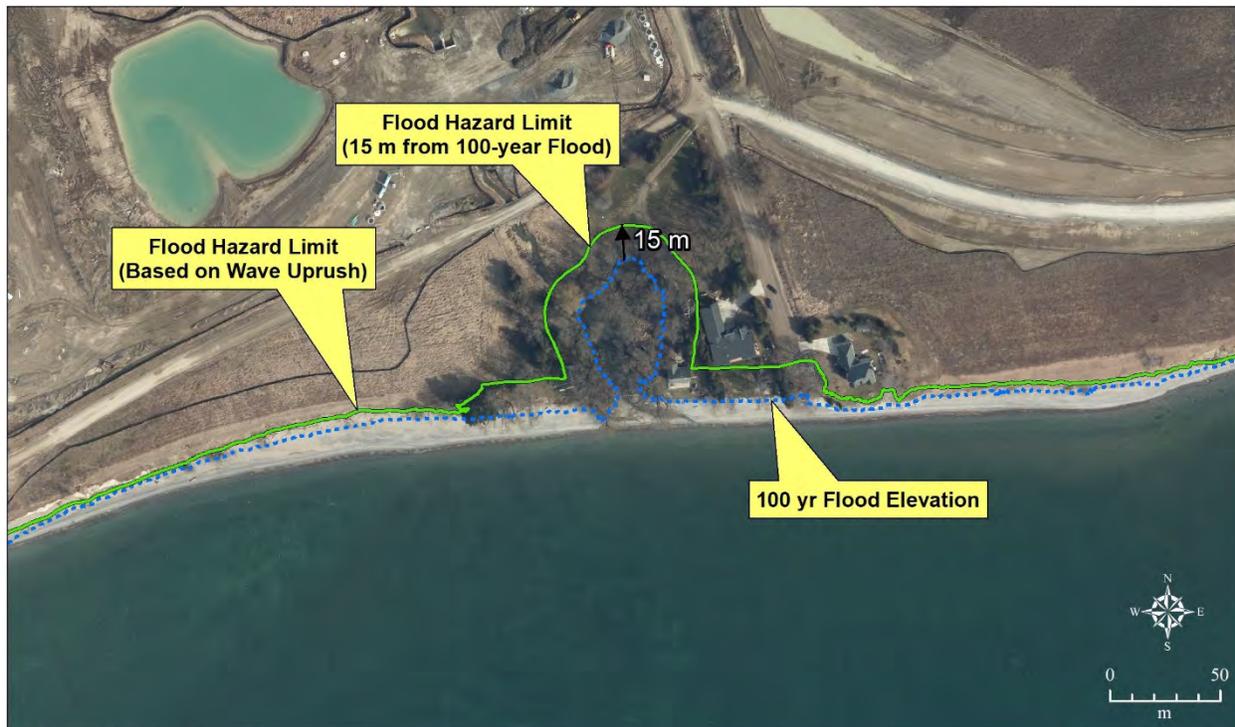
Figure 5.5 Sample of the Flood Hazard Limit with Runup Calculations and the 15 m Setback

Figure 5.5 provides a sample of the flood hazard mapping for a section of open coast where the wave uprush limit was calculated using the runup methodology. For the creek valley in the centre of the figure, waves are not able to propagate inland to the 100-year flood elevation and thus the use of the local runup value for wave uprush would not be appropriate. In these regions the standard 15 m setback has been applied. This type of review was completed for the entire study area to select the most appropriate methodology to map the wave uprush component of the flood hazard limit.

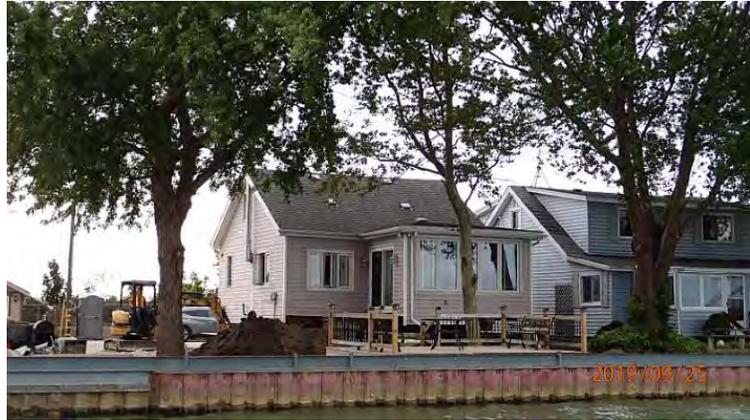
Raise building foundation and lowest openings above the flood hazard

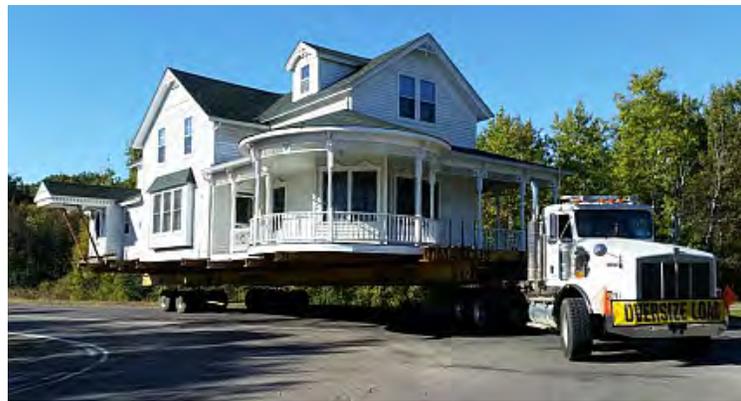
Relocate buildings further inland if they are threatened by erosion

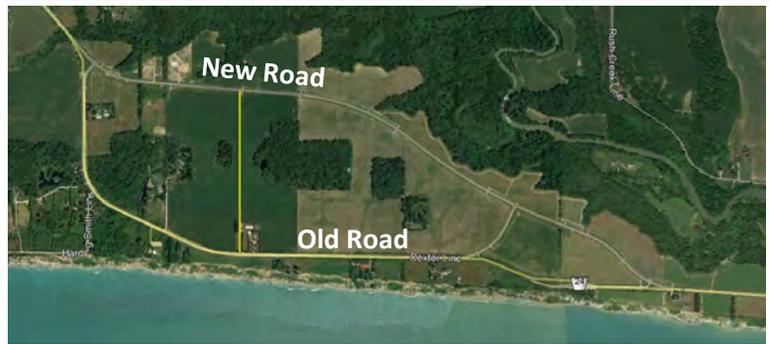
Re-align coastal highways threatened by erosion (e.g., old and new alignment of Dexter Line, Port Bruce, Lake Erie)

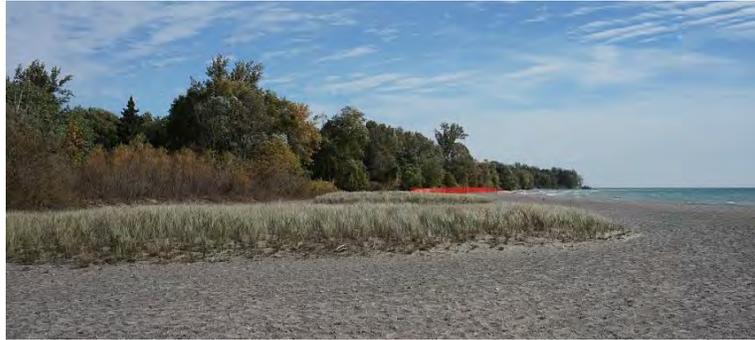
Construction of sand dunes at the back of the beach to increase beach width, elevation and resilience

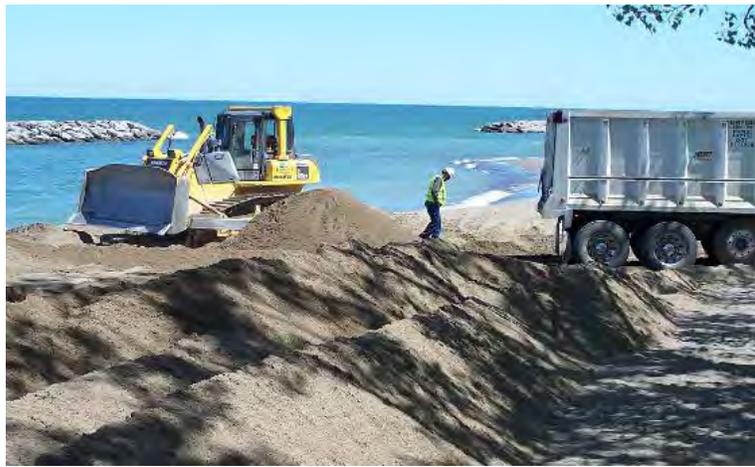
Artificial beach nourishment with sand trucked from inland sources (e.g., sand pit), dredged from navigation channels or bypassed around harbours

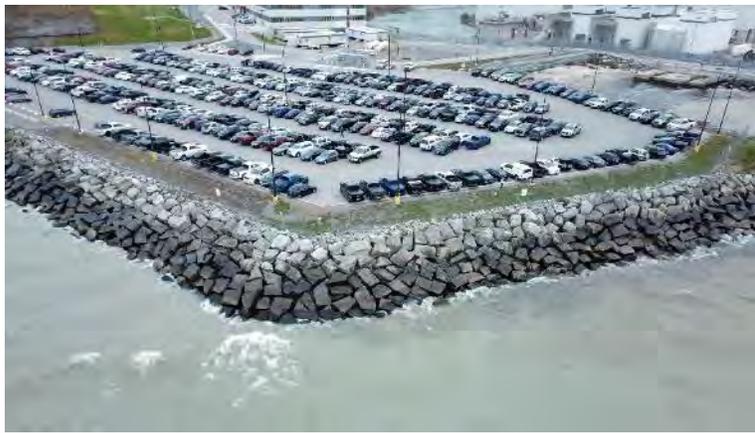
Construction of shore parallel protection, such as armour stone revetments and seawalls

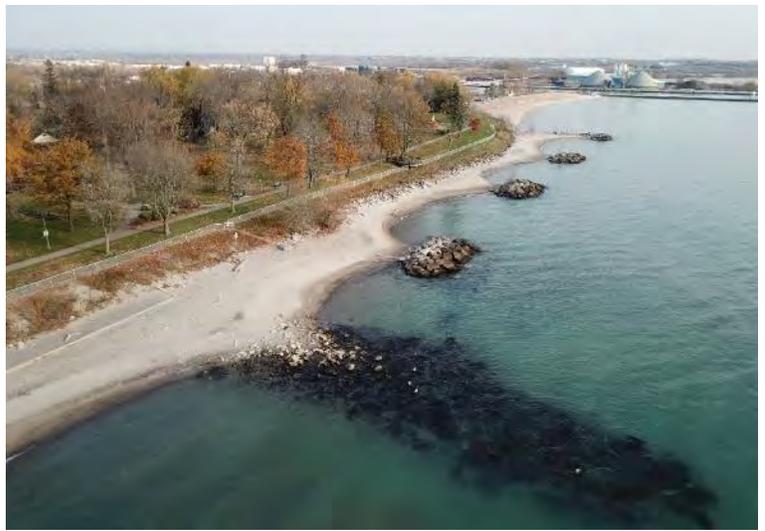
Construction of beach retention structures, such as offshore breakwaters and groynes (Oshawa)

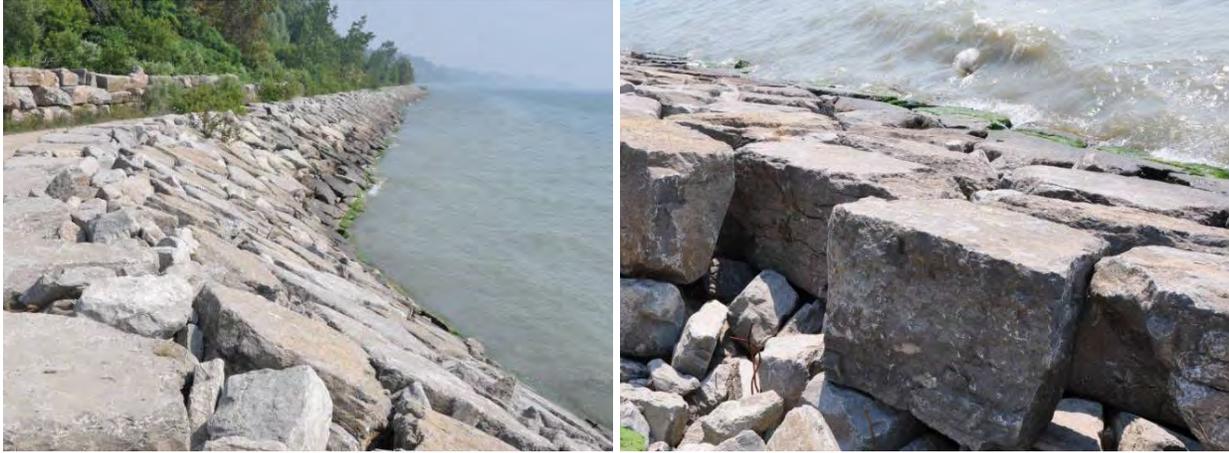
Figure 7.1 Sample armour stone revetments on Lake Ontario

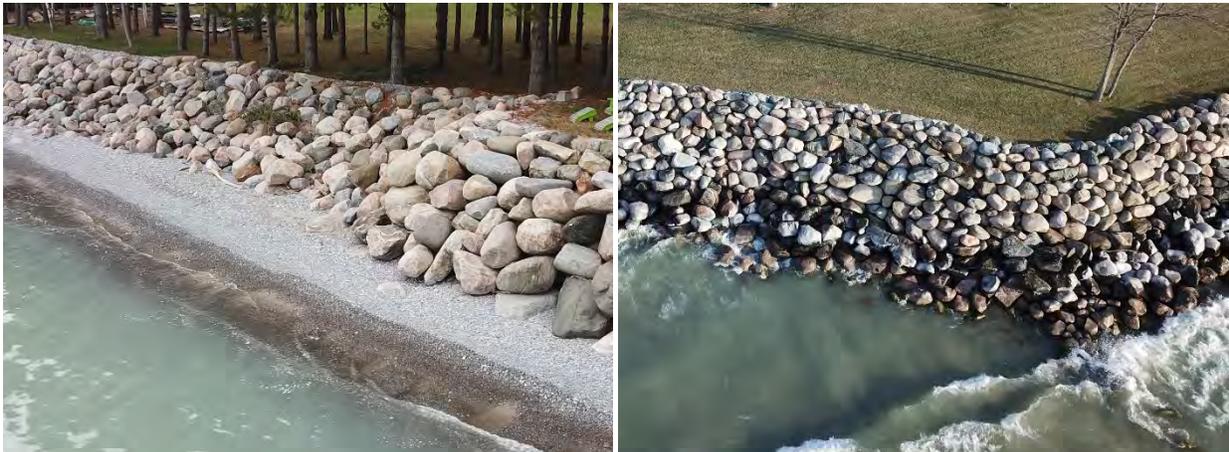
Figure 7.2 Sample field stone revetments on Lake Ontario

For certain regions particularly throughout the LTRCA, field stone (boulders) can be an acceptable and cost-effective alternative to armour stone as it is a naturally occurring material that can be locally sourced. Field stones are smoother and less angular than armour stone however, making them less stable on a slope. They also cannot be placed with as tight a packing density as armour stone therefore resulting in a higher void ratio. As such, field stone revetments must include at least two layers of boulders in the primary stone layer and be carefully designed by a qualified professional. Figure 7.2 presents examples of field stone revetments throughout the project region.

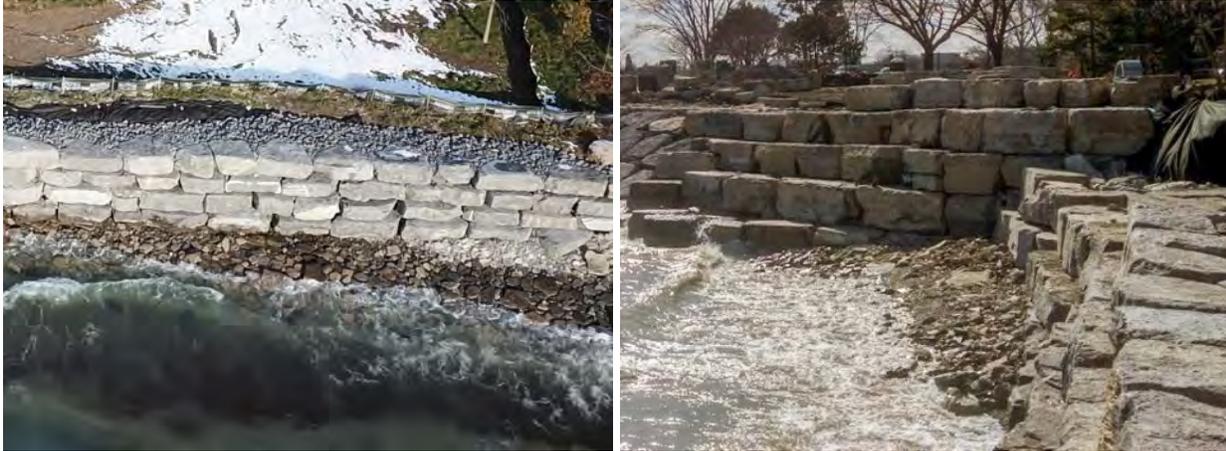
Figure 7.3 Sample armour stone seawalls on Lake Ontario

Where a vertical or near-vertical structure is preferred over a sloping structure due to space limitations or specific shoreline characteristics, stacked or stepped armour stone seawalls are recommended. Armour stone seawalls are particularly well suited for shorelines with flat, shallow bedrock. Special attention must be given to the design of the structure toe as vertical structures are often accompanied by increased vertical erosion of the lakebed (scour). Crest elevation, drainage and stone size are also critical considerations in the design of vertical or near vertical armour stone structures. Vertical armour stone seawall structures must be carefully designed by a qualified individual. Examples on Lake Ontario are provided in Figure 7.3.

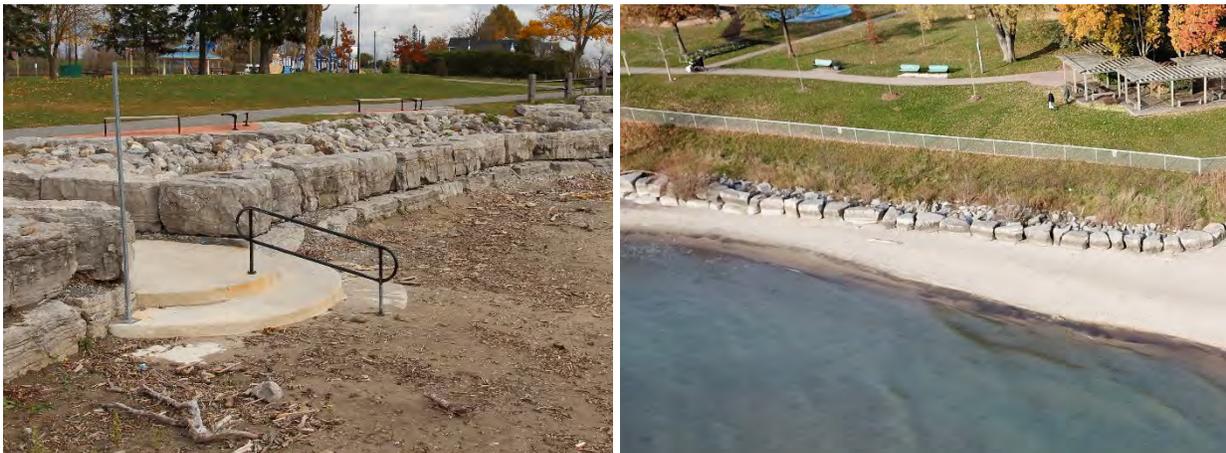
Figure 7.4 Sample armour stone beach curbs on Lake Ontario

Shoreline protection is generally not appropriate for dynamic beach environments. However, there may be some circumstances where protection and stabilization at the back of a beach is appropriate for existing development. For this scenario, an armour stone beach curb is recommended. A beach curb is a low-crested wall placed at the back of the beach, behind the beach crest, and founded at least 1 to 2 m below the typical beach crest elevation to account for potential variability in the beach profile. Figure 7.4 presents examples of armour stone beach curbs within the project region.

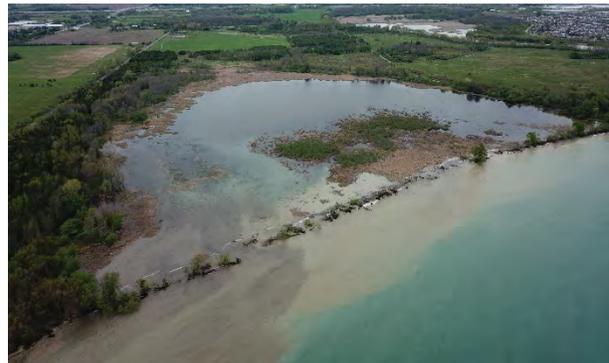
High Water Impacts on Barrier Beach

- Reach Length = approximately 5 km.
- Lakeside Neighbourhood Park to Whitby Harbour is a sub-cell at the western limit of the CLOCA jurisdiction.
- Eroding bluff shoreline in the west featuring hard glacial till, eroding barrier beaches in the central region, with Whitby Harbour defining the east boundary.
- Naturalized meadow vegetation at Lakeside Neighbourhood Park absorbs rainfall and helps stabilize bluff slope, resulting in a low long-term erosion rate.
- Sand and gravel eroded from the bluff supply sediment to the barrier beaches in Lynde Shores Conservation Area and the fillet beach at Whitby Harbour.
- Lynde Shores Conservation Area is part of a 550-hectare High Biodiversity area (Canadian Wildlife Service). The protective barrier beaches were negatively impacted by high lake levels in 2017 and 2019, threatening the previously sheltered marsh ecosystem.

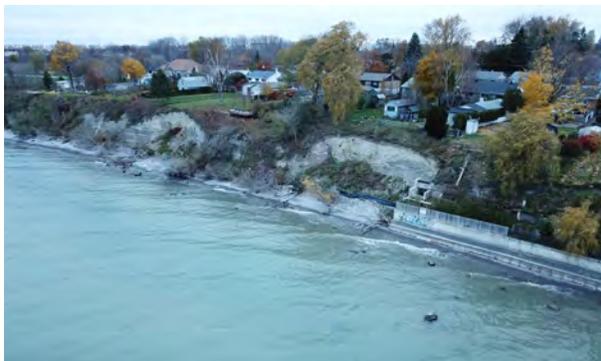
Eroding Bluff at Stone Street, Oshawa

- Reach 2 is 19% armoured, 81% natural.
- Armoured shoreline is predominantly located in front of Crystal Beach Blvd., Stone Street and Lakeview Park.
- Shoreline protection fronting Crystal Beach Blvd. and Stone Street is predominantly ad-hoc or under-designed. Structures should be monitored, and improvements should be considered.
- Flanking of protected portions of shoreline is prevalent along Stone Street where neighbouring properties are unprotected and erosion is ongoing.
- Lakeview Park features well engineered offshore breakwaters with tombolo's during periods of typical water levels, a termination groyne and beach curb. Structures should be monitored, and maintenance should be performed as required.
- The jetty at Oshawa Harbour is in moderate to good condition but should be monitored and maintained as required.
- Tolerance for additional shoreline armouring (low/medium/high):

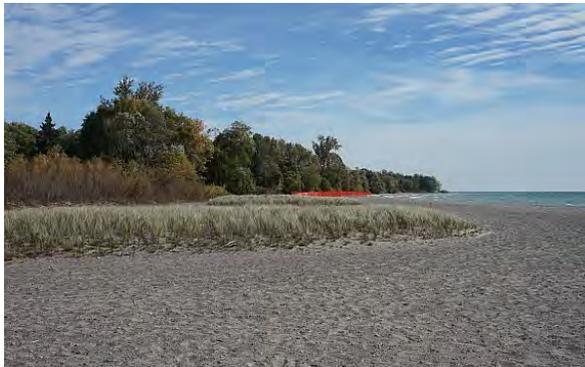
Natural Beach & Embryo Dunes at Darlington Prov. Park.

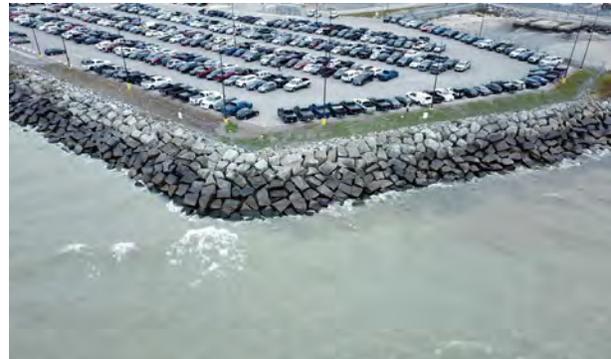
Shore Protection fronting Darlington Nuclear Power Plant

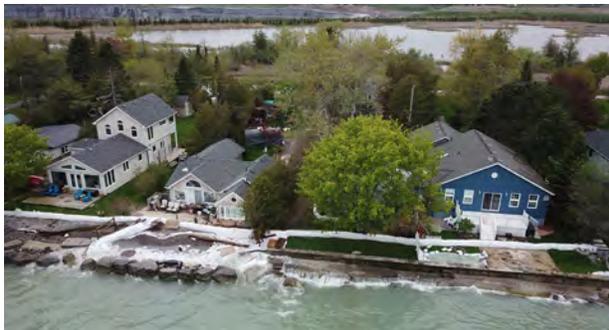
Cedar Crest Beach Blvd. during Record High Water Levels (May 2019)

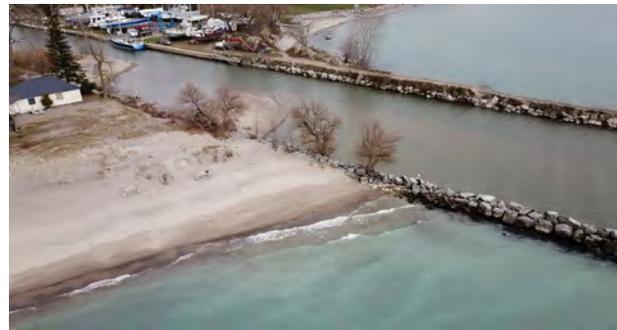
Fillet Beach and Jetties at Port Darlington (November 2018)

- Two armour stone jetties stabilize the navigation channel for the outlet of Bowmanville Creek and have been trapping sand on the west side since at least the early 1950s.

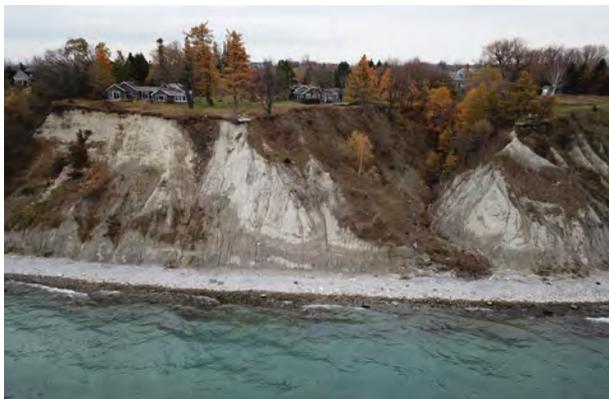
Eroding Bluffs at Bond Head

- Reach Length = approximately 23.4 km.
- This long reach stretches from the Port of Newcastle to Port Hope West Beach.
- East of the Port of Newcastle, the Bond Head bluffs and gullies dominate the shoreline.
- The central portion of the reach features large tracks of agricultural land and small shoreline communities, such as Port Granby and Port Britain.
- The Ontario Power Generation Wesleyville Storage is located 8 km west of Port Hope.
- Port Hope west beach is a large deposition sink for the sand and gravel transported west to each in this reach.
- Immediately west of West Beach, the railway into Port Hope runs right along the bluff crest and will soon require shoreline protection to stabilize the slope.

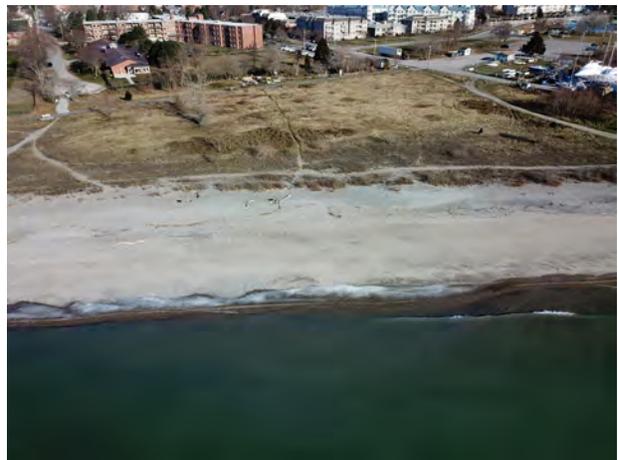
West Fillet Beach at Cobourg

- Reach Length = approximately 10.2 km.
- The jetties in Port Hope and Cobourg Harbour are the boundaries of a large littoral sub-cell with the Ganaraska Region Conservation Authority.
- Port Hope features sand accumulation in West Beach and a very narrow beach deposit on the east side of the jetties.
- Cobourg also features a large west beach that accumulates against the harbour. The east beach has been increasing in size since the 1950's partially due to sand that is dredged from the entrance to the port and hydraulically pumped onto the beach.
- Between Port Hope and Cobourg the shoreline is largely undeveloped and features a natural shoreline and the Carr's Marsh Conservation Area.

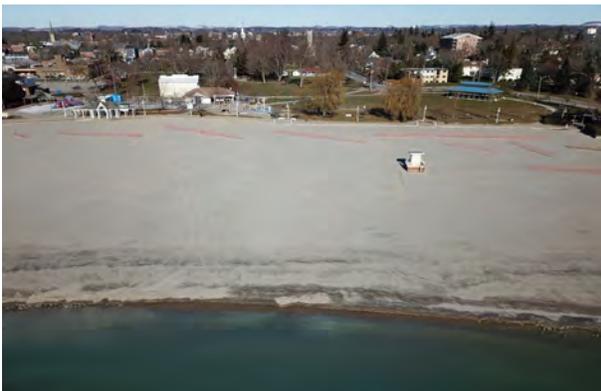
Cobourg Harbour East Beach

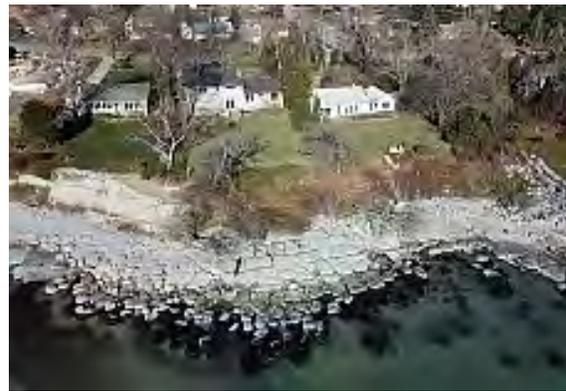
Bedrock Shoreline and Nearshore

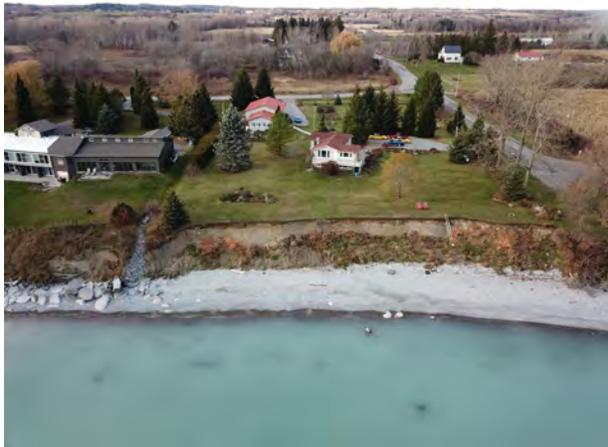
Eroding Bluff Shoreline, Victoria Beach

- Reach Length = approximately 16.4 km.
- Ogden Point to Presqu'ile Provincial Park is the final littoral sub-cell that was once part of a large littoral cell that extended from East Point Park in Scarborough to Presqu'ile Provincial Park (Reinders, 1988).
- The eroding bluff shoreline east of Ogden Point features shoestring development along the bluff crest.
- The central portion of the reach is primarily agricultural lands and natural areas.
- The shoestring development begins again in Popham Bay and extends to the northwest boundary of the Provincial Park.
- The Provincial Park is a major sediment sink as evident by the successive beach ridges that have formed over time and now connected to Gull Island.

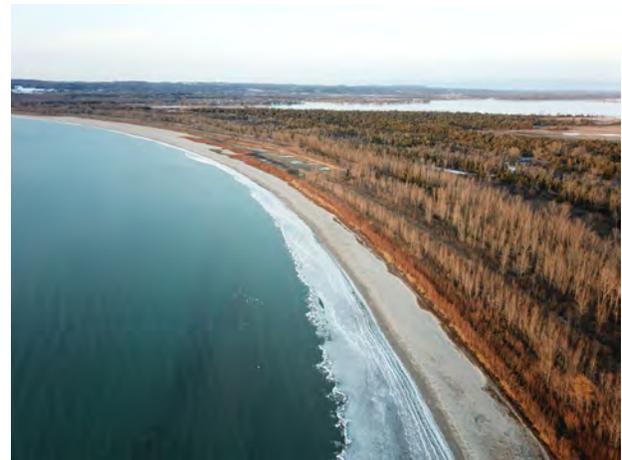
Presqu'ile Beach, Presqu'ile Prov. Park

- The primary depositional area for the reach is Presqu'ile Beach, which historically received much of the west to east transport along the entire project shoreline before the shoreline became fragmented into several sub-cells due to human development.
- The Popham Bay shoreline immediately west of Presqu'ile Beach is characterized by shallow bedrock shelves, which typically only house cobble and shingle beaches comprised of eroded bedrock material. Smaller silts and sands appear to typically move further offshore until they are deposited at Presqu'ile Beach.

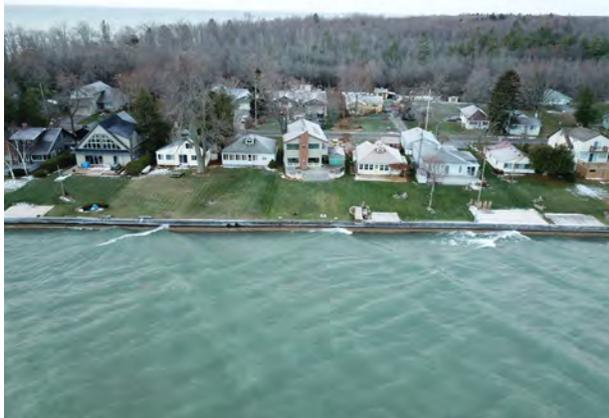
Concrete Seawalls, Presqu’ile Backside

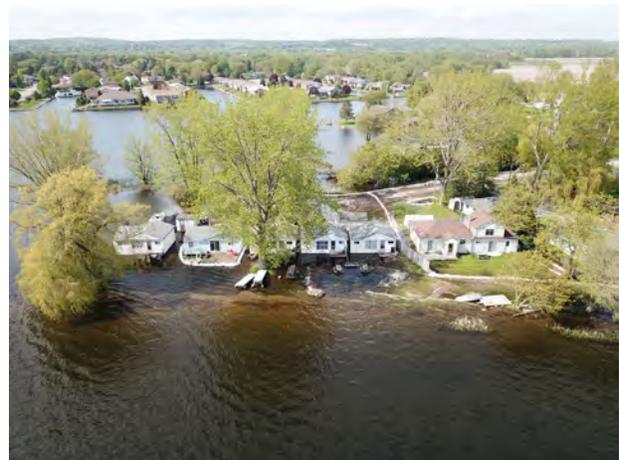
Flooded Properties in Gosport (May, 2019)

- Reach Length = approximately 22.0 km.
- Reach 10 is sheltered from Lake Ontario waves by Presqu’ile Provincial Park. The sandy bay extends from Presqu’ile Point to Shoal Point.
- Several of the communities were constructed on former coastal wetlands and are very vulnerable to high lake levels, as seen in 2017 and 2019.
- Undeveloped areas of the bay feature extensive coastal wetlands, including the eastern shore of the Provincial Park.
- The Trent-Severn Waterway is a constructed canal that connects the northeast corner of the bay with the Bay of Quinte near Trenton.

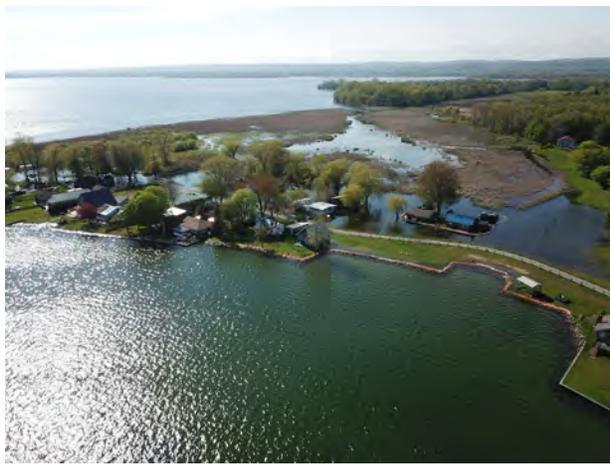
Flood Prone Properties, Evergreen Lane (May 2019)

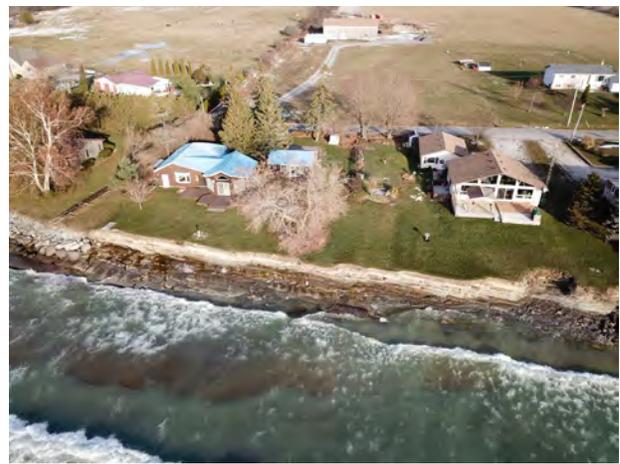
Exposed Bedrock Shoreline, Barcovan Beach Road (November 2018)

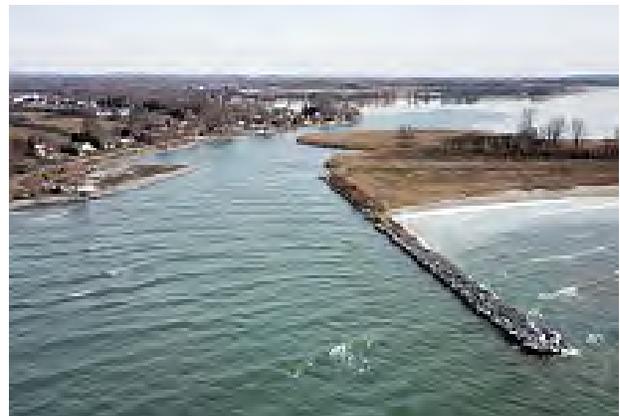
Entrance to Wellers Bay

- Reach Length = approximately 3 km.
- Low energy shoreline sheltered from Lake Ontario wave action.
- Mixture of natural shoreline with coastal wetlands and high-density development.
- Single rock jetty protects the navigation channel to the bay. Sediment that accumulates in the channel is dry-docked and disposed upland.
- Wellers Bay and the barrier islands were established as a National Wildlife Area in 1978 for the rare coastal habitats including natural beach, sand dunes, wetlands, and deciduous forest. The habitat is used by migratory waterfowl, nesting shore birds (see adjacent Belted Kingfisher), and several federally listed species at risk.
