# Riparian Corridors Restoration Plan

*Action Plan #2*

October 2017

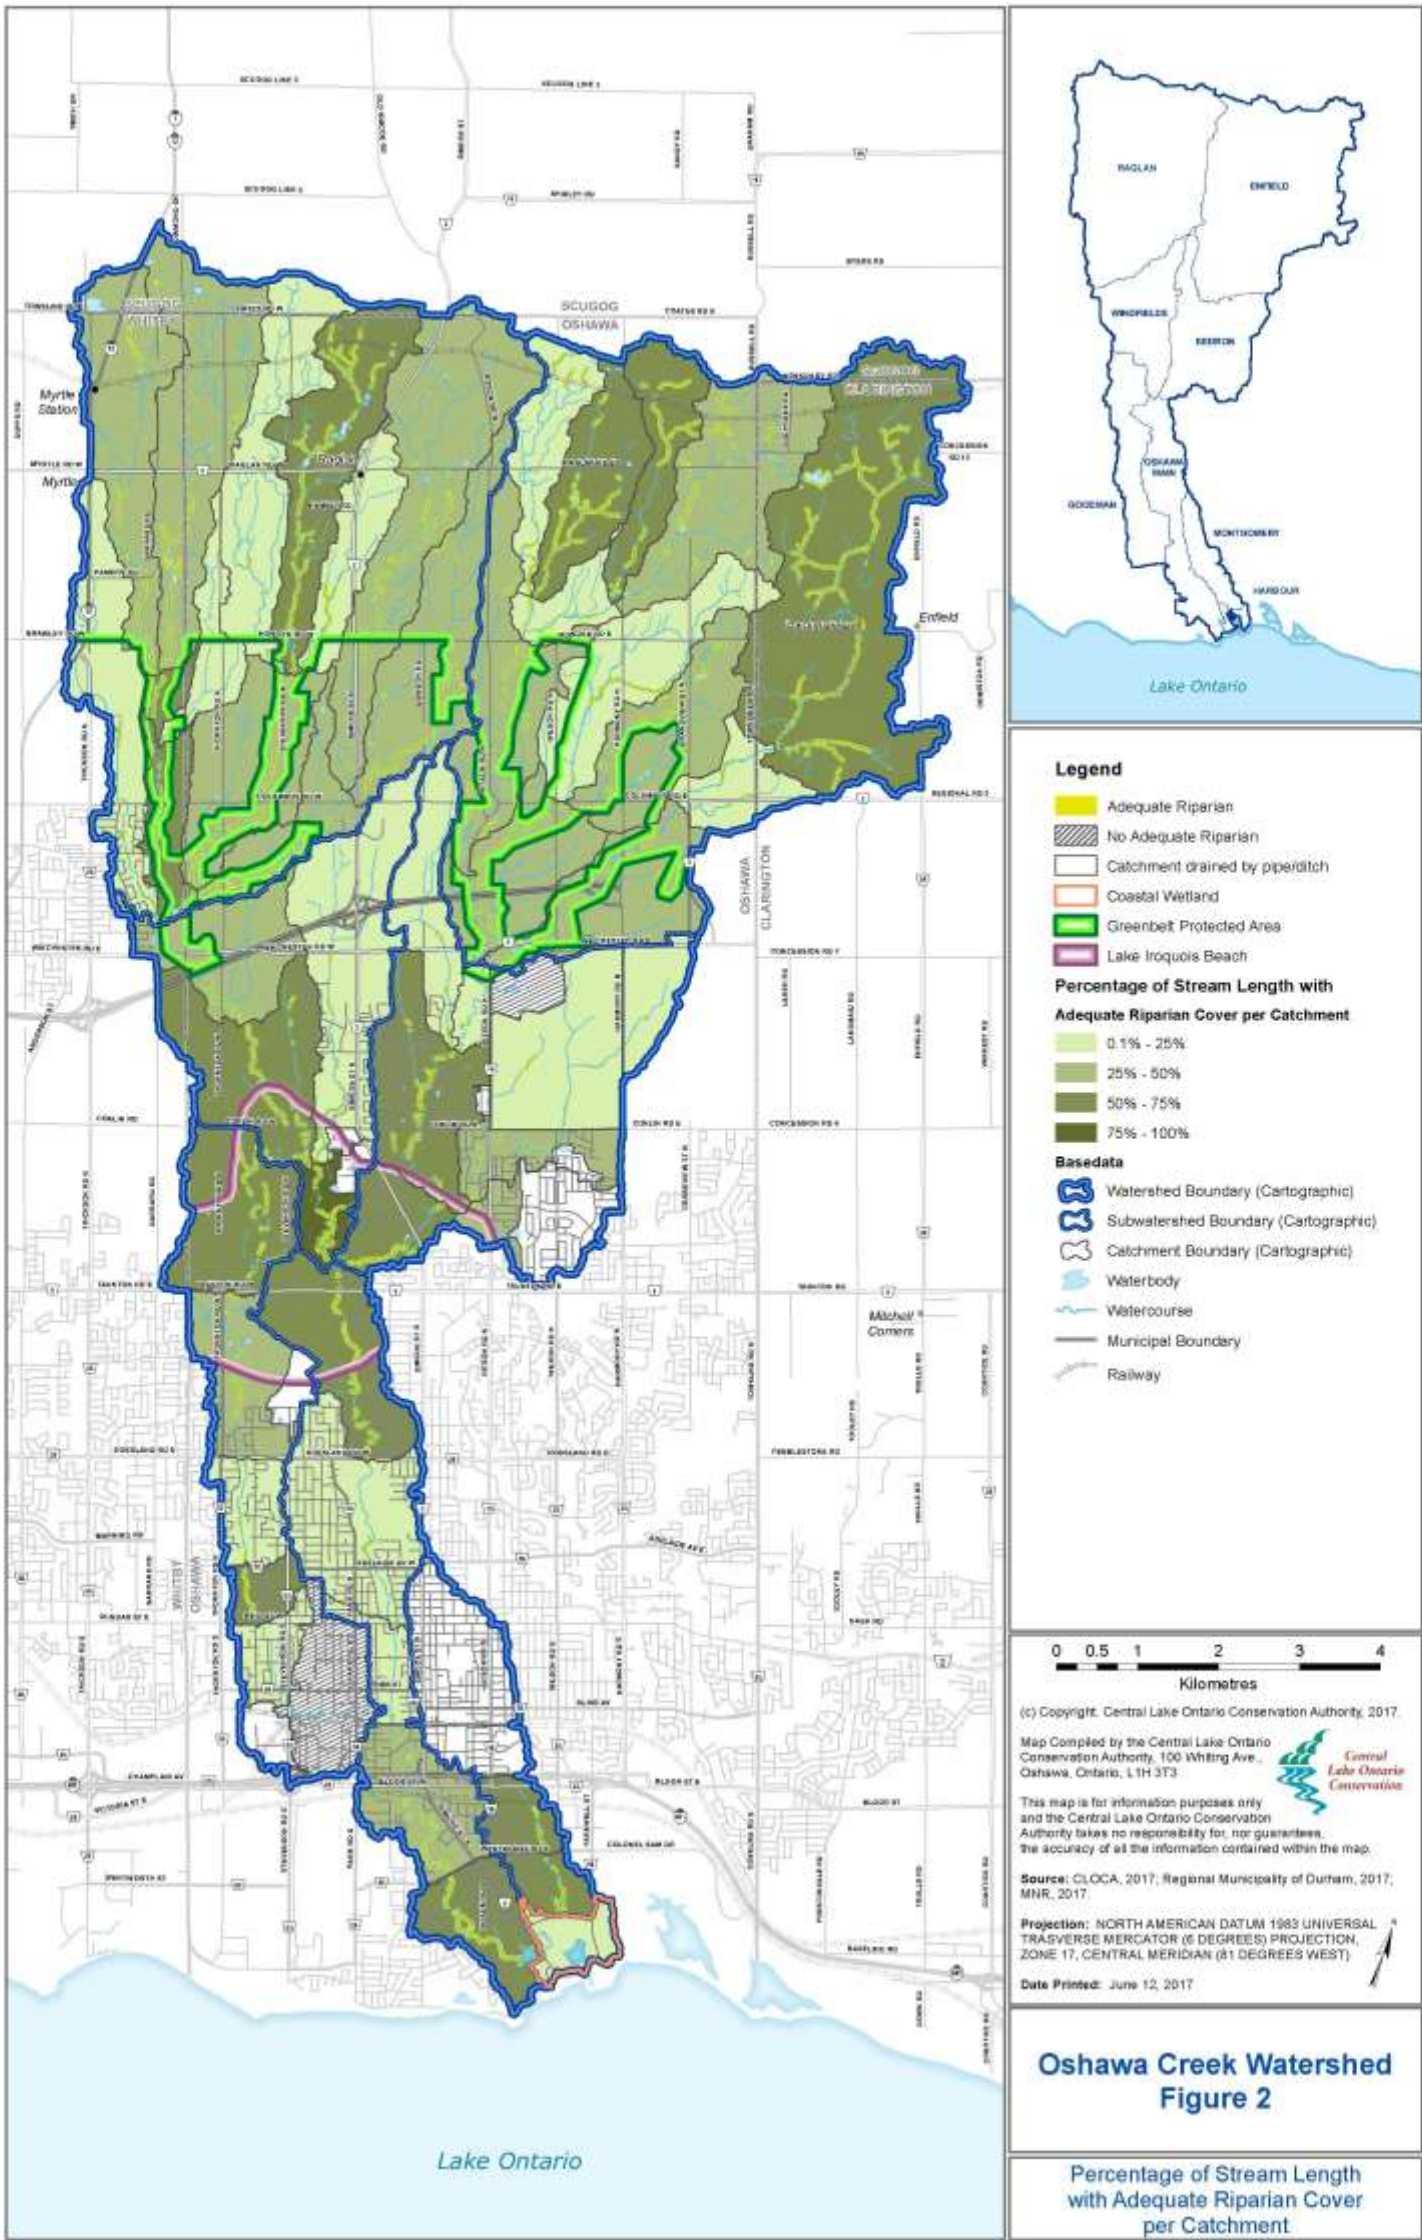
With reference to Figure 2, these recommendations provide specific suggestions which work towards achieving adequate riparian corridors within the Oshawa Creek watershed. It is recommended that the reader and implementer also refer to the “General Riparian Restoration and Enhancement Recommendations” provided in Section 2.4 when considering riparian restoration projects. An adequate riparian corridor provides 30m natural vegetation on both sides of a watercourse.

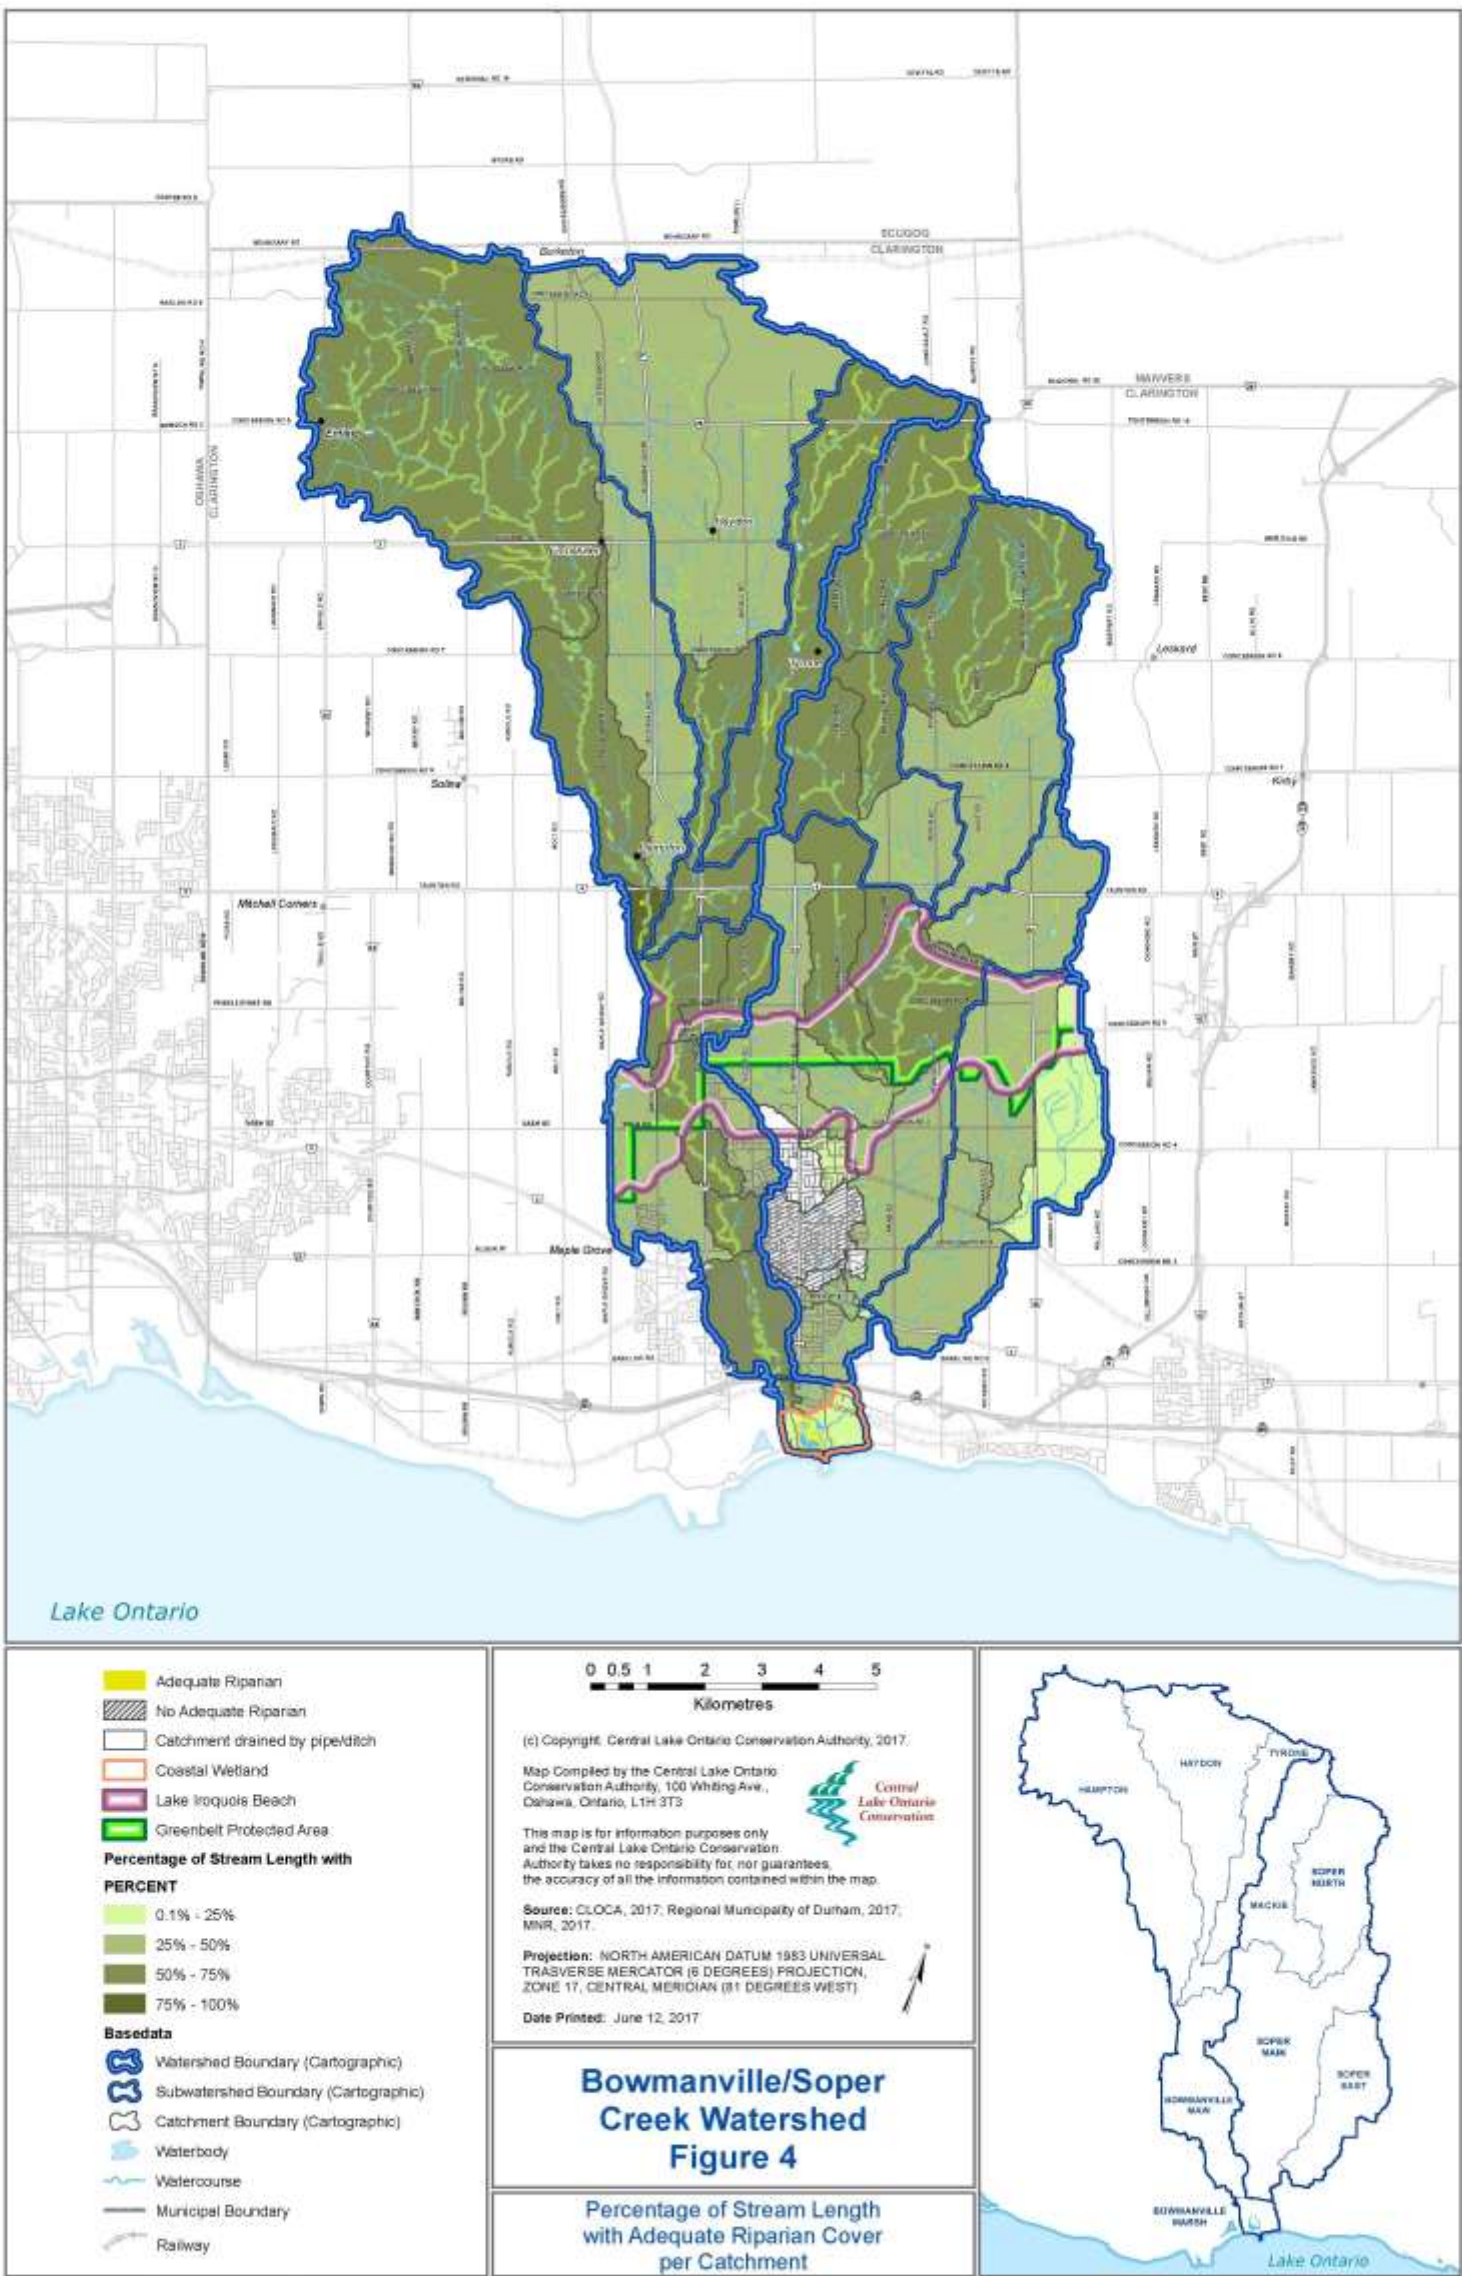
With reference to Figure 4, these recommendations provide specific suggestions which work towards achieving adequate riparian corridors in the Bowmanville/Soper Creek watershed. It is recommended that the reader and implementer also refer to the “General Riparian Restoration and Enhancement Recommendations” provided in Section 2.4 when considering riparian restoration projects. An adequate riparian corridor provides 30m natural vegetation on both sides of a watercourse.
