Central Lake Ontario Conservation

WATERSHED Report Card 2018

Central Lake Ontario Conservation has prepared this report card as a summary of the state of your forests, coastal wetlands, ground and surface water resources.

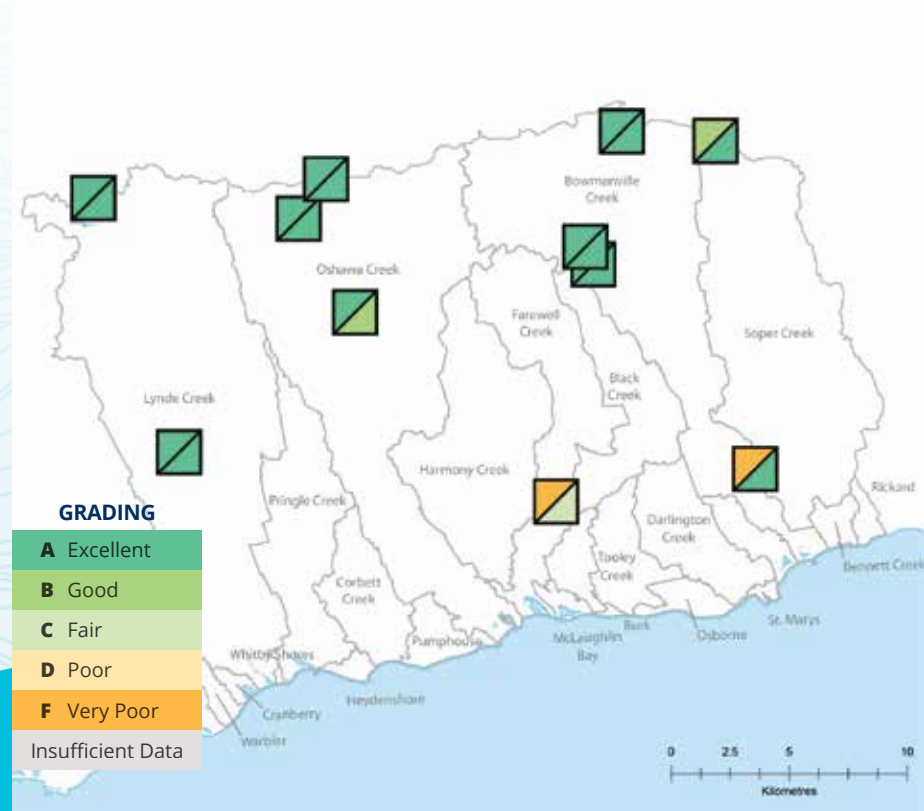
Groundwater Quality

Groundwater provides an important source of baseflow to our creeks and potable water to residents and businesses in our rural communities. Two indicators, nitrate and chloride, are used to assess groundwater quality. Concentrations of these indicators were measured at 11 Ontario Ministry of the Environment and Climate Change (MOECC) monitoring wells across our jurisdiction.

- Nitrate and chloride concentrations are better than the MOECC drinking water guidelines in 9 out of 11 wells which received an A grade.
- Concentrations of nitrate and chloride approach or exceed the drinking water guidelines at 2 of 11 wells resulting in poorer grades (less than an A grade). One of these wells is located in a shallow aquifer.
- The quality of water in a private well may vary from that of the monitoring wells. In some cases, the location of wells was selected to monitor local water quality issues.

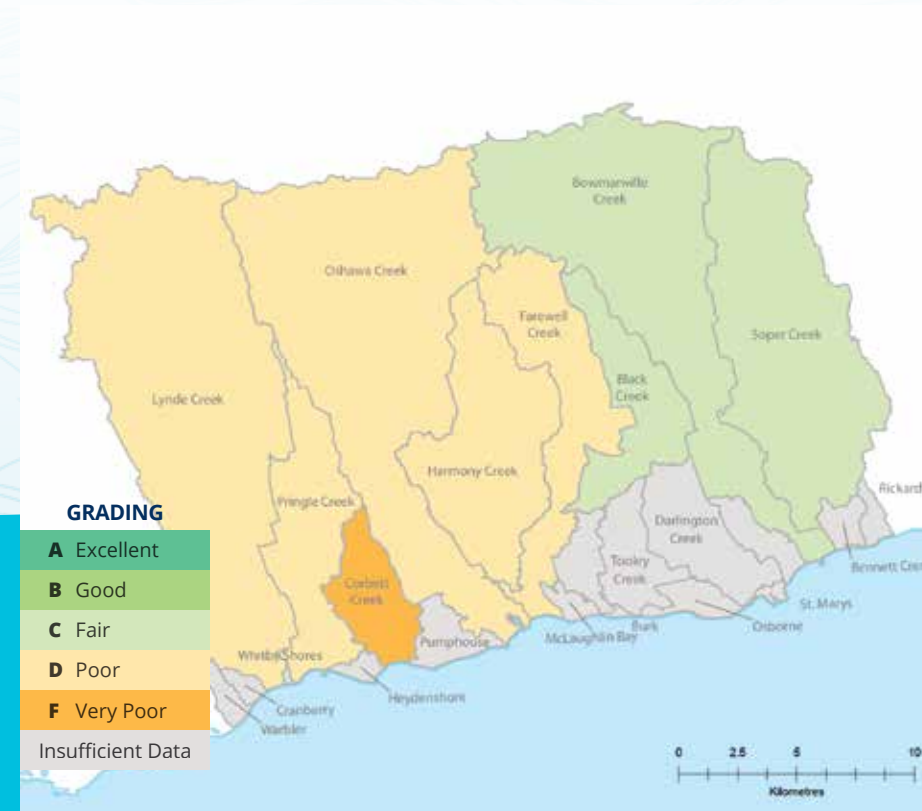
Surface Water Quality

Water in a creek is influenced by the surrounding land use and how that is managed. Concentrations of phosphorous, Escherichia coli (E.coli) and benthic invertebrates (small aquatic organisms living in the sediment) are measured at monitoring stations in our creeks to determine overall surface water quality in our watersheds. Only 1 watershed, the Oshawa Creek, has data to represent all 3 indicators.

- Grades range from C to F.
- While there has been an improvement in the Bowmanville Creek, we have seen a decline in the Lynde, Oshawa and Farewell Creek watersheds since the 2013 Watershed Report Card. More efforts are needed to reduce bacterial and nutrient inputs through improvements to land management practices. This will improve water quality and support healthy aquatic ecosystems.

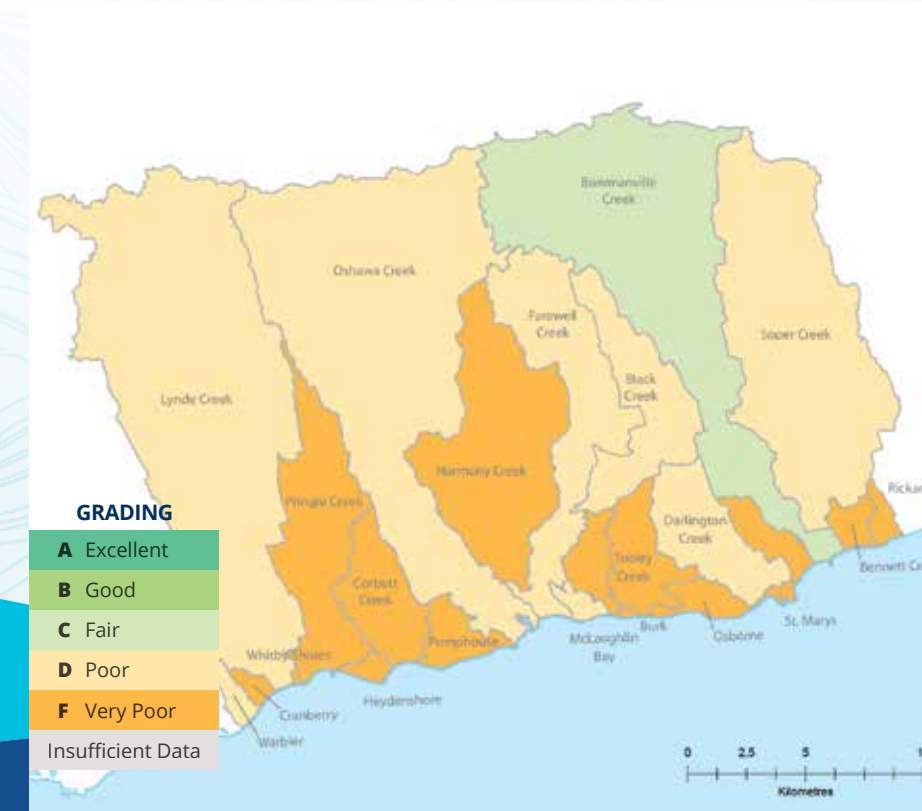
Forest Conditions

We know that trees clean our air and water, prevent erosion, reduce flooding and provide important habitat for wildlife. The more forested a watershed is, the healthier and more resilient it will be to change. The percentages of forest cover, forest interior and streamside cover were measured with Geographic Information Systems (GIS).

- Grades across our jurisdiction range from C to F.
- Bowmanville Creek was our highest scoring watershed with a C grade. Several watersheds including Soper, Pringle and Harmony Creeks have declined a grade since our last Watershed Report Card in 2013. Again many of the small watersheds in the southern portion of our jurisdiction, which sustain little forest cover due to urban and agricultural land use, continue to receive an F grade.
- Many forests across our jurisdiction are not well connected and interior forest is becoming increasingly rare in all of our major watersheds. Additional stressors like invasive species, building highways and continued urbanization contribute significantly to declining forest conditions.

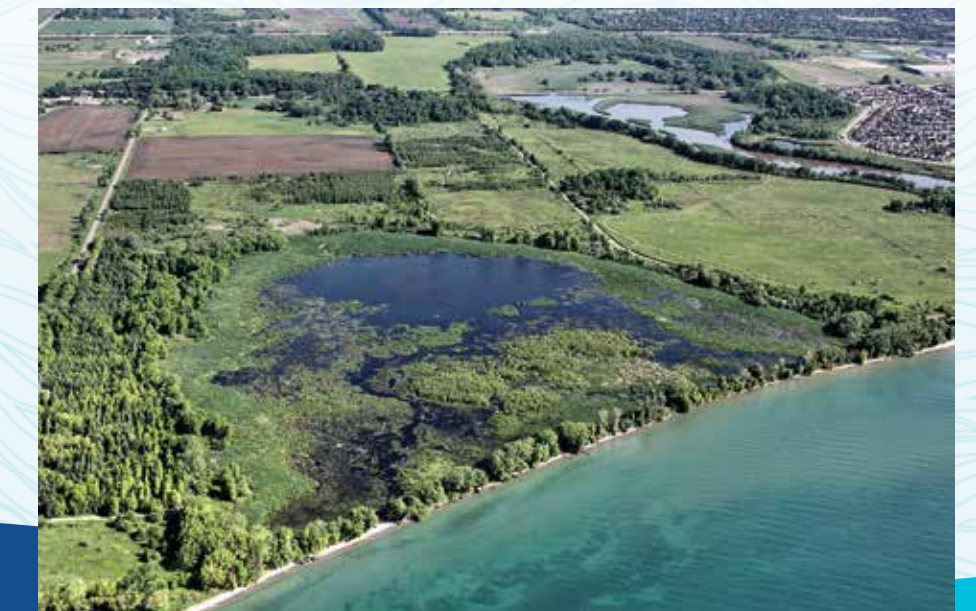
Durham Region Coastal Wetland Monitoring Program

The Durham Region Coastal Wetland Monitoring Project (DRCWMP) is a long-term monitoring program that uses biological and physical indicators to assess the condition of 18 coastal wetlands. The information collected through monitoring provides direction for management and restoration. Data is collected on water quality, water levels, bird, amphibian, fish, macroinvertebrate and submerged aquatic vegetation communities.

Monitoring data collected between 2012 to 2016 shows the wetlands in our jurisdiction, are generally in a state of poor health. Conditions in coastal wetlands reflect the cumulative impacts of changing land-use activities in our watersheds. Restoration and enhancement initiatives to improve water quality, vegetation cover, and wildlife habitat, will be necessary in both the wetlands and their watersheds to improve overall health of these important ecosystems.
