Lake Ontario Shoreline Management Plan

Central Lake Ontario Conservation Authority

Ganaraska Region Conservation Authority

Lower Trent Region Conservation Authority

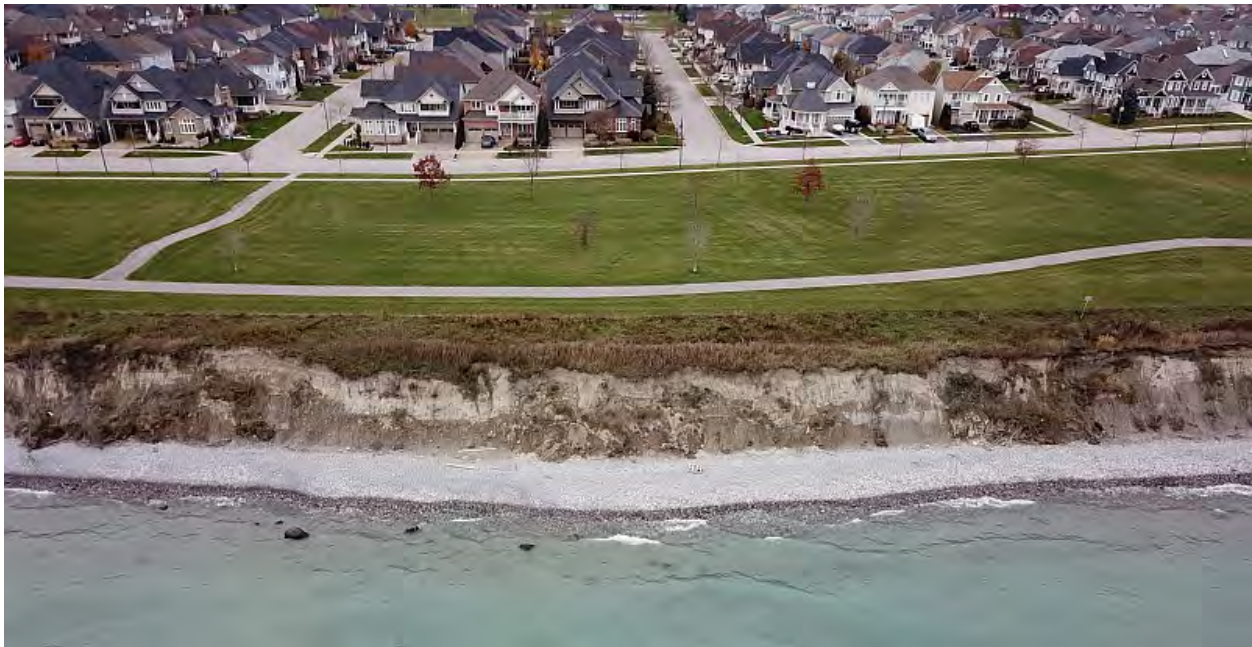
Figure 1.1 Erosion Buffer and Natural Area, Newcastle, Ontario

The report also included recommendations for land use planning to protect the aesthetic and recreational benefits of the shoreline. The 1990 SMP identified appropriate flooding and erosion hazard setbacks to protect future development within 66 individual shoreline reaches. The SMP is partly responsible for some of the most successful large-scale development setbacks on Lake Ontario. Refer to Figure 1.1 for an example of a large natural setback that buffers the development in Newcastle, Ontario.

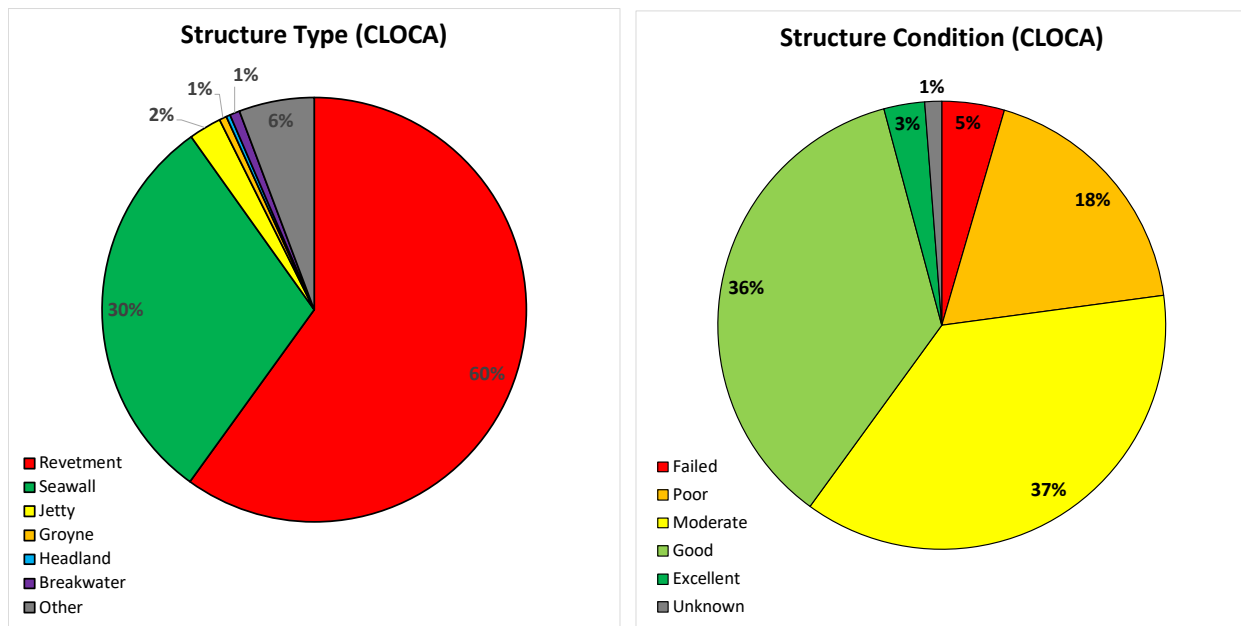
Figure 3.4 Summary shore protection statistics for CLOCA shoreline

Sample statistics from the shoreline protection database are provided in Figure 3.4, Figure 3.5 and Figure 3.6 for CLOCA, GRCA and LTRCA respectively. Additional statistics and summary observations by project reach (refer to Section 4.7) are presented in the accompanying reach summary documents (Appendix A). The entire shoreline database including tabulated statistics has been provided to the Conservation Authorities in digital form. The provided shore protection database and all presented statistics are reflective of the state of the shoreline in late 2018.

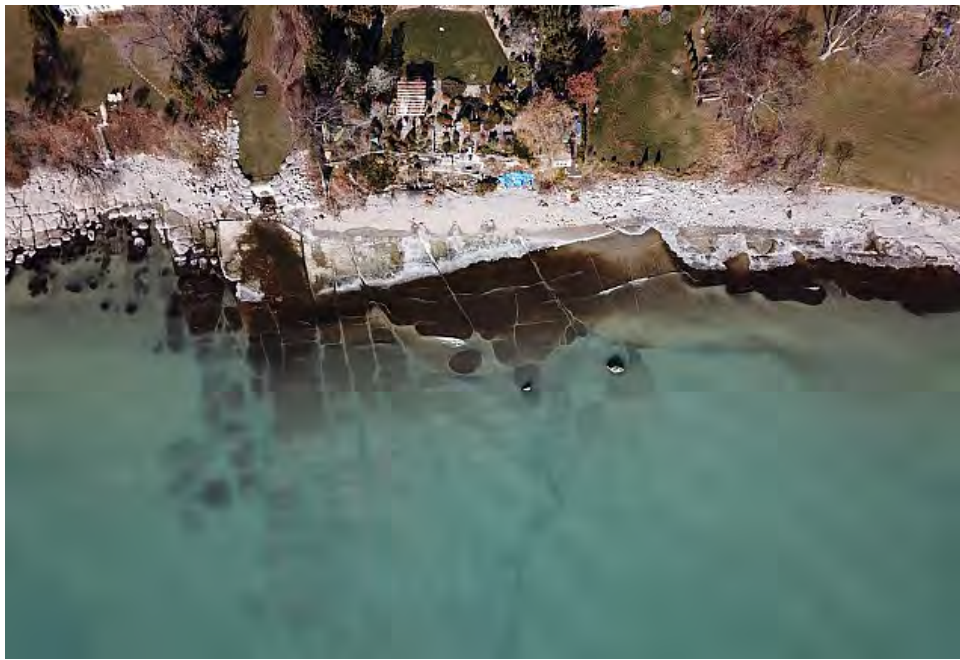
Figure 4.1 Exposed Limestone Bedrock East of Cobourg Harbour

The surficial bedrock in the study area consists of limestones and shales from the Middle Ordovician period, when the Great Lakes region was part of a warm tropical sea (OGS, 1991; SSW, 1990). In the western portion of the study area, the bedrock is covered by more recent glacial deposits. However, east of Cobourg, the limestone bedrock is often found at the waters edge and in the nearshore. Refer to Figure 4.1 for an aerial view of the exposed bedrock east of Cobourg Harbour.

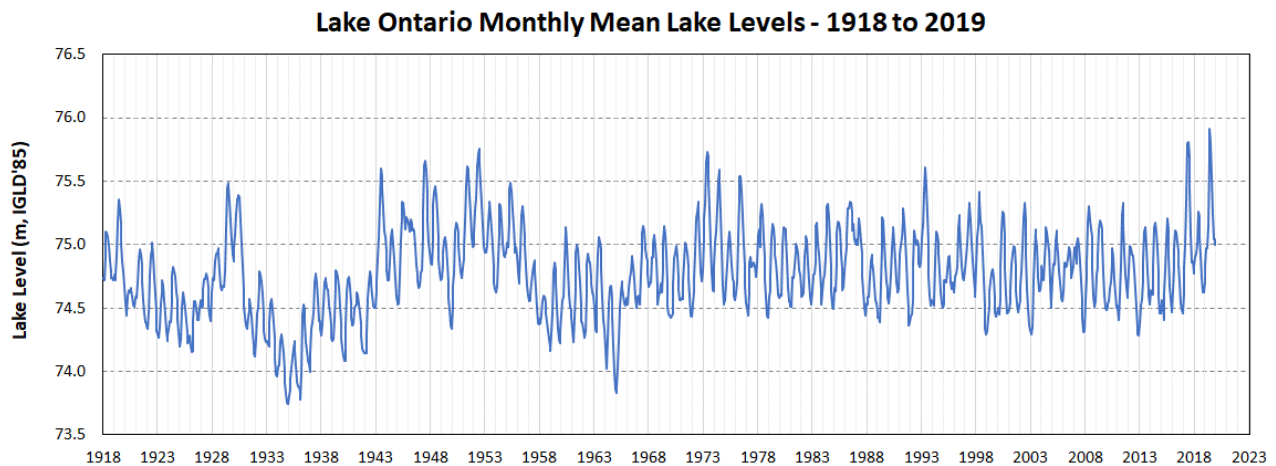
Figure 4.2 Monthly Mean Lake Levels from 1918 to 2019

Since the MNR publication more than 30 years of high-resolution static water level and storm surge data has been logged at numerous water level gauges around Lake Ontario. The monthly mean lake levels from 1918 to 2019 are presented in Figure 4.2. Moreover, numerical modelling, data processing and statistical analyses capabilities have improved significantly over those available more than three decades ago. Finally, water level regulation practices have been adjusted and adapted since the introduction of water level regulation on Lake Ontario in 1960, most recently with the implementation of Plan 2014 which came into effect in 2017.

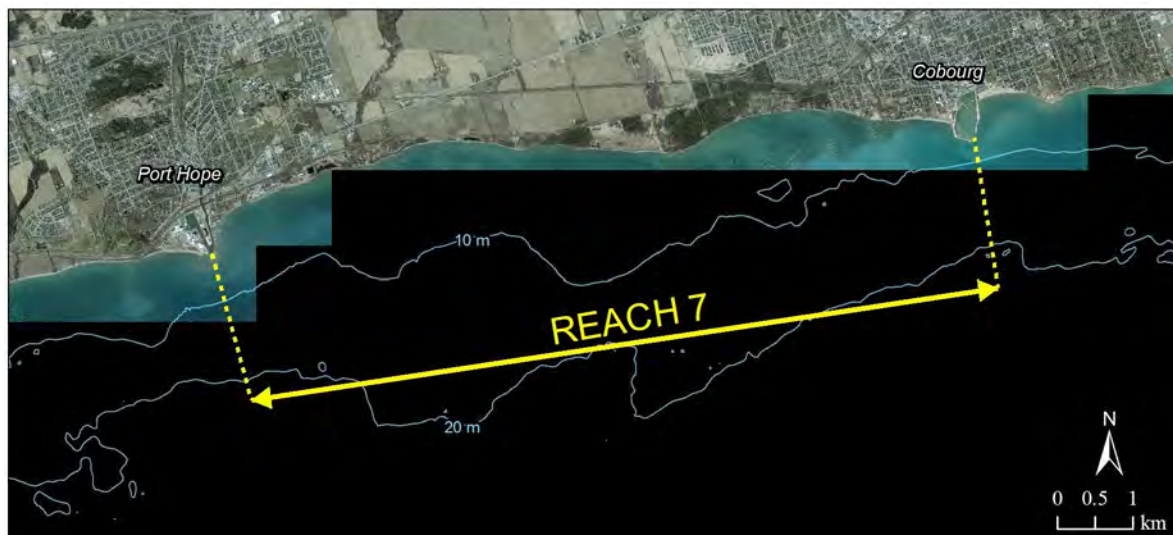
Figure 4.18 Reach 7 Boundaries from Port Hope to Cobourg

Today, much of the historical littoral cell from East Point to Presqu'ile has been sub-divided into small sub-cells by harbour jetties and port facilities on headlands, which are partial barriers to longshore sediment transport. For example, the coast from Port Hope to Cobourg is a sub-cell of the larger littoral cell from East Point to Presqu'ile. In this region there is only limited exchange of sediment with the adjacent sub-cells due to the harbour and rivermouth jetties at Port Hope and Cobourg (refer to Figure 4.18).

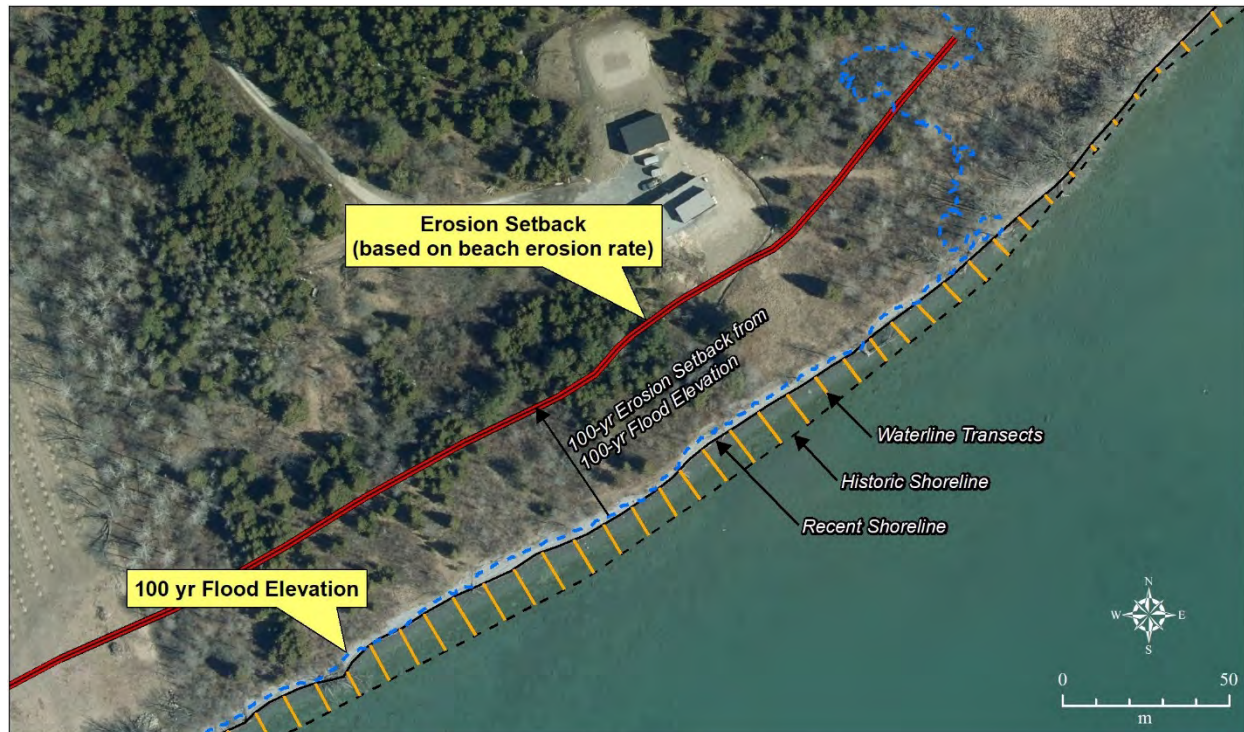
Figure 5.3 Erosion Hazard Setback Methodology for Beach Shorelines

This process was repeated for all eroding beach areas within the project study limits. A sample of the methodology is presented in Figure 5.3.

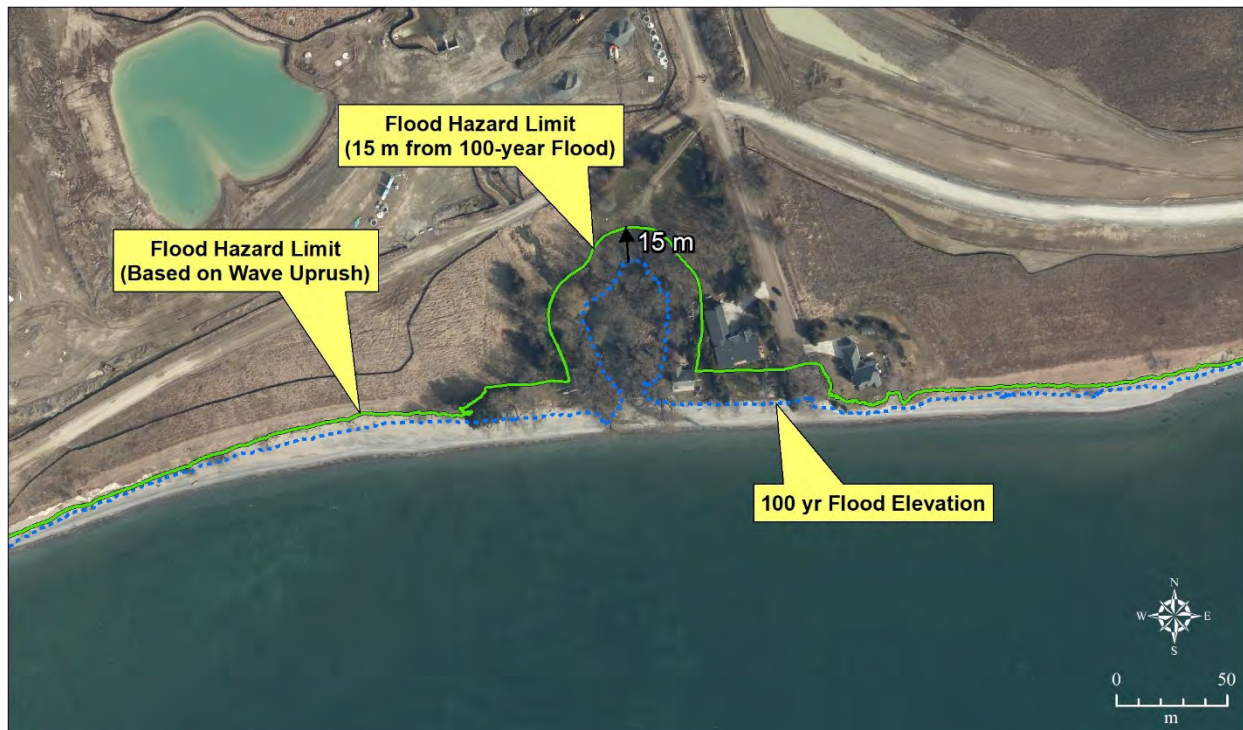
Figure 5.5 Sample of the Flood Hazard Limit with Runup Calculations and the 15 m Setback

Figure 5.5 provides a sample of the flood hazard mapping for a section of open coast where the wave uprush limit was calculated using the runup methodology. For the creek valley in the centre of the figure, waves are not able to propagate inland to the 100-year flood elevation and thus the use of the local runup value for wave uprush would not be appropriate. In these regions the standard 15 m setback has been applied. This type of review was completed for the entire study area to select the most appropriate methodology to map the wave uprush component of the flood hazard limit.

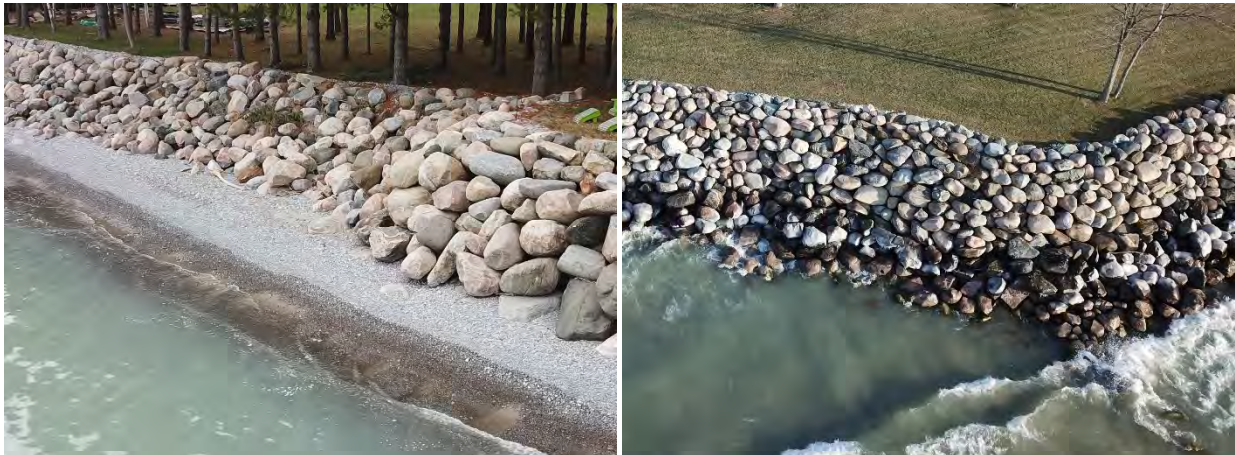
Figure 7.2 Sample field stone revetments on Lake Ontario

For certain regions particularly throughout the LTRCA, field stone (boulders) can be an acceptable and cost-effective alternative to armour stone as it is a naturally occurring material that can be locally sourced. Field stones are smoother and less angular than armour stone however, making them less stable on a slope. They also cannot be placed with as tight a packing density as armour stone therefore resulting in a higher void ratio. As such, field stone revetments must include at least two layers of boulders in the primary stone layer and be carefully designed by a qualified professional. Figure 7.2 presents examples of field stone revetments throughout the project region.

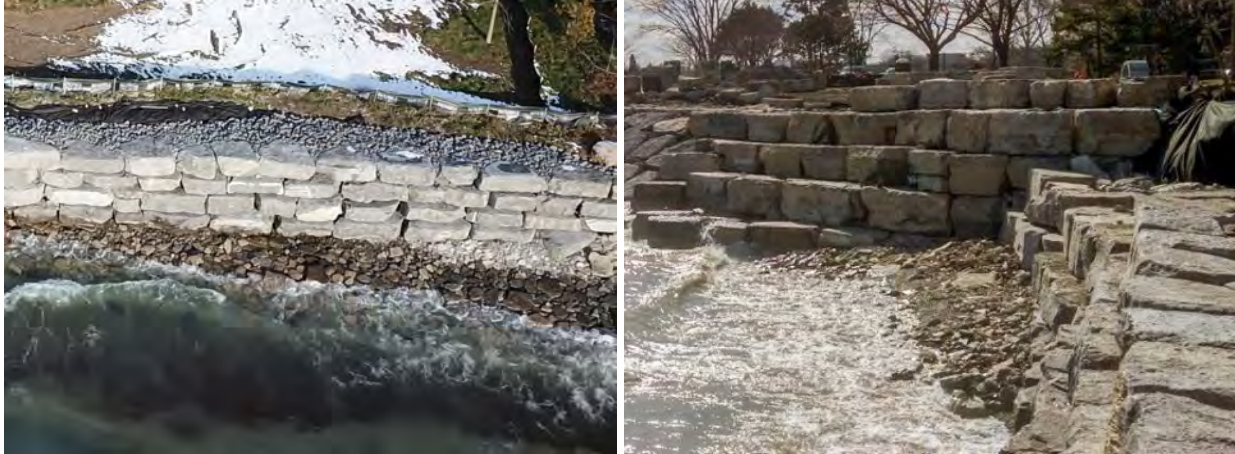
Figure 7.3 Sample armour stone seawalls on Lake Ontario

Where a vertical or near-vertical structure is preferred over a sloping structure due to space limitations or specific shoreline characteristics, stacked or stepped armour stone seawalls are recommended. Armour stone seawalls are particularly well suited for shorelines with flat, shallow bedrock. Special attention must be given to the design of the structure toe as vertical structures are often accompanied by increased vertical erosion of the lakebed (scour). Crest elevation, drainage and stone size are also critical considerations in the design of vertical or near vertical armour stone structures. Vertical armour stone seawall structures must be carefully designed by a qualified individual. Examples on Lake Ontario are provided in Figure 7.3.

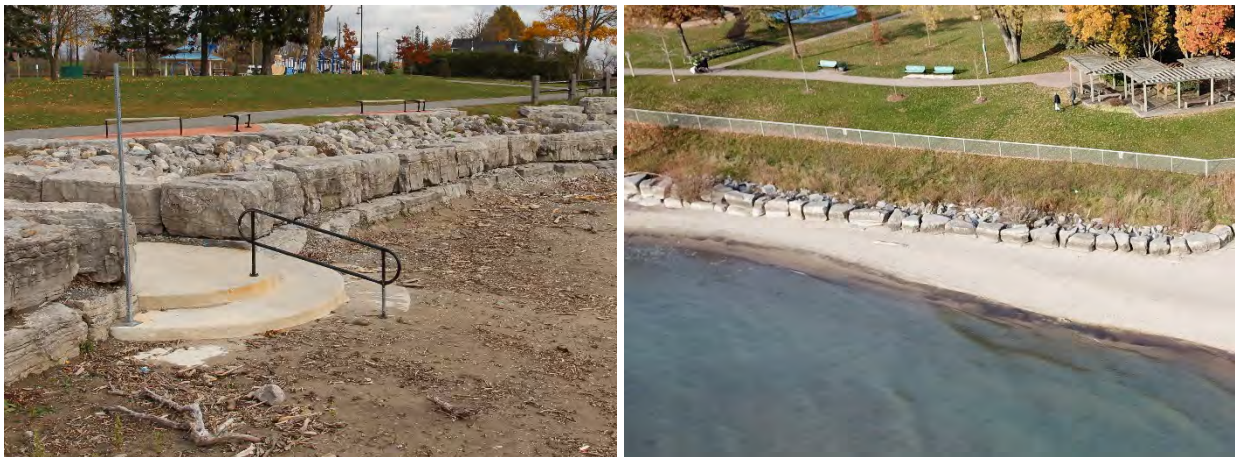
Figure 7.4 Sample armour stone beach curbs on Lake Ontario

Shoreline protection is generally not appropriate for dynamic beach environments. However, there may be some circumstances where protection and stabilization at the back of a beach is appropriate for existing development. For this scenario, an armour stone beach curb is recommended. A beach curb is a low-crested wall placed at the back of the beach, behind the beach crest, and founded at least 1 to 2 m below the typical beach crest elevation to account for potential variability in the beach profile. Figure 7.4 presents examples of armour stone beach curbs within the project region.
