## Port Darlington Shore Protection Concepts

November 16 2018 | 12875.101

Central Lake Ontario Conservation Authority  
100 Whiting Avenue  
Oshawa, Ontario L1H 3T3

W.F. Baird & Associates Coastal Engineers Ltd.

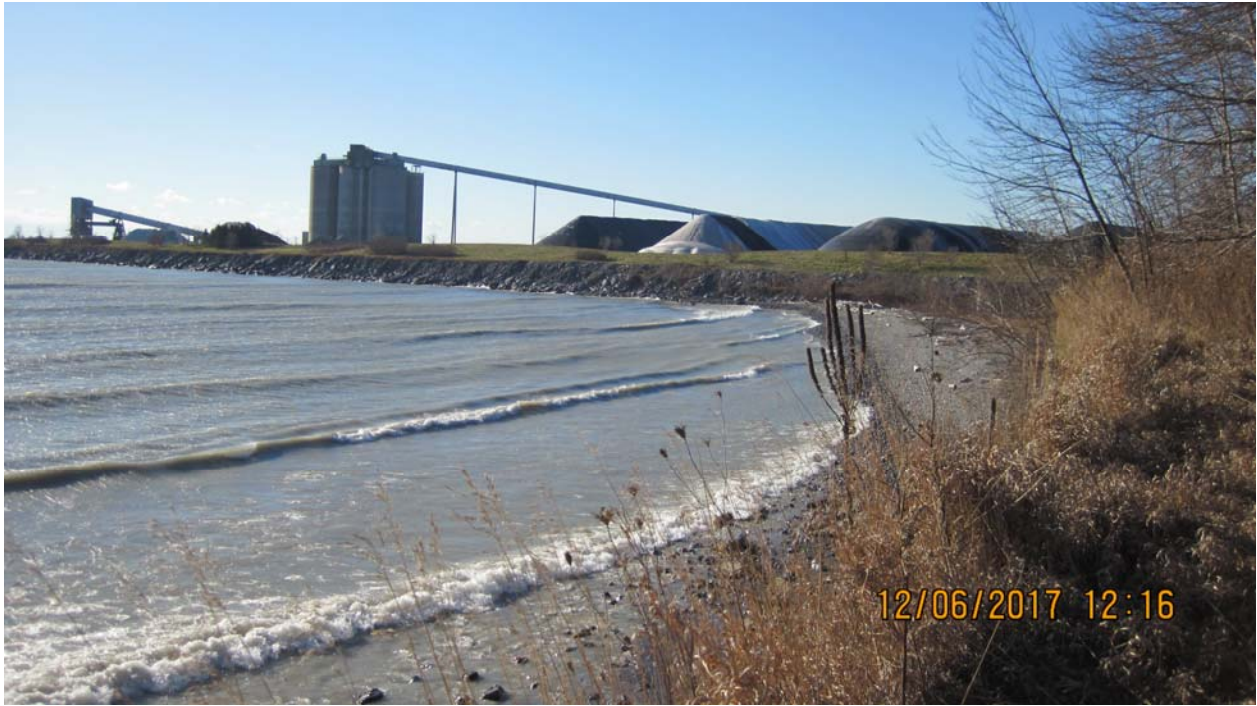
Figure 2.1: West end of study shoreline with fillet beach deposit on east side of St. Marys Cement

The west end of the study shoreline features eroding cohesive bluffs. A fillet beach has deposited at the west end of the reach, adjacent to the St. Marys Cement pier as shown in Figures 2.1 and 2.2. The beach is sand, cobble and boulder composition. A drainage channel has been excavated from the Westside Creek Marsh. On the day of the site visit (December 6, 2017), the beach deposit obstructed the channel mouth.

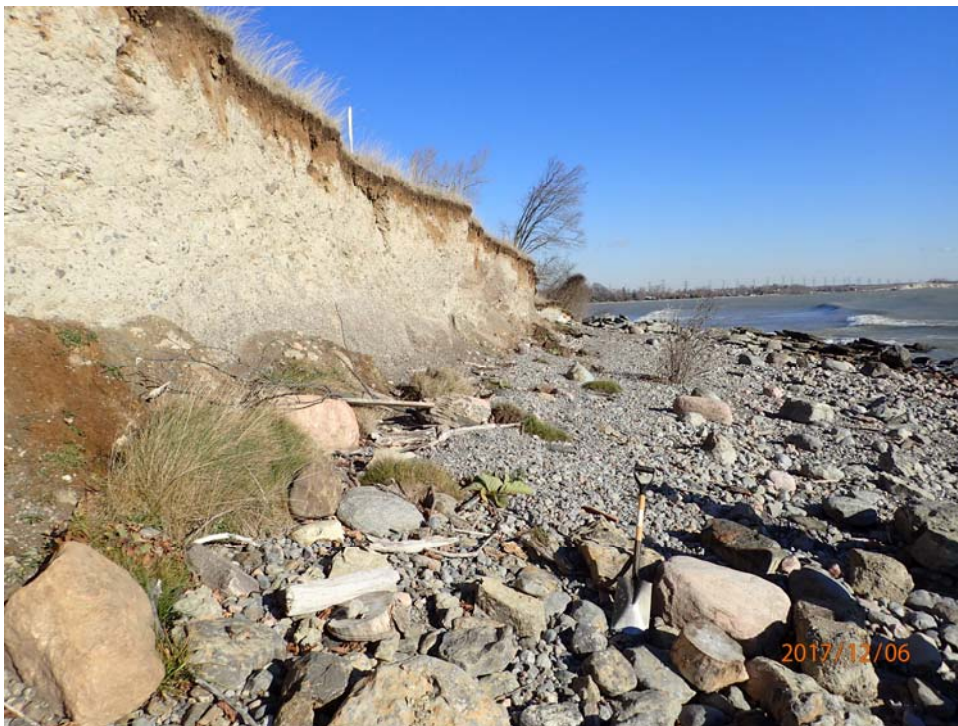
Figure 2.2: Eroding bluff and cobble and boulder beach at west end of study shoreline

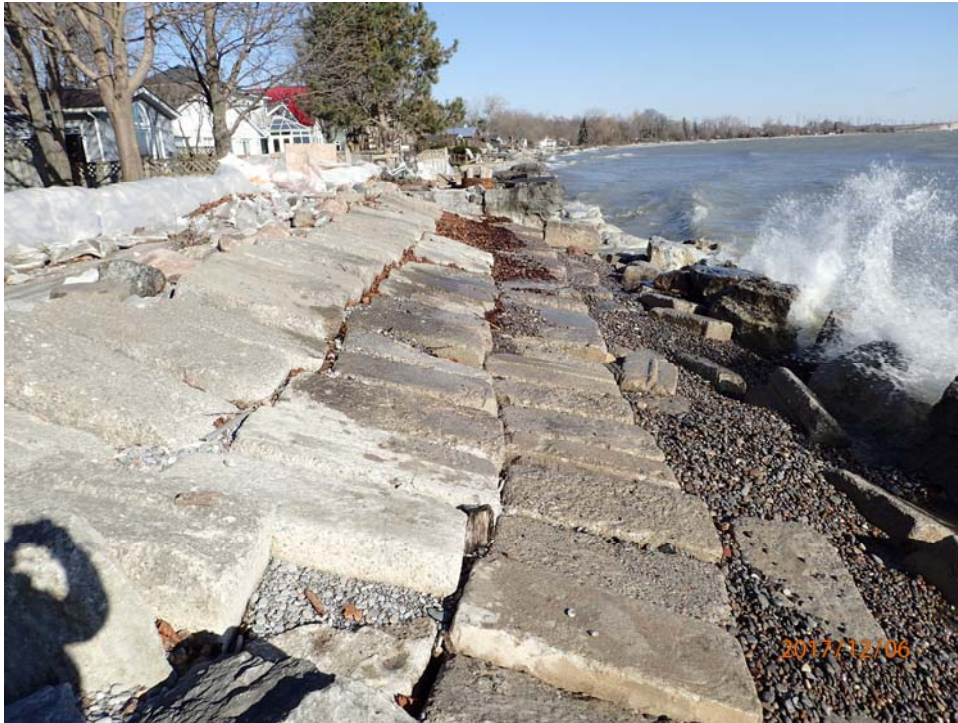
Figure 2.3: Concrete block revetment at Cedar Crest Beach Road

East of the cohesive bluff, along the shoreline backed by Cedar Crest Beach Road, the shoreline historically was a barrier beach, separating the Westside Creek Marsh from Lake Ontario. Presently, it is developed with permanent residences. The area has experienced erosion and flooding, and the shoreline is armoured with various types of protection including concrete wall, armourstone, gabions and ad hoc protection; examples are shown in Figures 2.3 to 2.6.

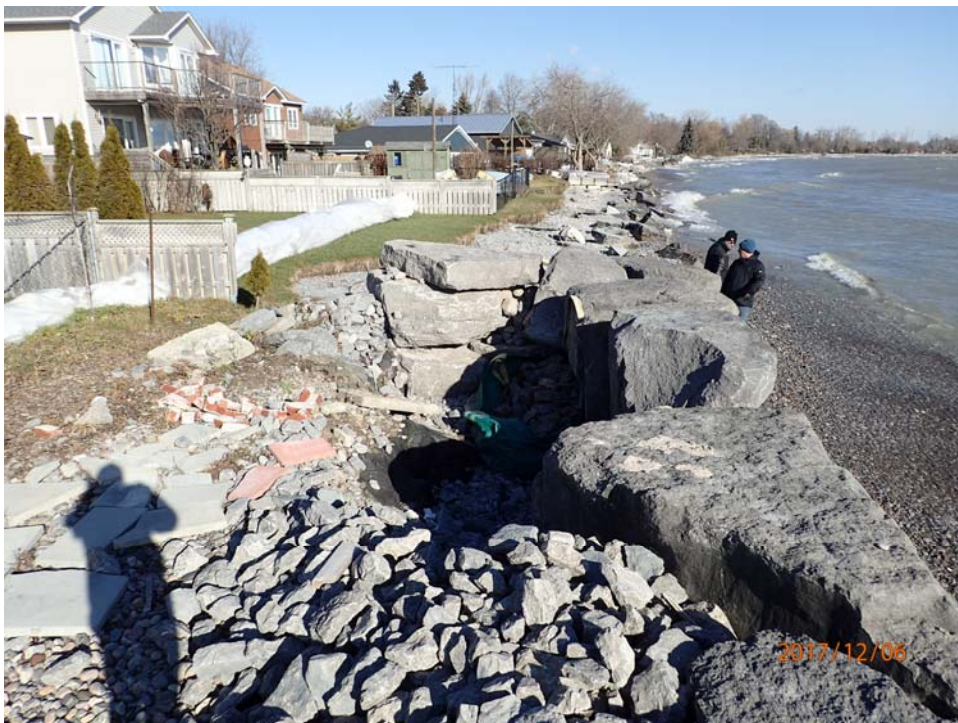
Figure 2.4: Armourstone protection at Cedar Crest Beach Road

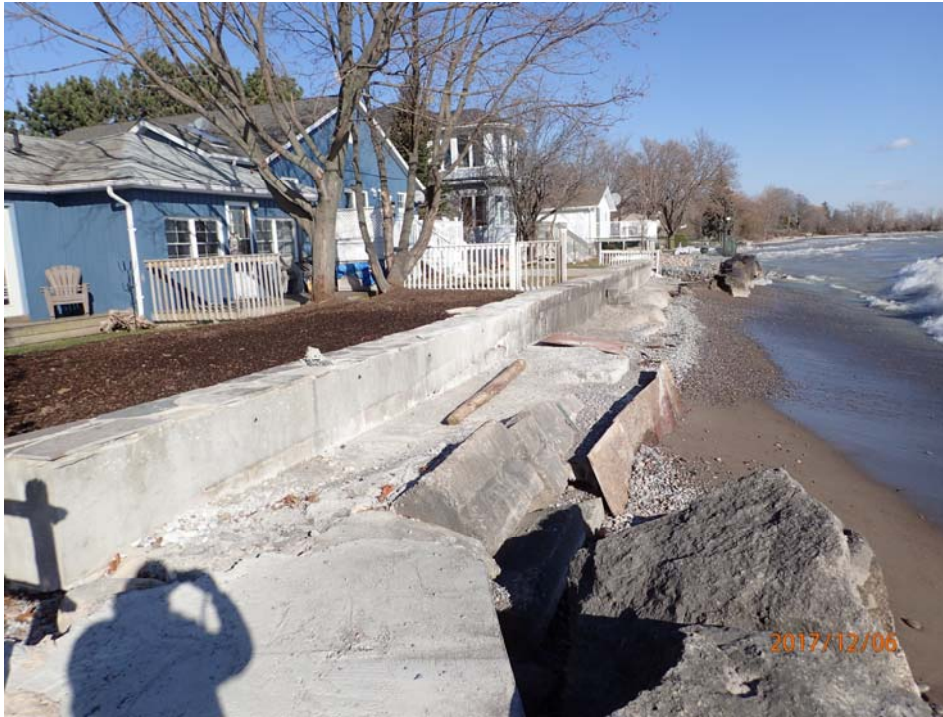
Figure 2.5: Concrete seawall at Cedar Crest Beach Road

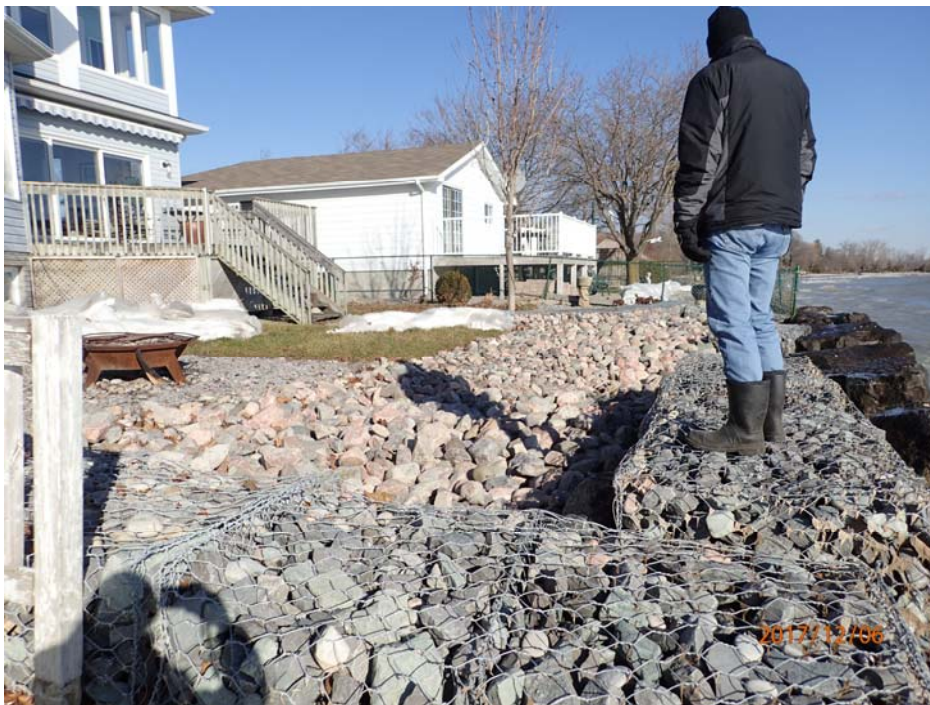
Figure 2.6: Gabion shore protection at Cedar Crest Beach Road

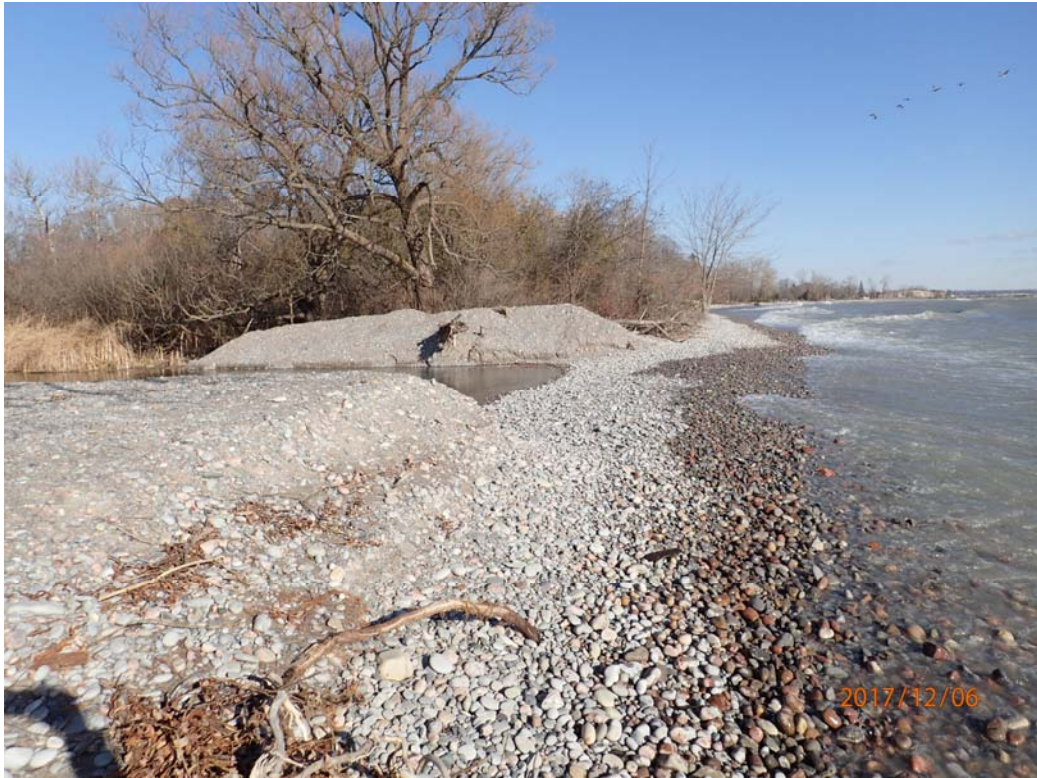
Figure 2.7: Mouth of Westside Creek with dredge spoil visible on east bank

Westside Creek marks the eastern limit of Cedar Crest Beach Road. A sand and cobble bar obstructed flow at the creek mouth on the day of the site visit (Figure 2.7). The mouth had been dredged to permit flow and dredge spoil was visible on the east bank.

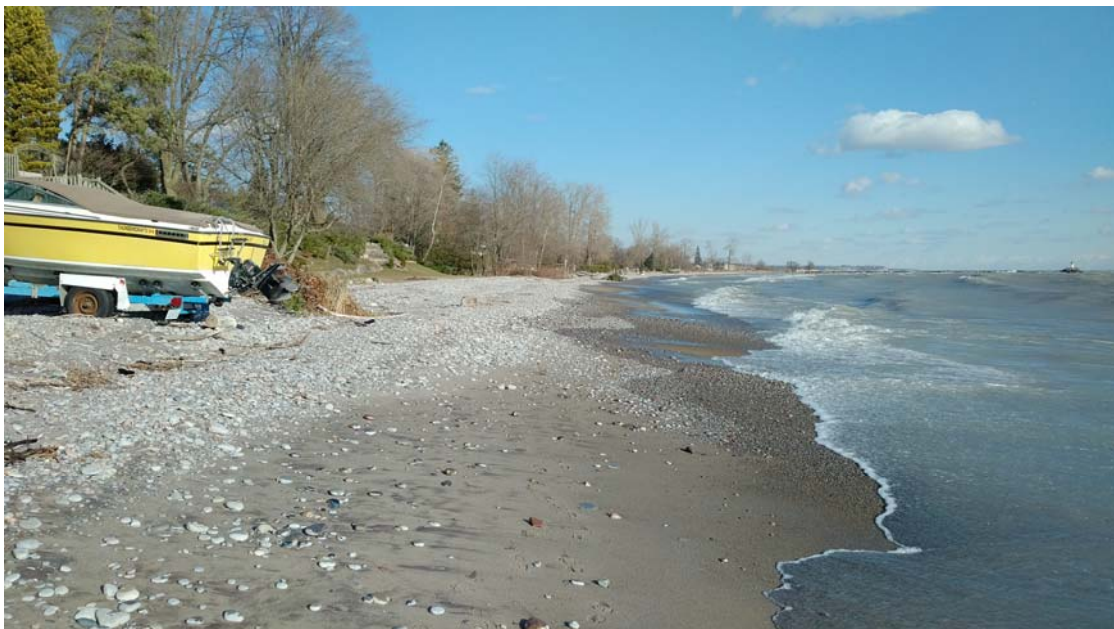
Figure 2.8: View east from Westside Creek along beach backed by Cove Road

The shoreline east of Westside Creek, backed by Cove Road is a sand and cobble beach. The properties are deeper than those along Cedar Crest Beach Road, and houses are generally setback further from Lake Ontario as shown in Figures 2.8 and 2.9. Shore protection structures have generally not been constructed and the beach has a natural appearance.

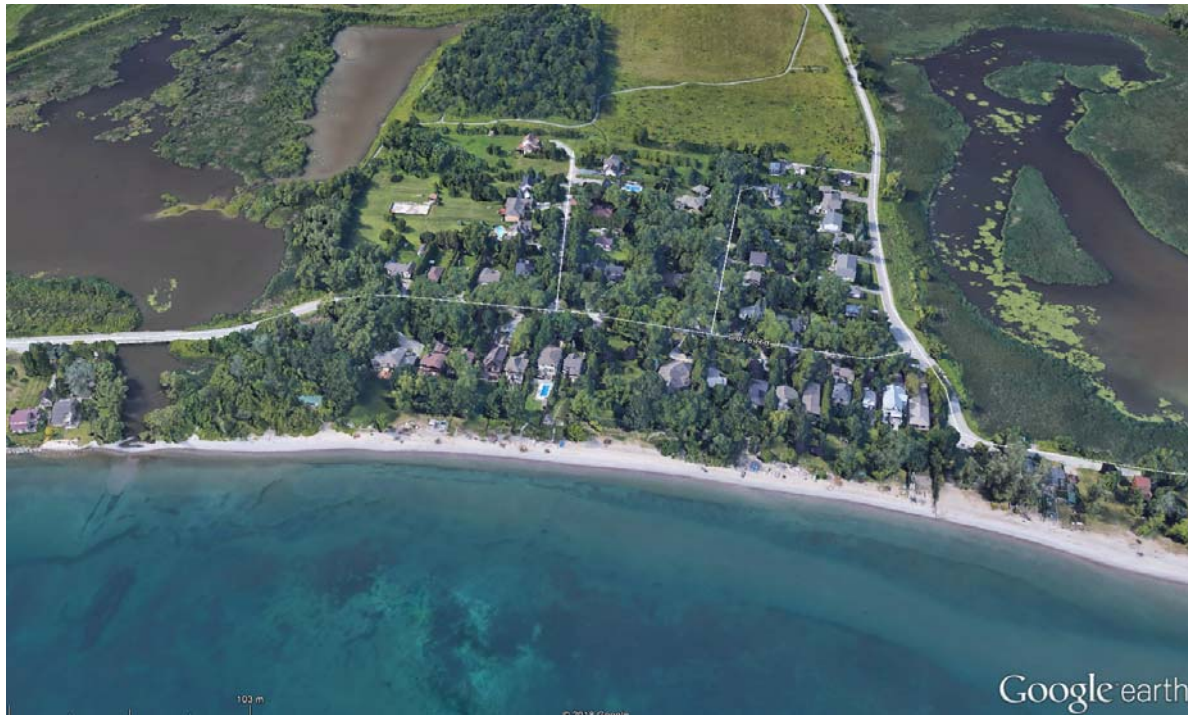
**Figure 2.9: Shoreline backed by Cove Road in centre of image, showing larger setbacks for houses compared to adjacent shorelines along Cedar Crest Beach Road and West Beach Road**

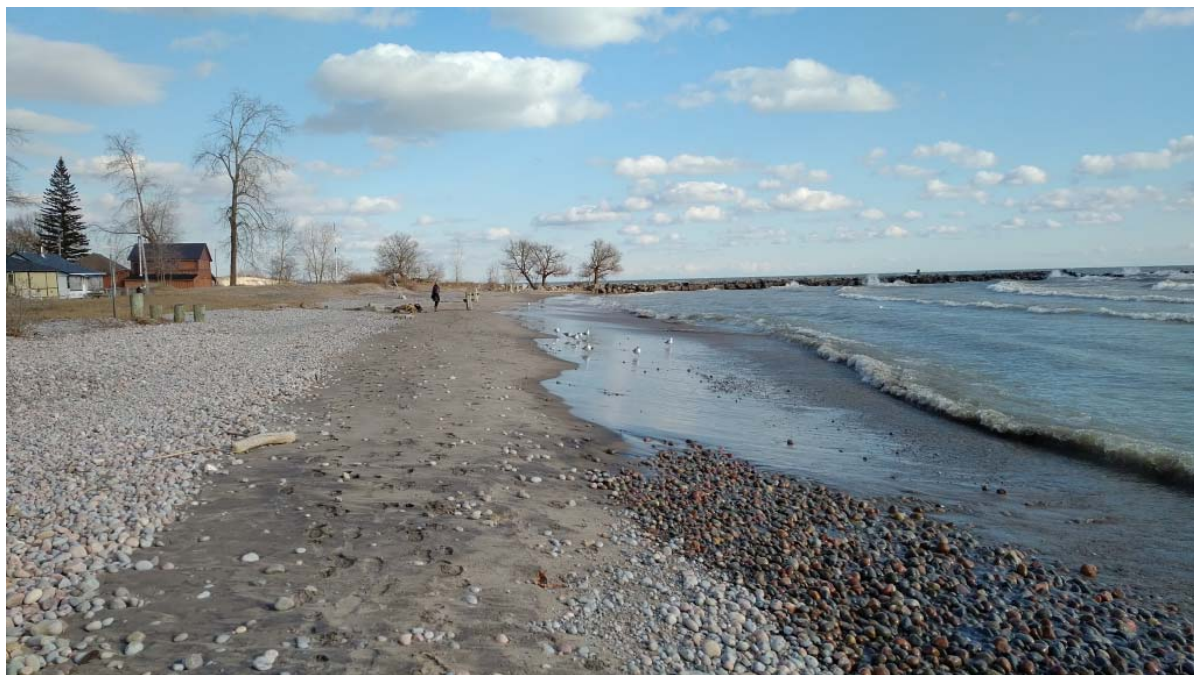
**Figure 2.10: View east along shoreline fronting West Beach Road with Darlington Harbour pier in background**

West Beach Road is located east of Cove Road. This stretch of shoreline is a sandy barrier beach that separates the Bowmanville Marsh from Lake Ontario. The beach has accreted as sediment is transported in an easterly direction and deposits on the west side of the breakwater at the mouth of Bowmanville Creek (Figure 2.10). The breakwaters that mark the entrance to Bowmanville Harbour are in a state of disrepair, and the sand is now bypassing the west breakwater by moving over, through and around the offshore end of the structure, and depositing in the channel. This is discussed further in Section 2.4. The houses are generally set back from Lake Ontario and the beach is unprotected along this shoreline.

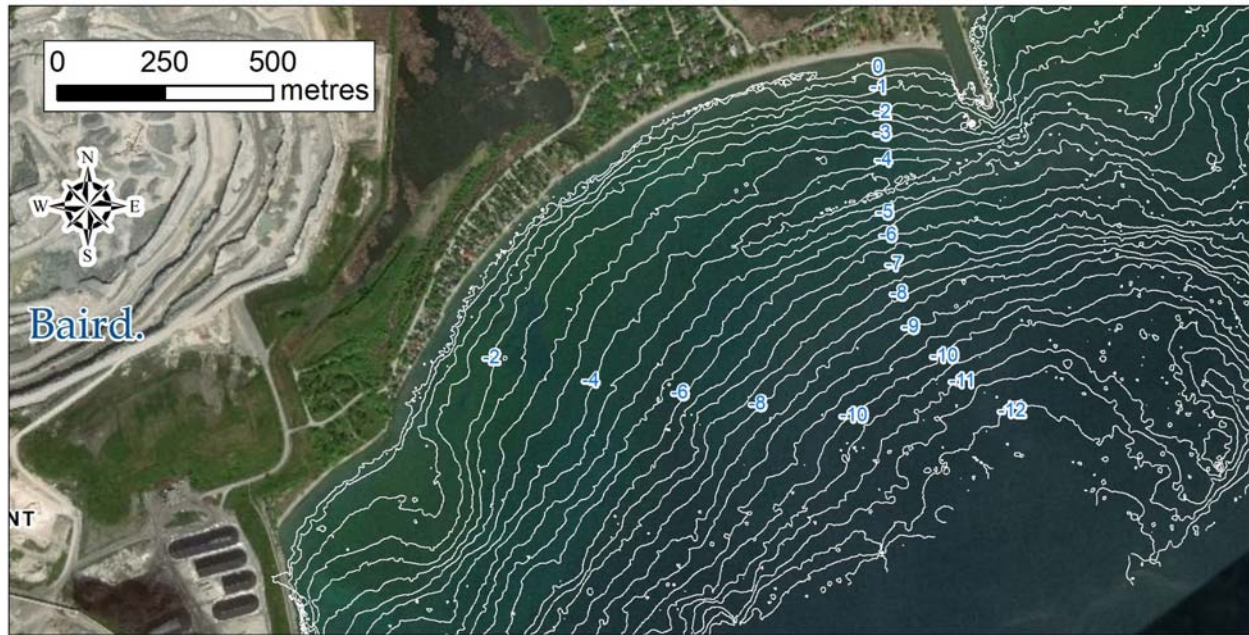
Figure 2.11: Bathymetry data from 2001 SHOALS

The 2001 Scanning Hydrographic Operational Airborne LiDAR Survey (SHOALS) data were used to define the bathymetry in the study area. Figure 2.11 shows a shallower shelf feature at the west end of the study site, indicating harder substrate compared to the lakebed to the east. The contours indicate an area of sediment deposition on the west side of the breakwater west of Bowmanville Creek where the fillet beach has deposited.
