Cranberry Marsh Management Zone Strategy

Lynde Shores C.A. Management Plan A Plan For Two Dynamic Coastal Wetlands

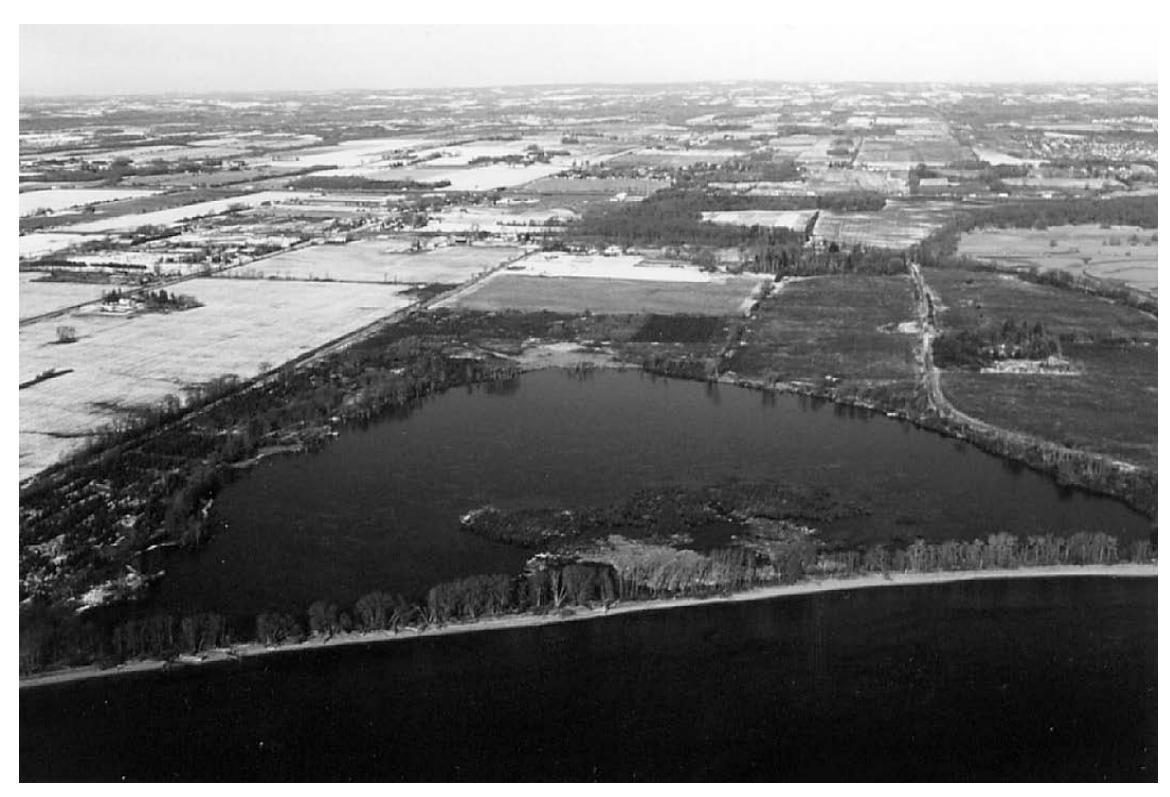
Aerial View of Cranberry Marsh Looking North from Lake Ontario (1999)

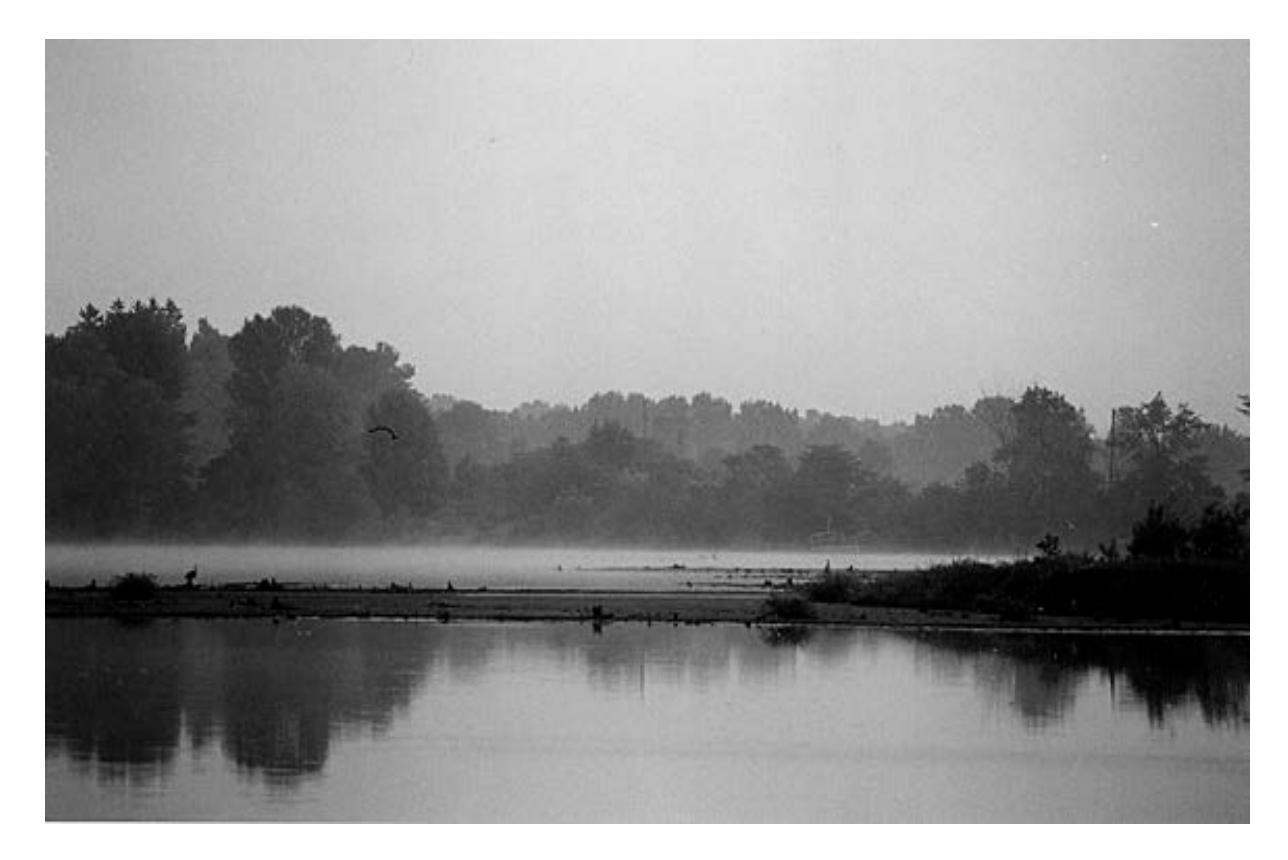
Looking East over Cranberry Marsh

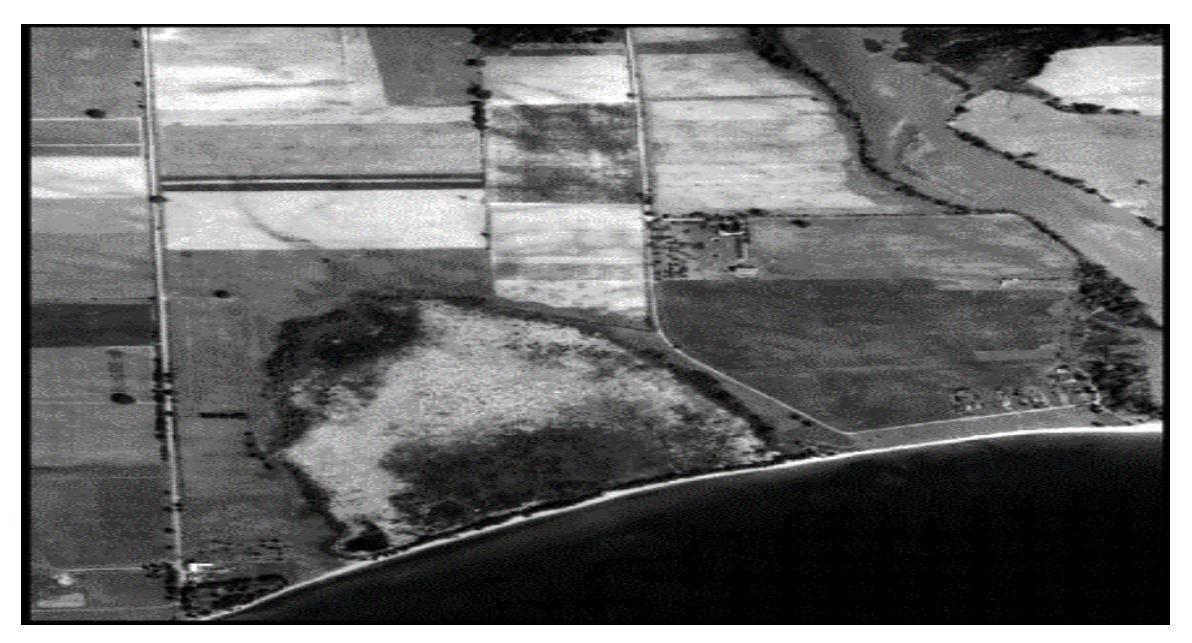
In 1954, the first available aerial photography indicated that Area 4 was completely vegetated.

Cranberry Marsh, 1954

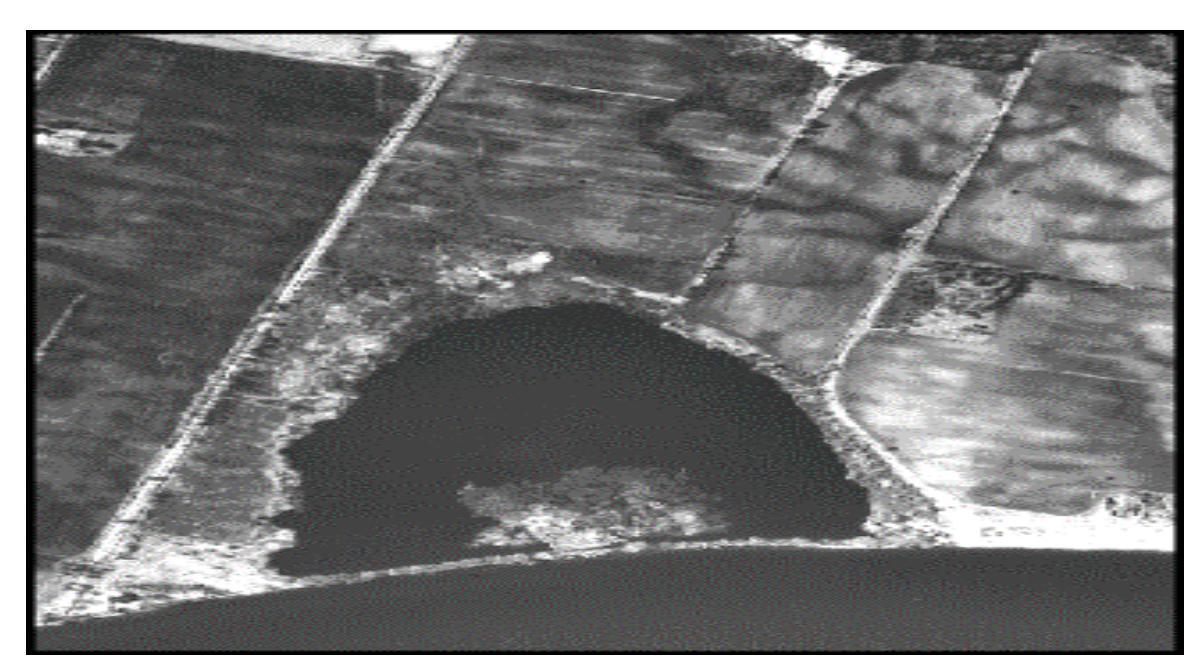
The decline is documented as occurring between 1983 and 1987. The 1989 aerial photography shows the open water state that Area 4 is currently displaying.

Cranberry Marsh, 1989

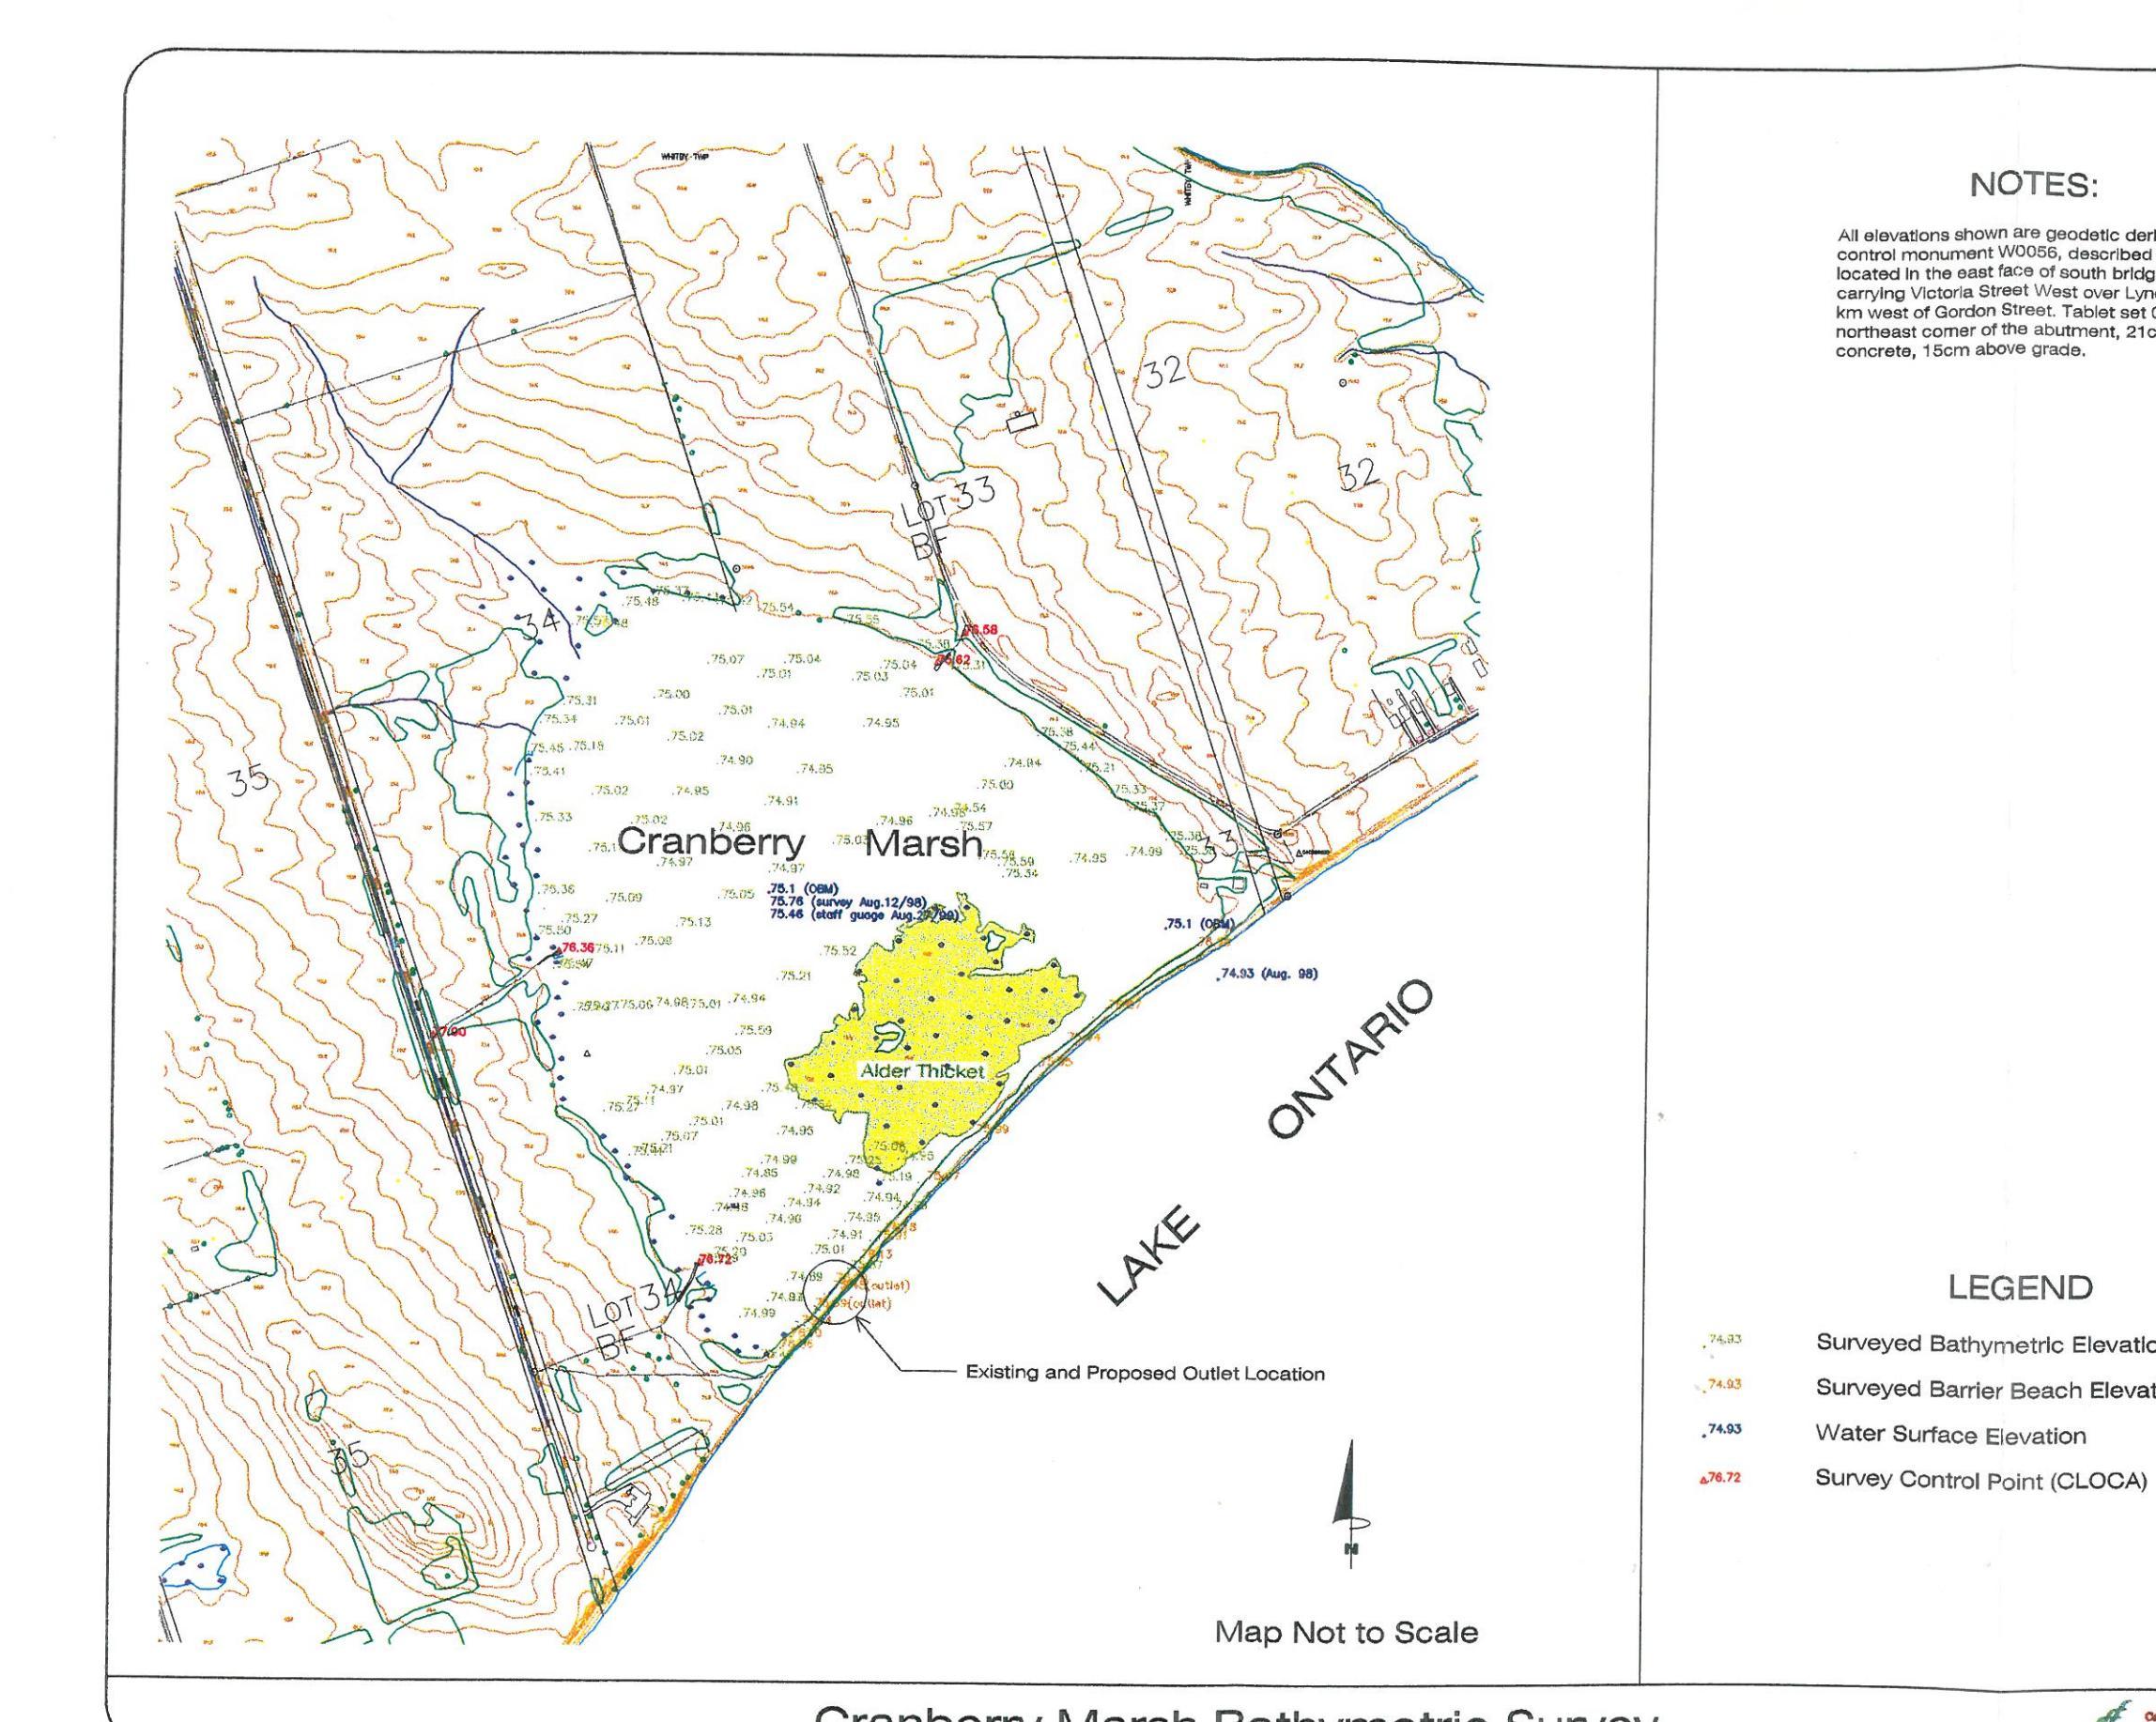
A survey of the *bathymetry* of the marsh, and *water level monitoring* indicates the current fluctuation in water levels through the various seasons, and variety of water depths in the marsh. This information is also used to forecast the appearance of the marsh under low water (drained) conditions (see Figure 3).

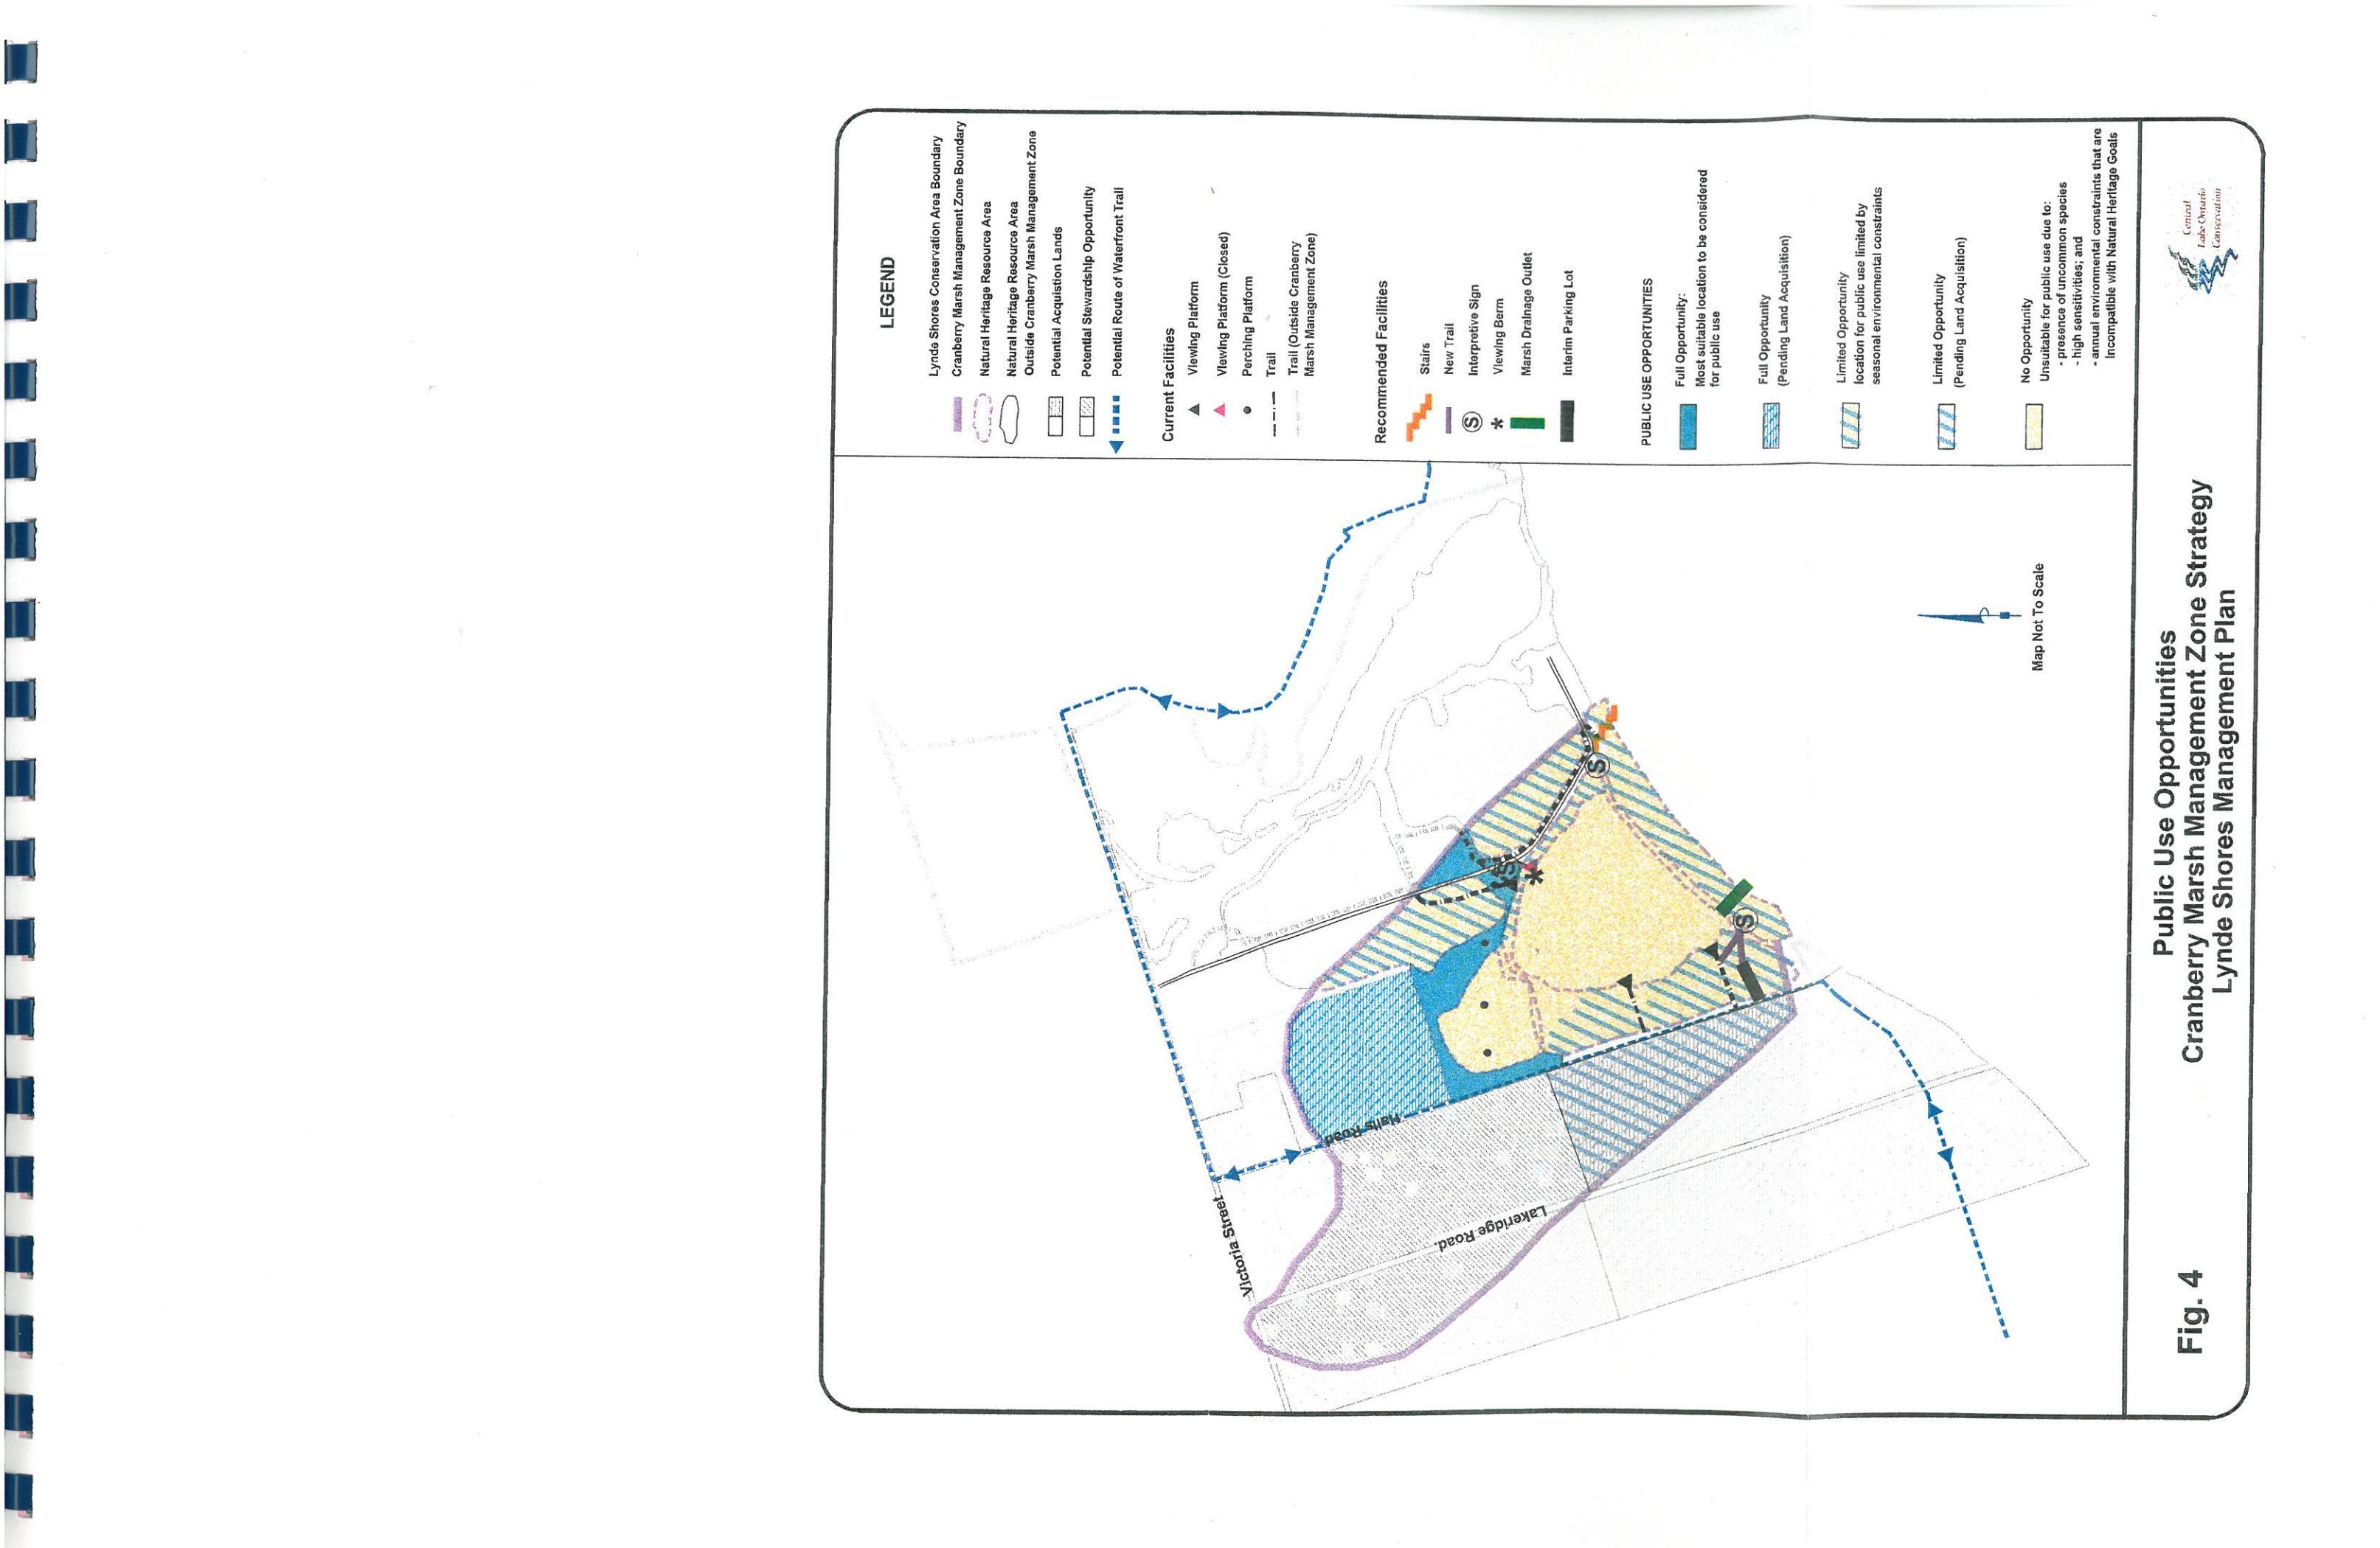
The facilities requested were compared with those presently on site, and relative to the natural heritage attributes of the site. The following list provides a summary of the recommendations concerning future public use. These recommendations are also summarised in Figure 4.

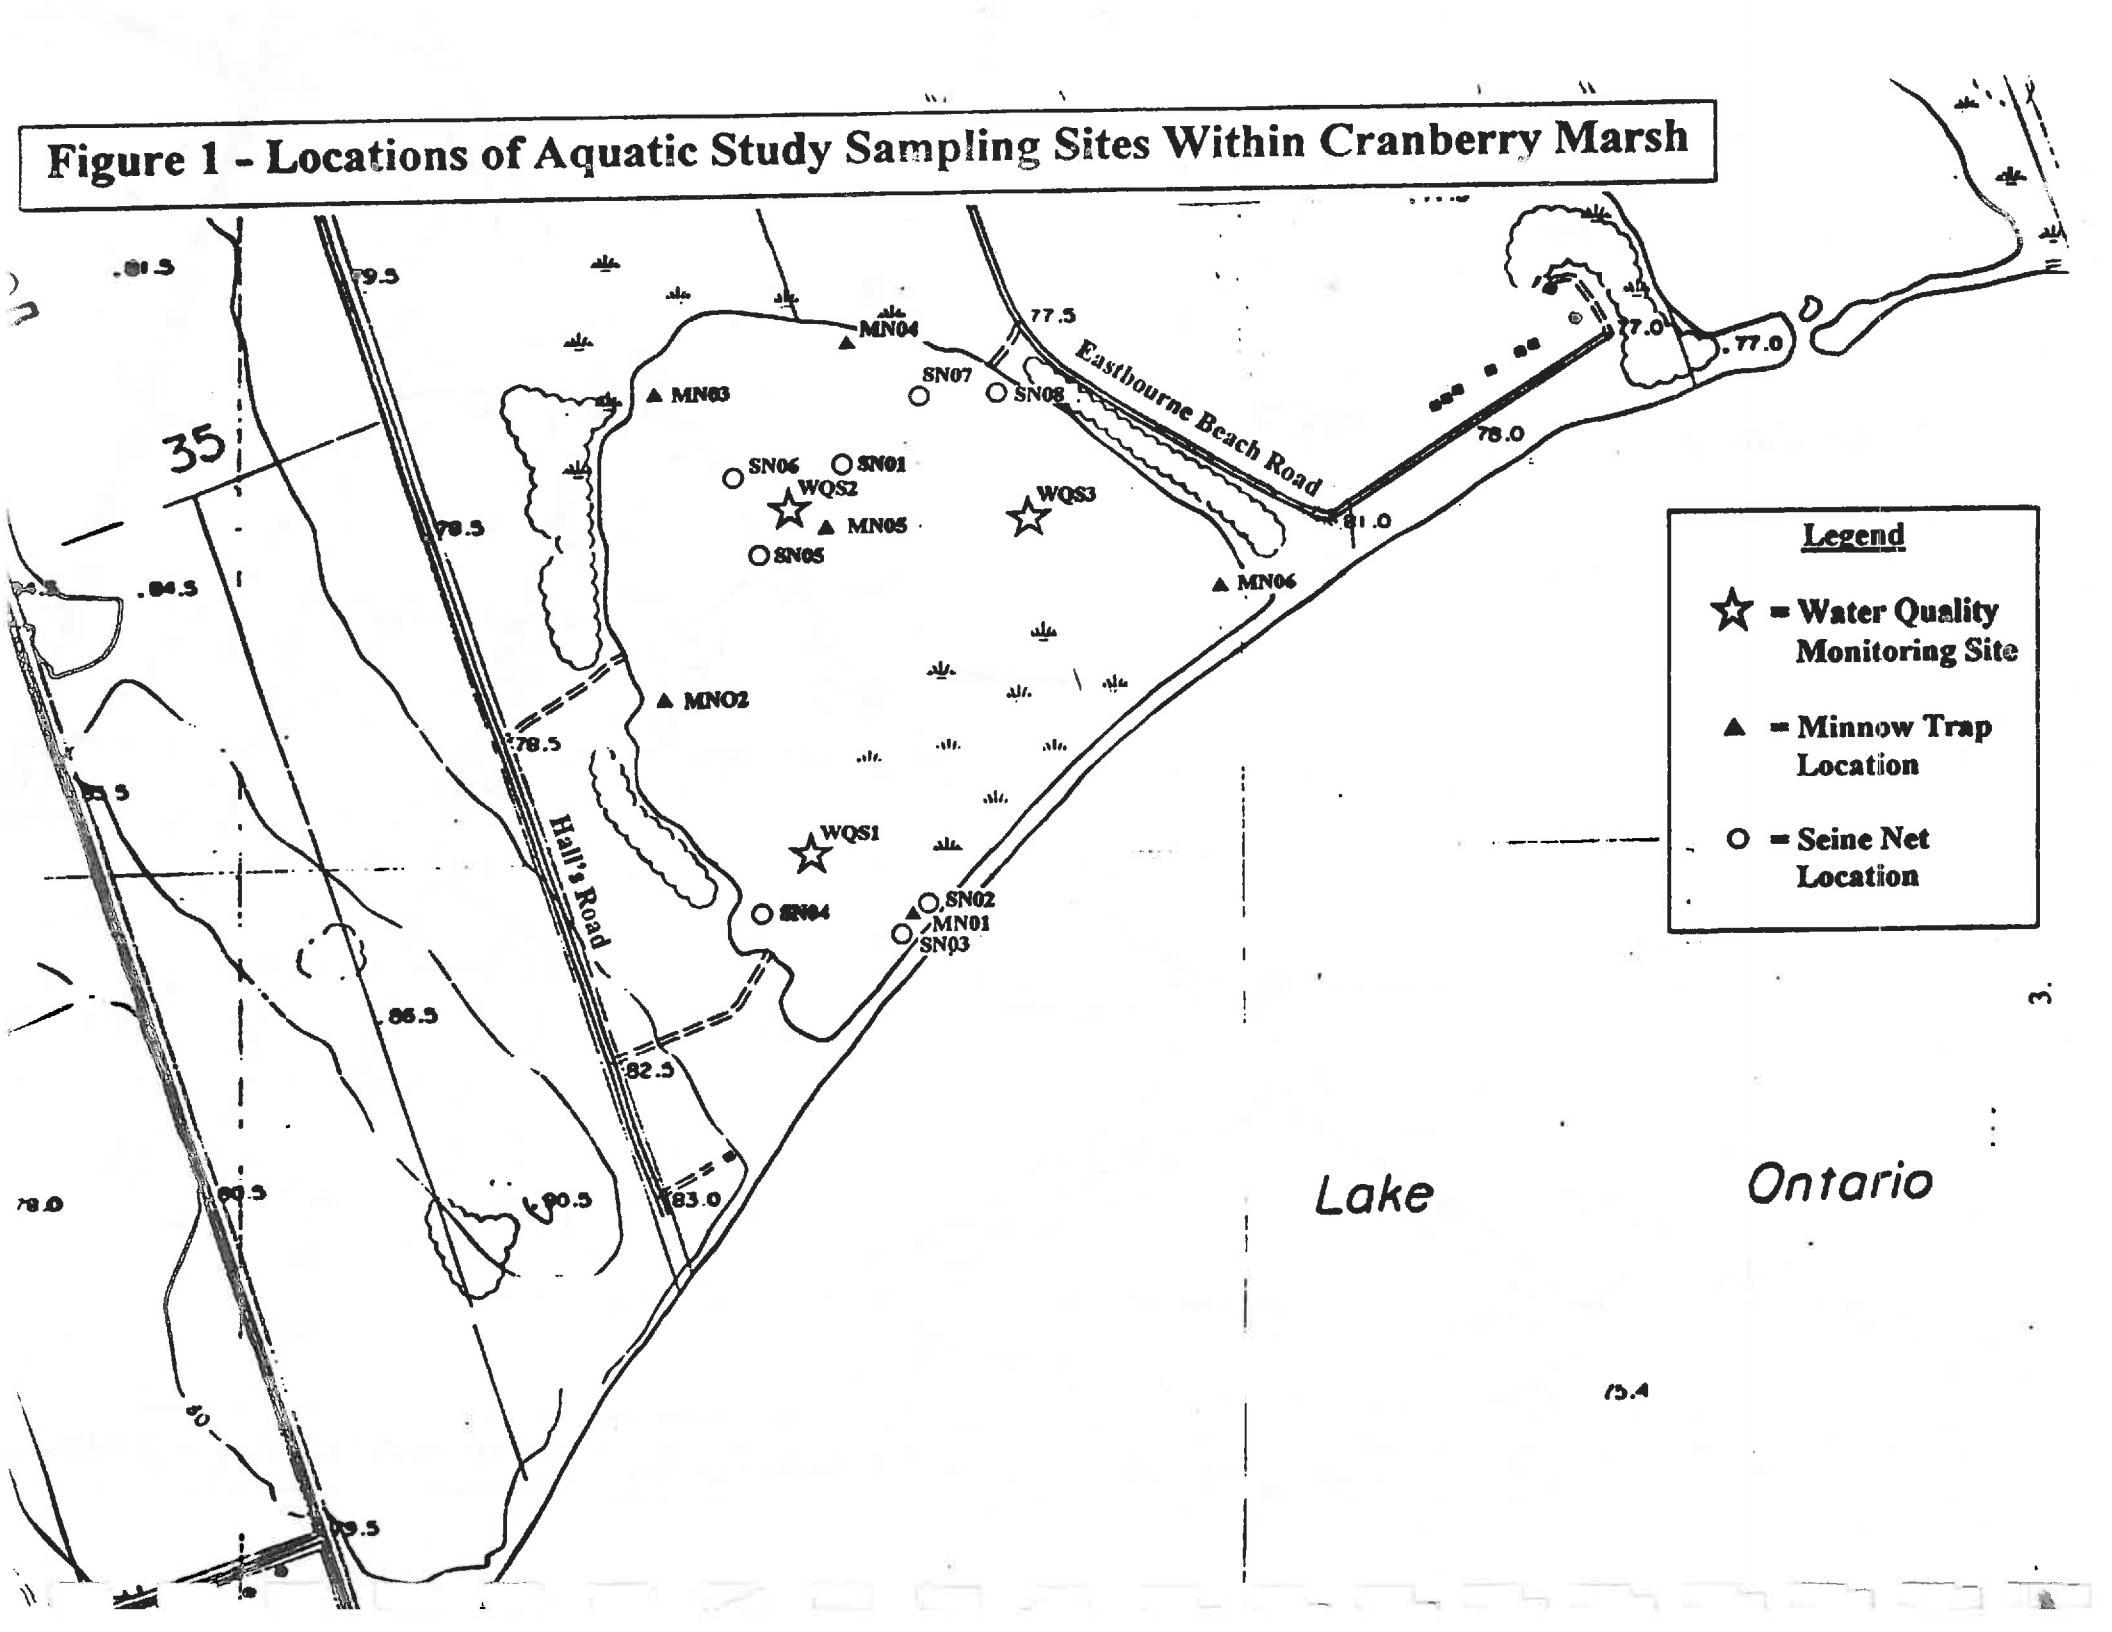
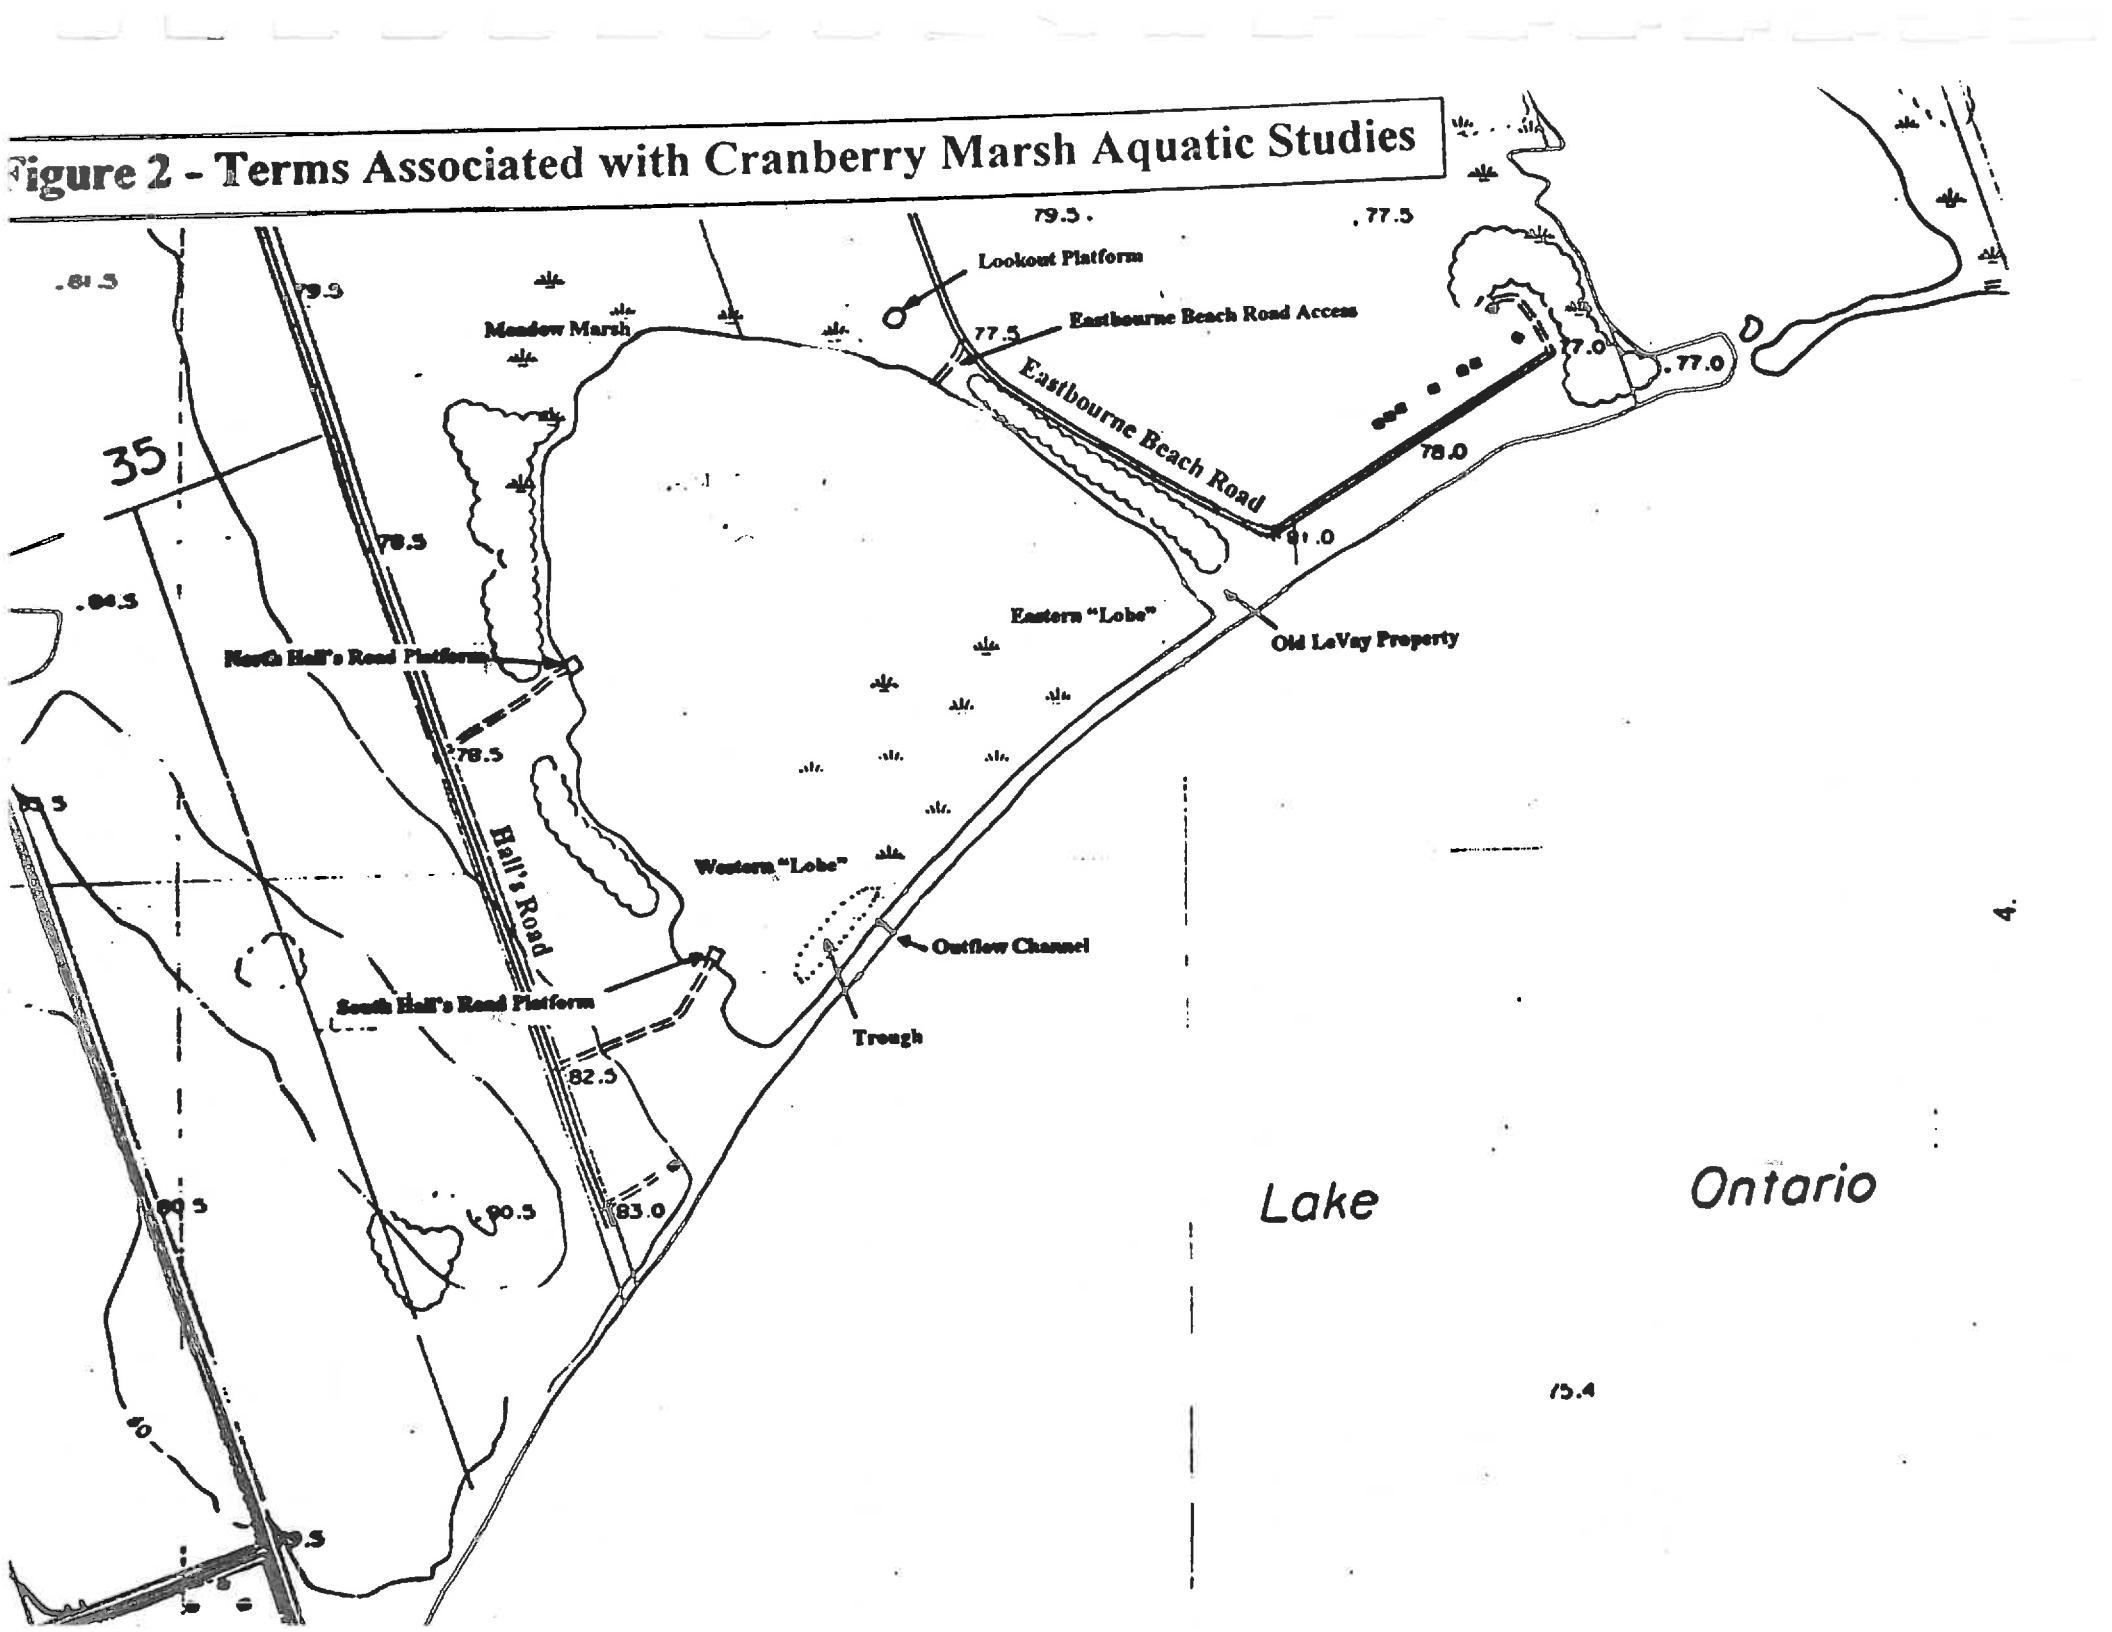
A total of six minnow traps were set in areas of the marsh where sufficient depth and cover (structure) would facilitate capture (Figure 1). Terms associated with site are illustrated in Figure 2. All minnow traps were baited with 45 grams of "Kibbles and Bits" dog food, and were set for a 21 hour duration. A description of each station is provided below;

- MN01 set at the outflow channel in the "western lobe" at a depth of 500 mm over a muck and branch substrate.
- MN02 set south of the north Halls Road Platform at a depth of 240 mm over a muck substrate.
- MN03 set off the west end of the Meadow Marsh at a depth of 150 mm over a muck substrate.
- MN04 set off the raised lookout platform depth of 150 mm over a muck and branch substrate.
- MN05 set at a stump close to the middle of the marsh 500 mm over a vegetated muck substrate.
- MN06 set in the "eastern lobe" on the old LeVay Property at a depth of 250 mm over a muck and branch substrate.
