REPORT

CENTRAL LAKE ONTARIO CONSERVATION AUTHORITY

DATE: September 19, 2017

SUBJECT: **Lake Ontario Shoreline Management at Port Darlington, Municipality of Clarington**

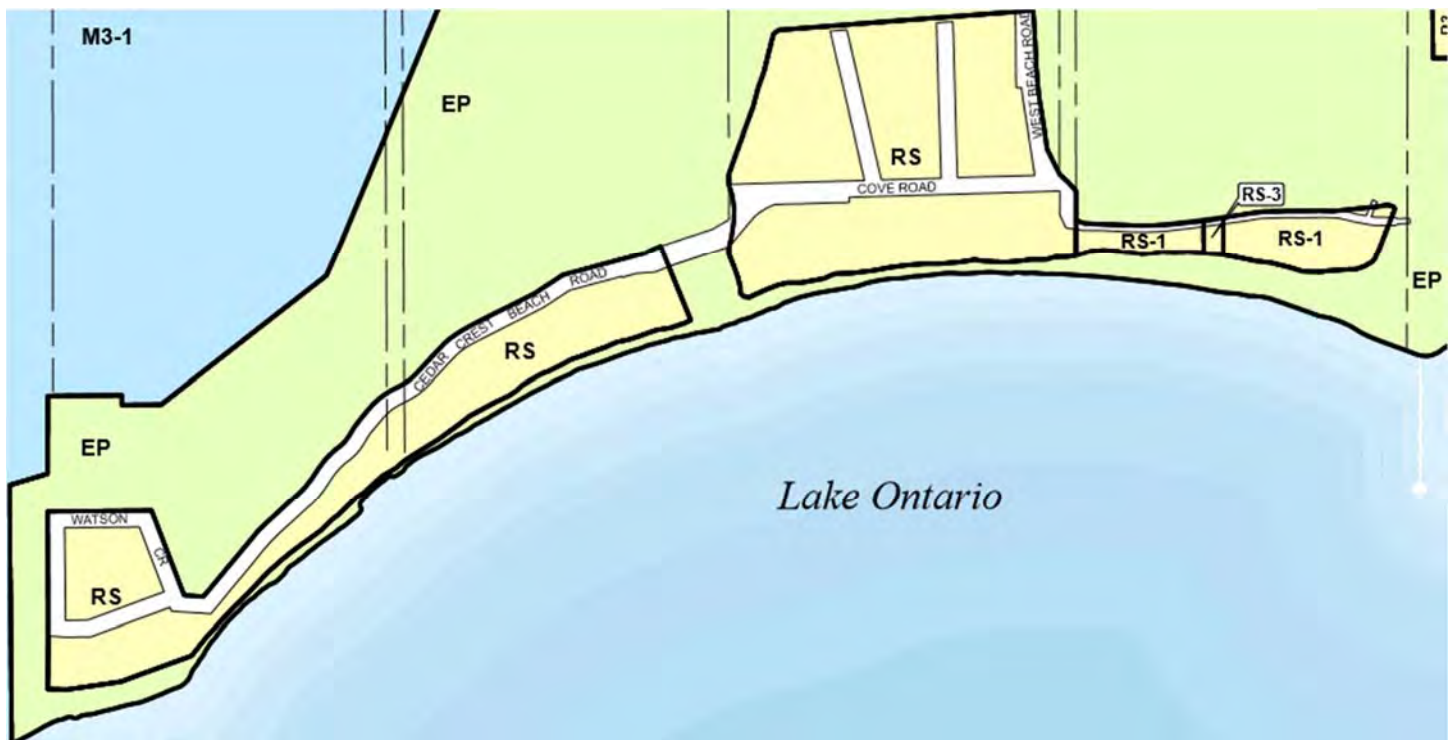
Figure 1: Current By-law 84-63 Zoning Schedule for the west Port Darlington Area

During the preparation of the draft By-law, the majority of the shoreline was initially placed within an Environmental Protection or “EP” zoning classification, which is intended to avoid development. Within the Port Darlington area, both barrier dynamic beaches and residential lots along both Cedar Crest Road and West Beach Road were placed entirely within an EP classification. However, following objections of several landowners at that time, a new Residential Shoreline “RS” classification was created and the final By-law, as enacted, limited the “EP” area to a thin strip along the Lake Ontario Shoreline. This zoning classification, with some modification, continues to the present and is reproduced in Figure 1. Below:

By-law 84-63 provides that within the Residential Shoreline zone, permitted residential uses include a single detached dwelling, a seasonal dwelling and a home occupation use. Further, existing seasonal dwellings may be converted to a single detached dwelling with private servicing.

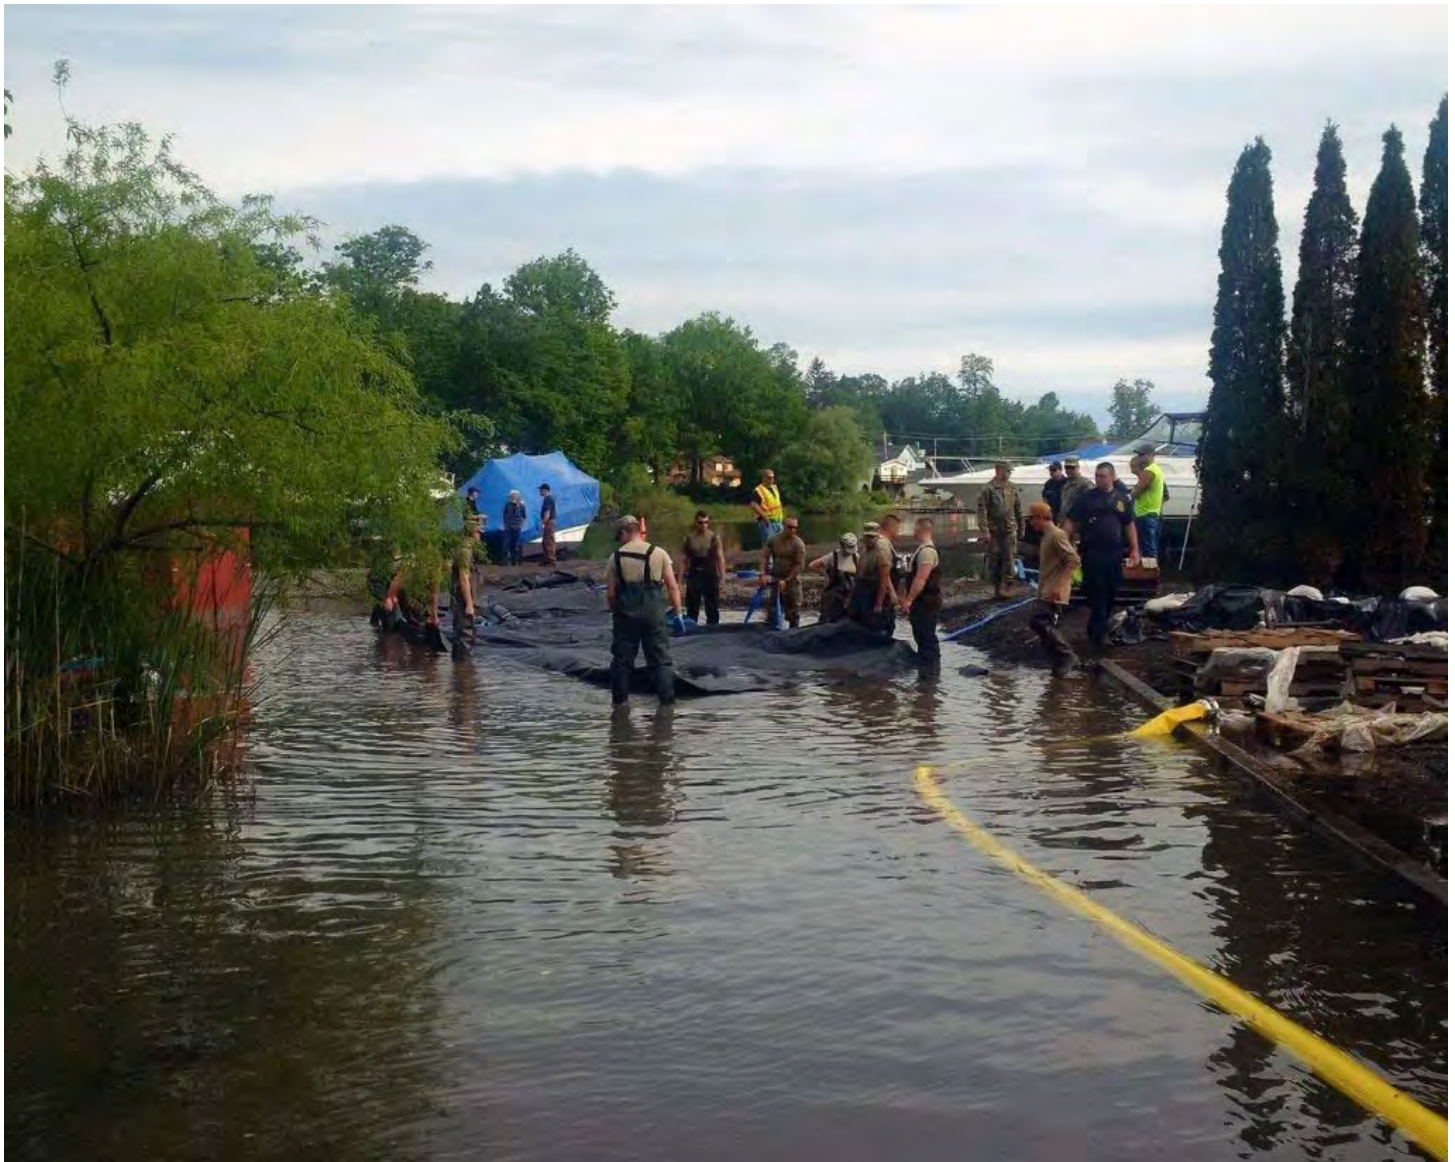
US Army National Guard members deploy a water-filled cofferdam by Sodus Point, New York, to help control Lake Ontario floodwaters. Credit: [US Army National Guard](#)

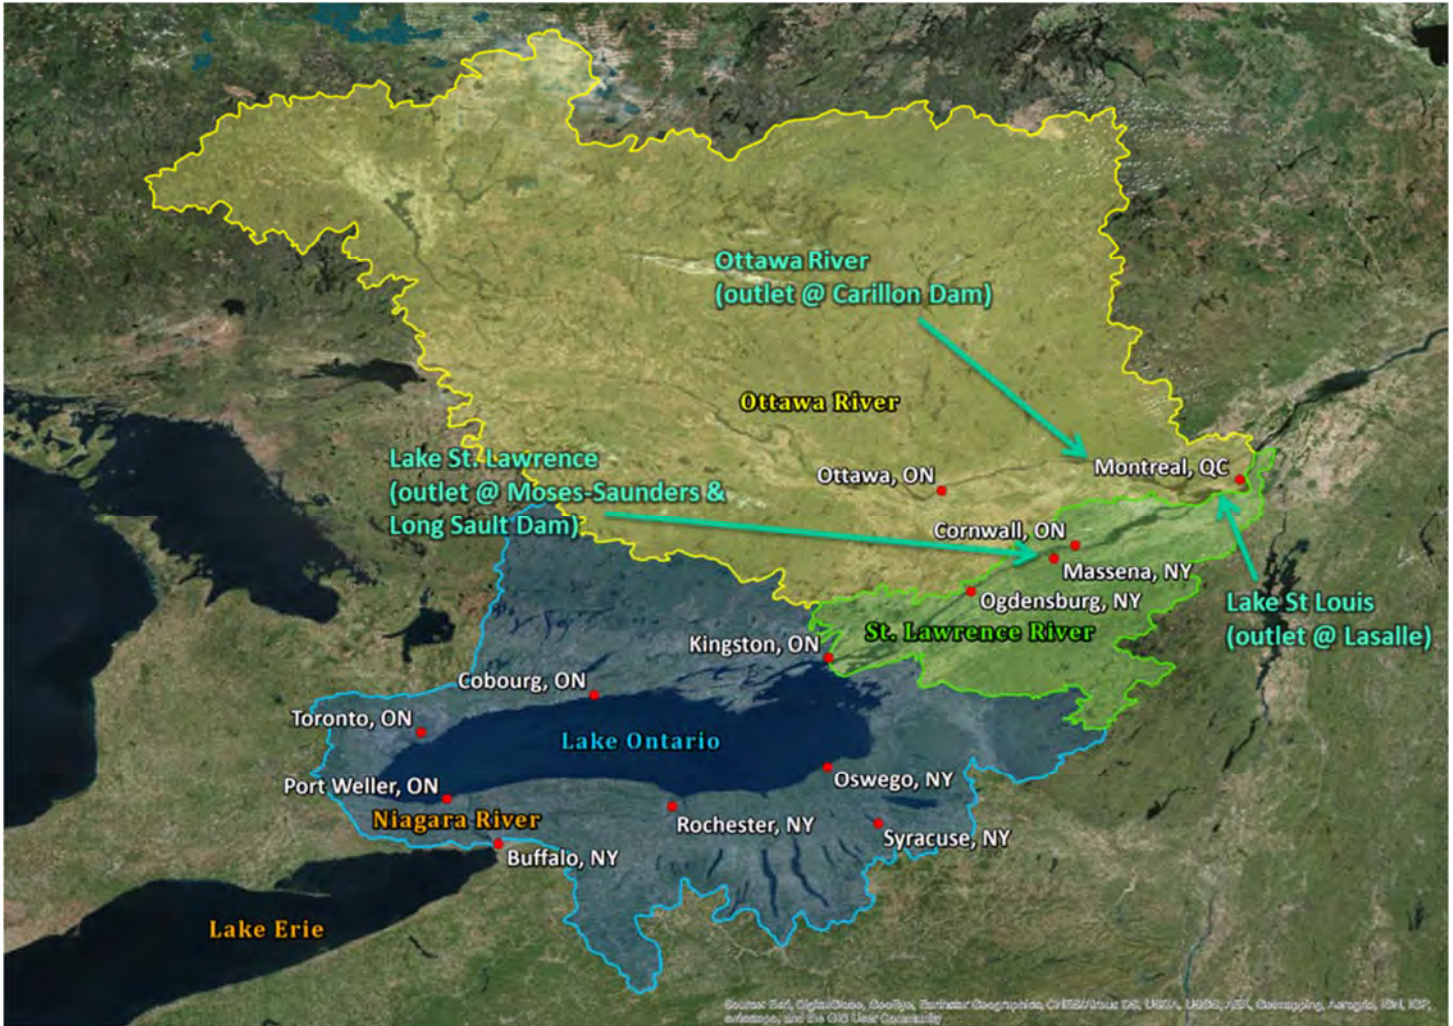
Watershed basin map with outlet locations. Credit: Environment & Climate Change Canada
